Monthly Status Report – April/May

Date of Report: June 1, 2021

The Project entitled “Big Horn Condo Siding Replacement & Exterior Upgrades” is designed by Hip & Humble Architects. The overall site consists of 24 wood-framed buildings. Of the 24 buildings, they are made up of 13 duplexes, 9 four-plexes, 1 tri-plex and 1 five-unit complex. The work is developed into two phases; Phase 1 contains 11 buildings, and Phase 2 contains 13 buildings. While the work is scheduled from April thru November, physical work is limited to weather conditions. The base contract includes removal of the wood siding and replacing it with the metal siding and wainscot; and the Owner options include windows, front and patio doors, and garage doors. Deterioration rework is considered “contingency work” and is included as a part of the Base Bid through an approved Change Order. The project is being performed by Langlas & Assoc as the General Contractor, and KCD Enterprises as the main subcontractor under the contract by Langlas & Assoc. Work commenced on site beginning April 19, 2021.

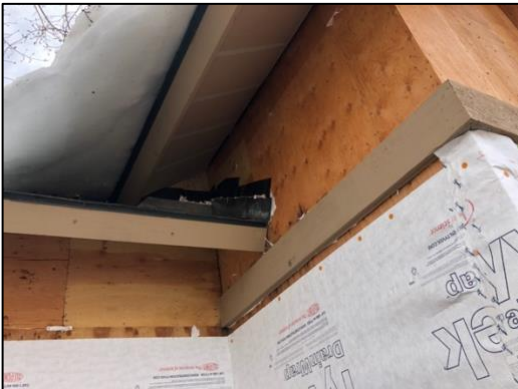
Upon removal of the building siding and vapor barrier, it was confirmed that proper installation of step flashing was identified at wall-to-roof conditions. However, it was also noted that these same locations did not have existing diverters in place. As a part of the contractor's installation, the diverters will be installed and verified by MCM. New building wrap (Tyvek material) has been placed throughout the building.

Existing Step Flashing In Place – No Diverter

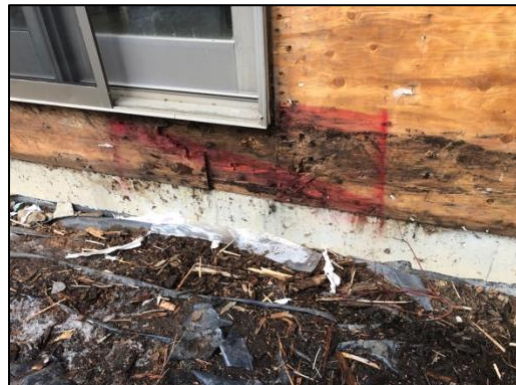
Bldg E1 Unit #9 Deteriorated Lumber

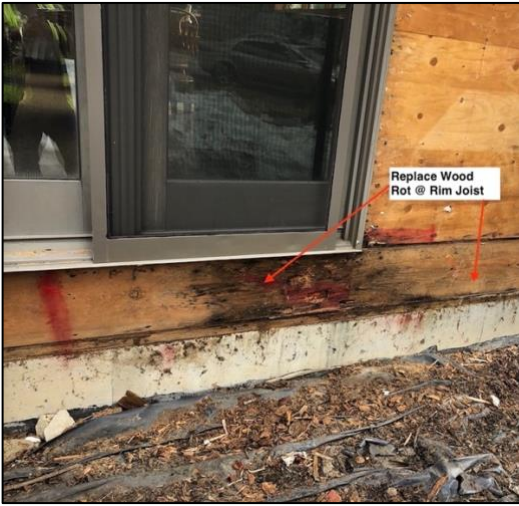
Bldg E1 Unit #8 Rotted Rim Joist

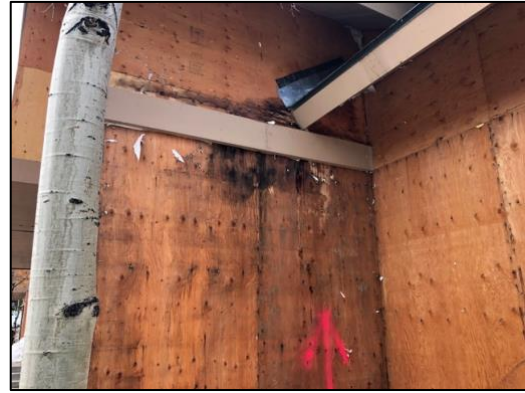
Work commenced on May 6, 2021 with removal of the wood siding and the vapor barrier. Unit #28 (exterior entry area) showed evidence of significant suspicious mold on the existing sheathing; the area was marked by MCM for removal and further review. After sheathing was removed, the wood top plates were deteriorated by mold, and were identified by MCM for further review and recommendations by Redleaf Engineering. The Structural Engineer provided a remediation for the replacement of the top plates. The work was performed by the contractor and verified by MCM. Photos of finished work was forwarded to the Redleaf Engineering. Vertical studs in this area were treated by the Mold Specialist. It was assumed that this was caused by the lack of a diverter in this location. Other areas throughout the building were identified and mitigated by the Mold Mitigation Specialist.

Bldg E4 Unit #28 Entry Exterior Mold - 1

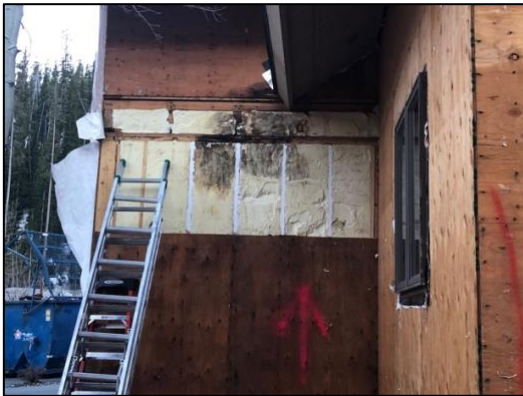
Bldg E4 Unit #28 Entry Exterior Mold - 2

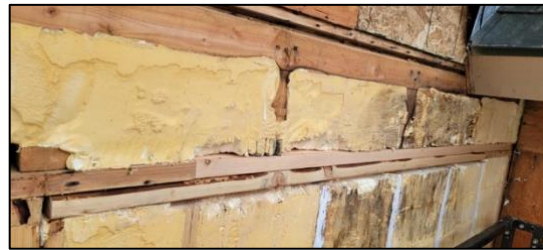
Bldg E4 Unit #28 Entry Exterior Repaired

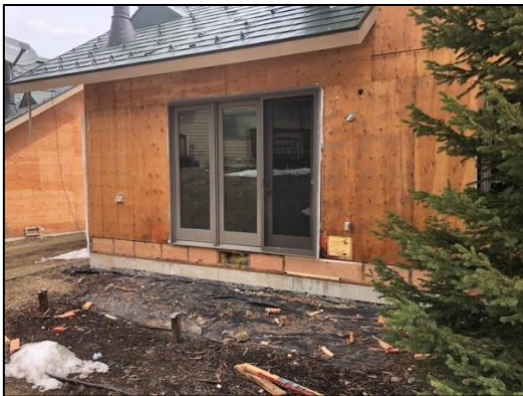
Bldg E4 Unit #28 New Ledger Blocking

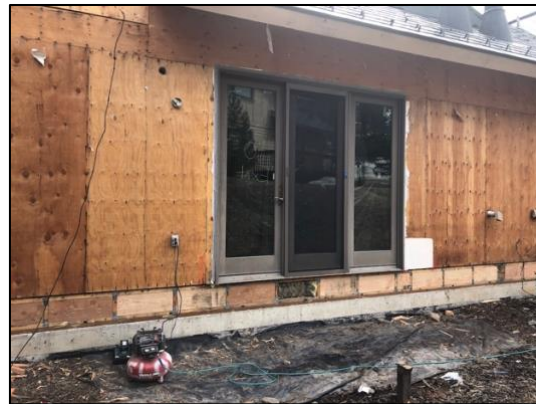
Bldg E4 Unit #29 New Ledger Blocking

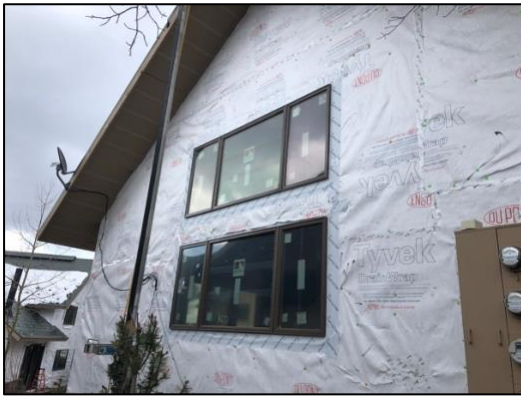
Window installations began with Unit #24. New windows were verified by MCM to include all steps according to the requirements of the contract drawings. Initial installations were challenging due to existing site conditions, but as progress was made the windows were installed with less issues.

Bldg E3 Unit #24 New Windows

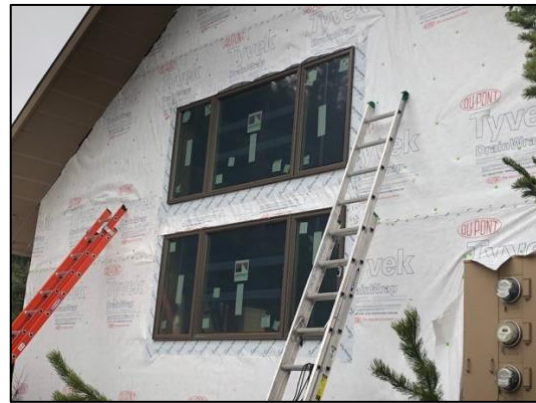
New windows installed were verified by MCM to include all steps according to the requirements of the contract drawings.

Bldg E1 Unit #8 New Windows
