Daily Observation Report

PROJECT: BIG HORN CONDO SIDING REPLACEMENT & EXTERIOR UPGRADES PHASE 1

REPORT #: 001

ADDRESS: 12 RUNNING BEAR ROAD

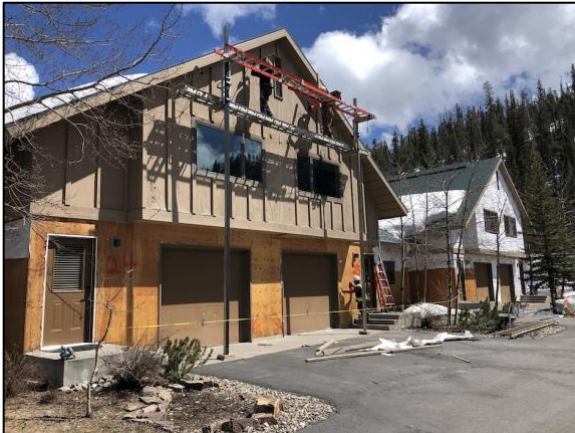
Bldg E3 South Side – Looking East

OBSERVATIONS – CREW MOBILIZED AND BEGAN DEMOLITION.

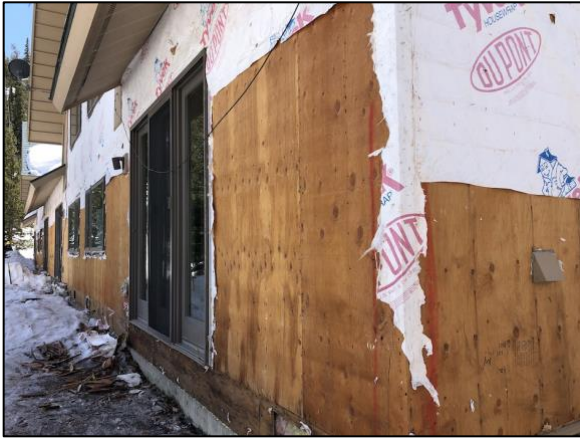
Bldg E3 North Side

OBSERVATIONS – BUILDING E3. 1) CREW CONTINUED WITH DEMOLITION OF SIDING, BATTENS, TRIM, AND MOISTURE BARRIER. 2) ON SOUTH SIDE AS VAPOR BARRIER WAS REMOVED BEHIND THE EXISTING SIDING, THE EXISTING PLYWOOD SHEATHING APPEARED TO BE IN VERY GOOD CONDITION; SOME PREVIOUS MARKINGS NEAR GARAGE JAMBS (SEE PHOTOS) WERE STILL IN PLACE. 3) CRAWLSPACE VENTS WERE FOUND TO HAVE BEEN STUFFED WITH INSULATION, THEREBY BLOCKING NATURAL VENTILATION INTO THE SPACE. 4) UNIT #24 DECK WAS REMOVED. EXISTING SHEATHING UNDER DECKING WAS MARKED FOR REMOVAL AS EXISTING CONDITIONS INDICATED POSSIBLE WOOD ROT. DEPENDING ON REMOVAL OF SHEATHING, FURTHER MATERIAL MAY BE IDENTIFIED. UNIT #25 DECK WAS REMOVED. MCM WILL CONTACT REDLEAF ENGINEERING FOR FURTHER DISCUSSION AND RESOLUTION.
