Daily Observation Report

Date of Report: May 10, 2021
 Prepared By: D. Saenz

PROJECT: BIG HORN CONDO SIDING REPLACEMENT & EXTERIOR UPGRADES PHASE 1

REPORT #: 013

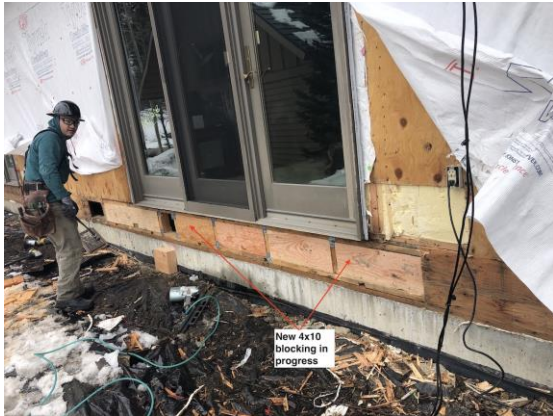
Bldg E3 Unit #25 Blocking

E3 - Suspicious areas ^{that were} marked at decking locations were removed. Progress was made in installing the "Solid 4x10 blocking" in the required areas. Two new kitchen windows (Units #24, #25) were removed and new Anderson windows installed. Sill pan, caulking, and window tape were installed properly. See below regarding trim.

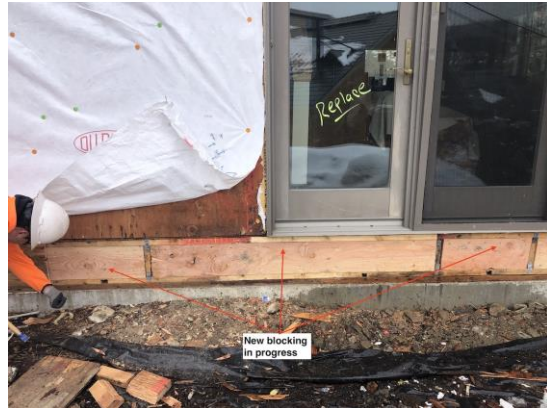
Bldg E3 Unit #24 Blocking

Unit #24/25 - Kitchen windows were out of plumb by about 1/8" - 3/16". No shims were in place in the existing window. Existing interior trim was required to be removed for setting of new shims. Windows were installed accurate and plumb. Further finished carpentry work may be required.

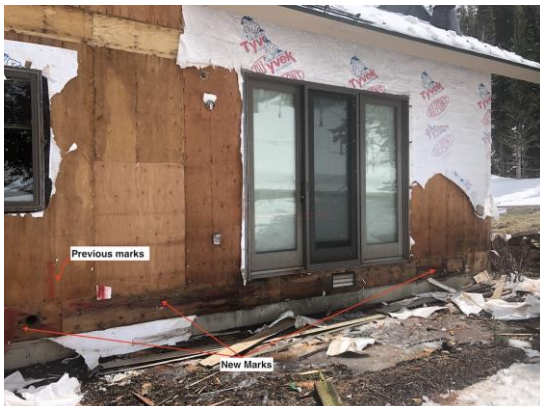
E4 - Continued progress was made on completing the removal of the siding and vapor barrier. Areas were marked for the contractor to expose due to suspicious conditions. MCM will schedule a visit for Redleaf to conduct an observation.

Bldg E4 Unit #31 Areas Marked

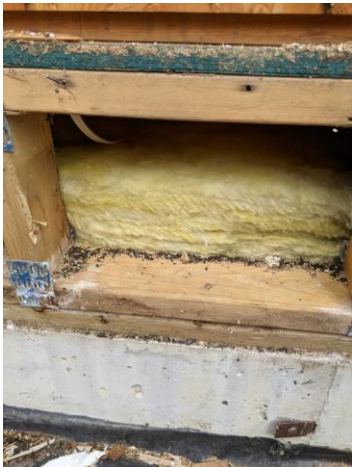
Walked Buildings E2 and E4 with SE for initial observations that were identified to be corrected by the contractor. Problem areas are similar to what has been discovered in previous buildings (E1 and E3). Areas have been marked by MCM and are consistent with observations by the SE. It should be noted that Units #20, #21, and #28 discovery was found to show evidence of pests.

**Building E4 Unit #21 Possible
Pest Control Problems**

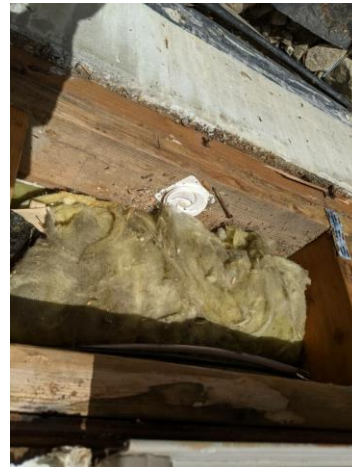
**Building E4 Unit #28 Possible
Pest Control Problems**

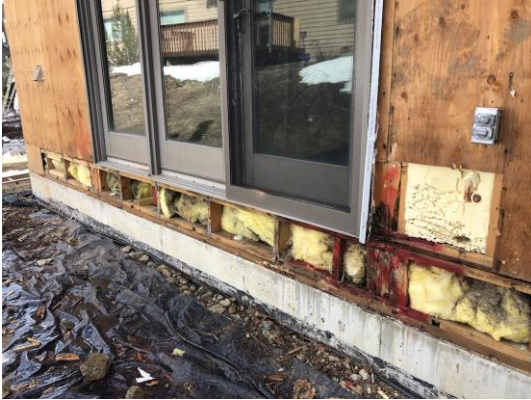
E1 - Building was walked and verified by ServoPro representative (mold specialist) to identify suspicious areas of possible mold. Areas were marked for technicians to mitigate on 5/13.

Bldg E1 Unit #11 Discoloring

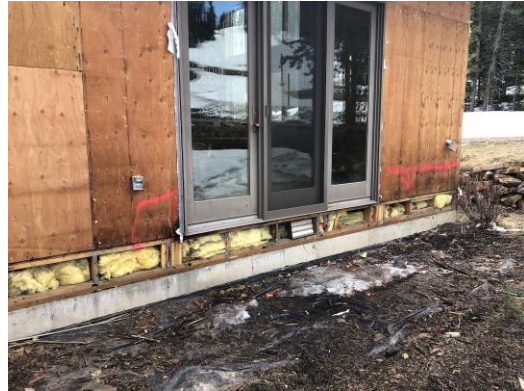
Bldg E1 Unit #8 Discoloring

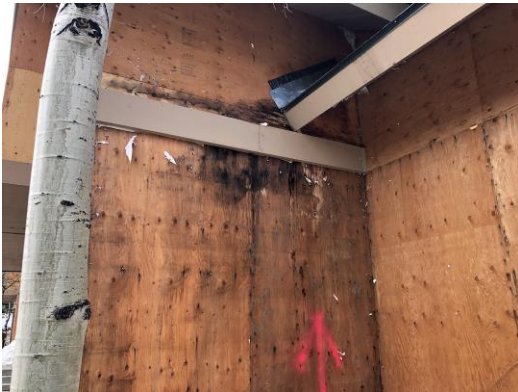
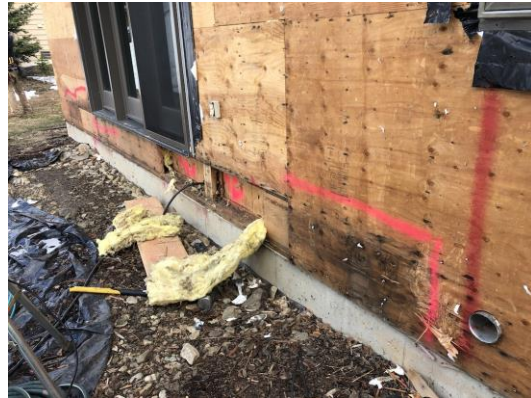
E4 - Building was walked and verified by ServoPro representative (mold specialist) to identify suspicious areas of possible mold. Areas were marked for technicians to mitigate on 5/13.

Bldg E4 Unit #28 Discoloring

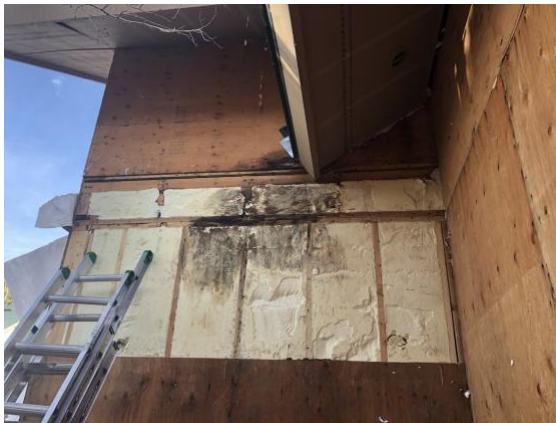
Bldg E4 Unit #28 Exterior Wall at Entry-3

UNRESOLVED ISSUES/FACTORS CONTRIBUTING TO DELAY – **Unit #28 Exterior entry wall showed significant damage near sloped roof (see photos). Area was marked for removal. Once removed it was evident that the damage of moisture in the sheathing has turned to mold and infiltrated the double top plates at a minimum. Findings were sent to SE for recommendation forthcoming.

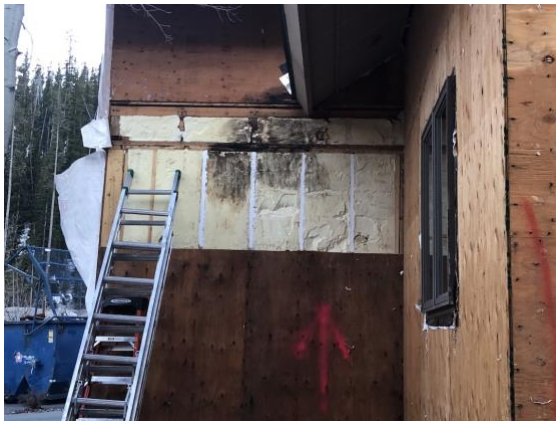
OBSERVATIONS – 1) Continued removing areas marked for mold mitigation. Removed existing sheathing at Unit #28. See note below**. **2)** Provided building wrap at buildings E1, E3 on sides that have been properly reviewed by MCM, SE, and mold specialist. **3) Building E2, E4:** Identified mold suspicious areas were treated by a mold specialist. Other areas have received building wrap as required. **4)** Mold Specialists were on site to perform suspect mold mitigation. Various areas that were marked by a mold specialist were mitigated. **5)** Unit 52 - Visually confirmed that the interior ledger board of the existing deck has thru-bolts from the exterior ledger board consistent with the SE requirements. Information was relayed to the SE.

Bldg E4 Unit #28 with Vert Studs Treated

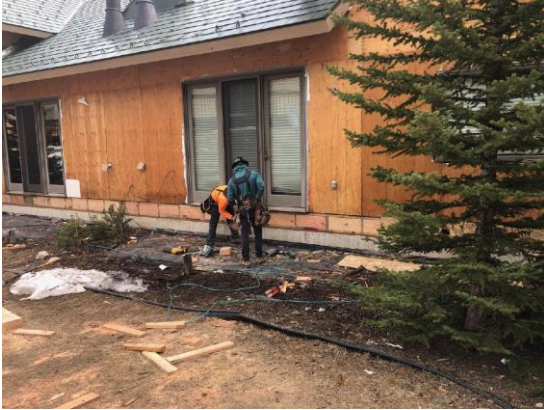
Building E4 Unit #30 Deck Blocking in Place

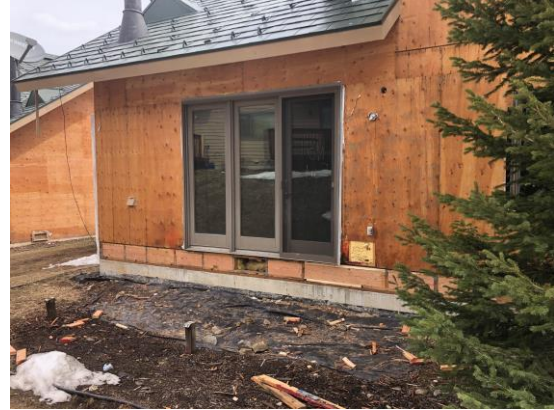
Building E4 Unit #28 Deck Blocking in Place

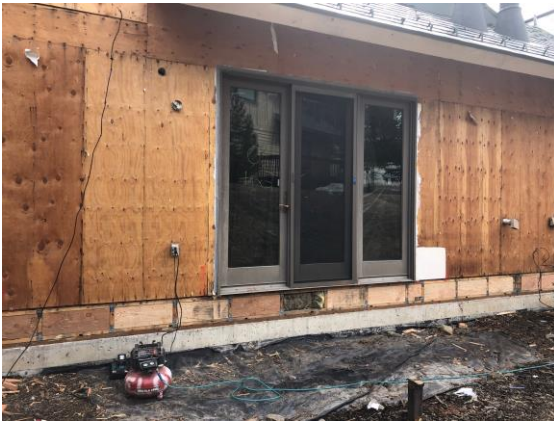
Building E4 Unit #29 Deck Blocking in Place

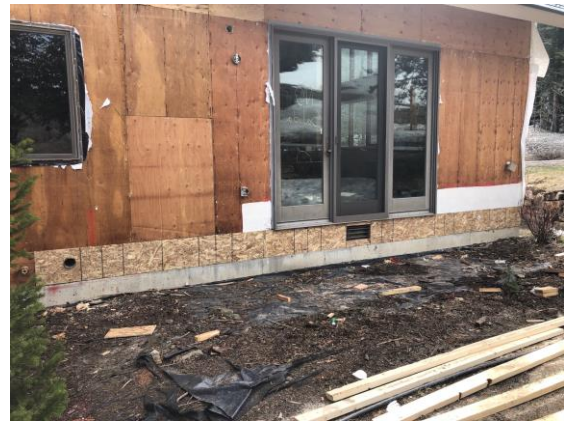
Building E4 - Unit #31 Sheathing over blocking

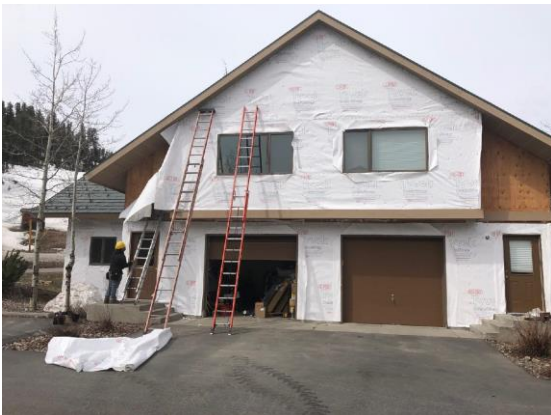
Building E4 - Units 31,30 Building Wrap

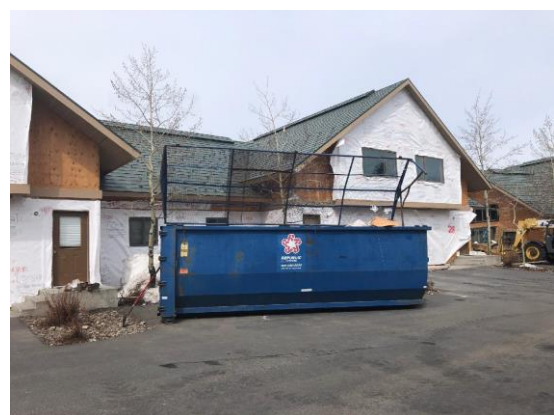
**Building E4 - Units 29, 28
Building Wrap North Side**
