Daily Observation Report

Date of Report: May 17, 2021
 Prepared By: D. Saenz

PROJECT: BIG HORN CONDO SIDING REPLACEMENT & EXTERIOR UPGRADES PHASE 1

REPORT #: 018

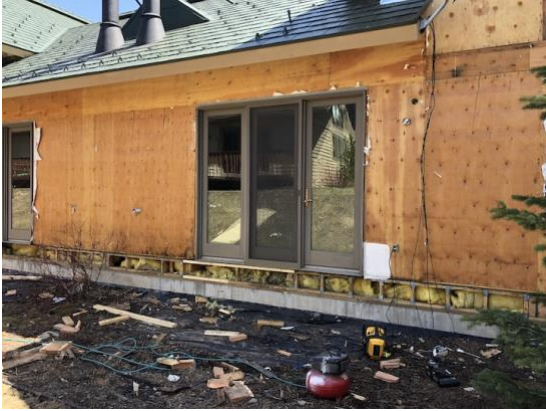
Bldg E2 Unit #22 Blocking in Progress

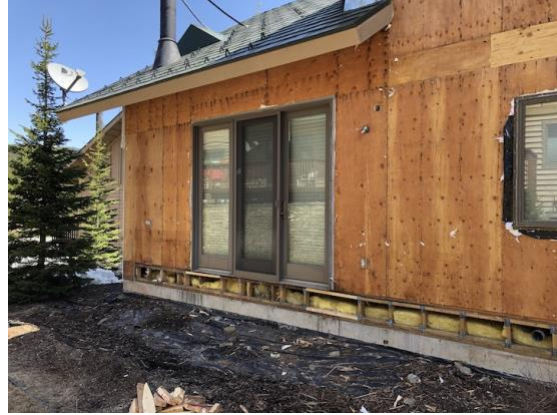
Bldg E2 Unit #20 Blocking in Progress

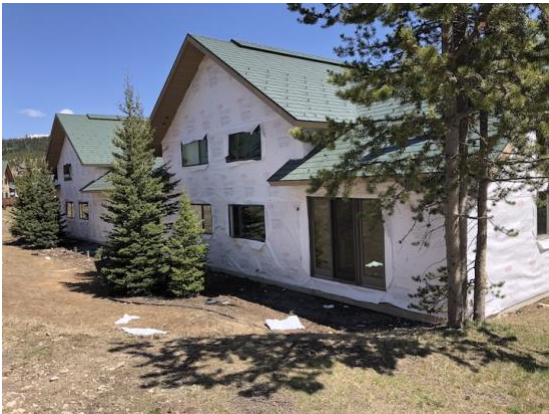
Bldg E4 South & East Sides Wrap in Progress

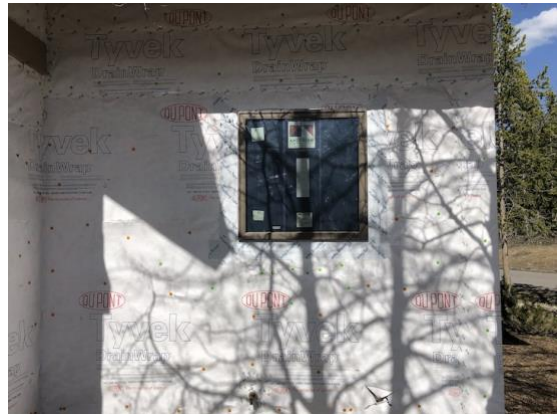
Bldg E3 Unit #27 Kitchen Wdw in Place

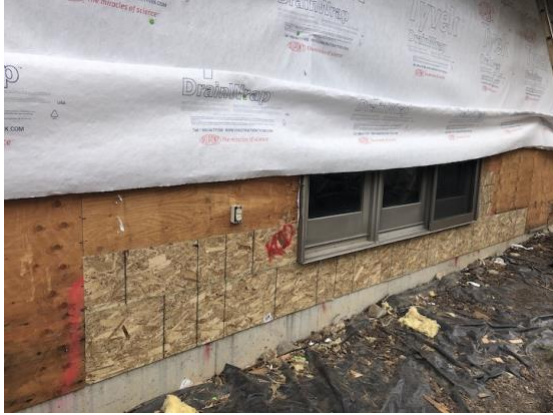
Bldg EW1 Unit #10 Repairs Complete

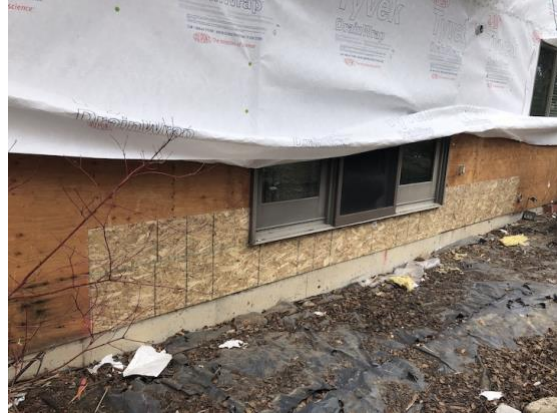
Bldg EW1 Unit #09 Repairs Complete

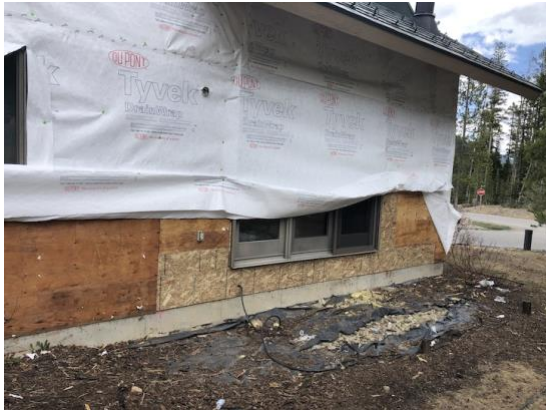
Bldg EW1 Unit #18 Repairs Complete

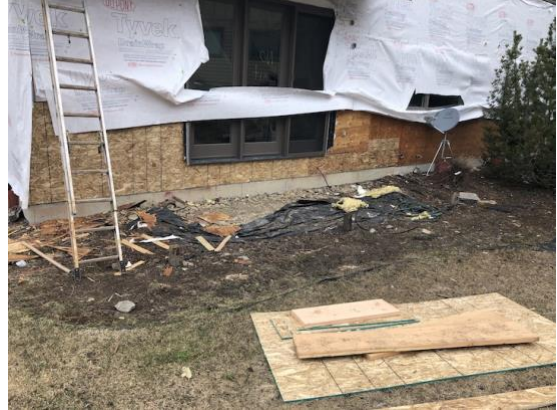
Bldg EW1 Unit #11 Repairs Complete

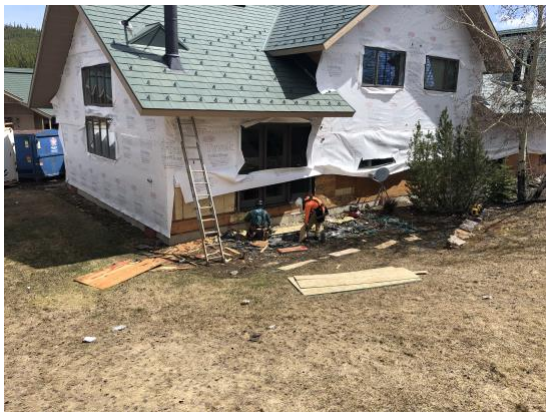
Bldg E1 Unit #11 Blocking Progress

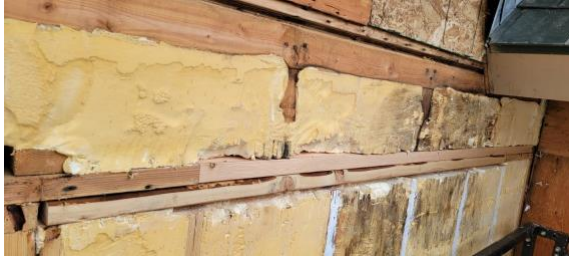
Unit #28 Top Plate at Entry Repair

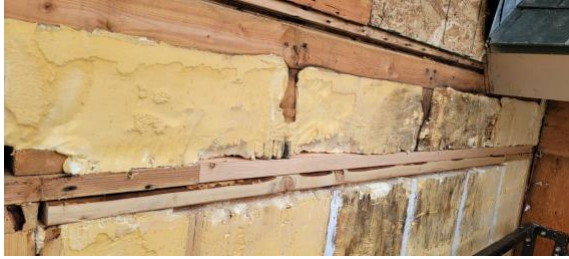
Unit #28 Top Plate at Entry Repair

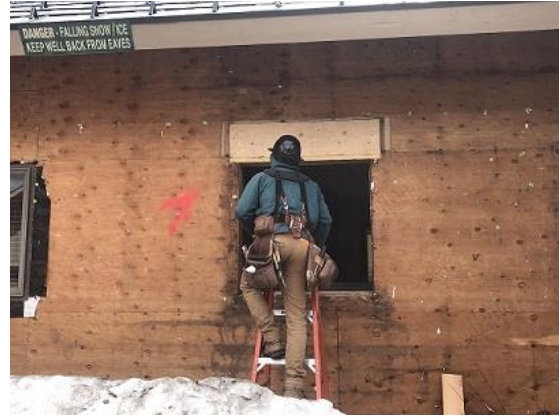
Bldg E1 Unit #10 New Kitchen Window Header
