Daily Observation Report

Date of Report: May 24, 2021
 Prepared By: D. Saenz

PROJECT: BIG HORN CONDO SIDING REPLACEMENT & EXTERIOR UPGRADES PHASE 1

REPORT #: 023

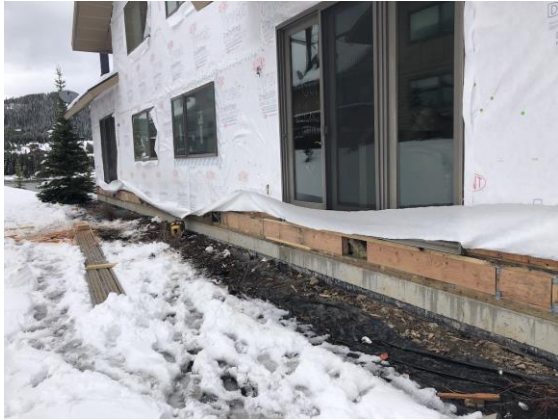
OBSERVATIONS – 1) E1: Progress of Unit 10 new window was underway. Sill pan has been verified. **2)** E2: Ledger blocking was installed and verified by MCM. **3)** E3: Unit #25 upper bedroom window is in progress. MCM noticed some suspicious lumber at the head of the window (see photo). MCM requested the contractor to remove the material that appeared to be dry-rot for further review. After removal of the dry-rot material, the subsurface was in good condition. The material removed was replaced with similar material.

**Bldg E2 Units #20 & #21
Future Deck Area Blocking**

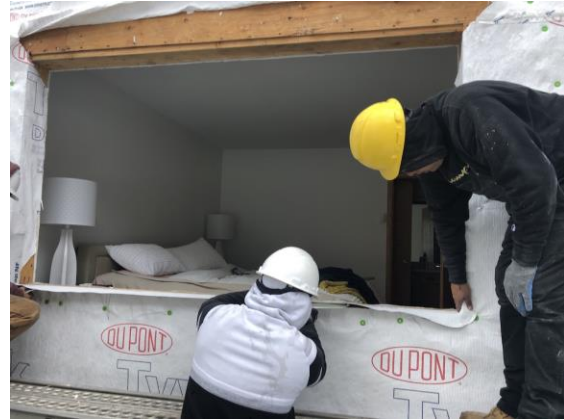
Bldg E1 Unit #10 Window Installation Progress

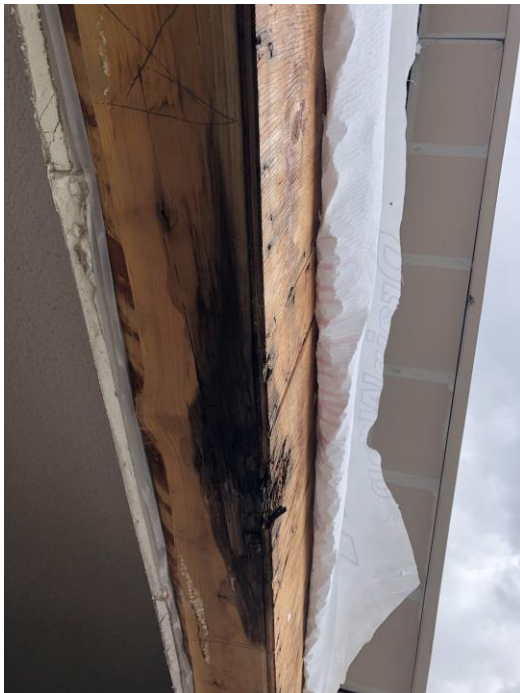
Bldg E3 Units #25 Window Head

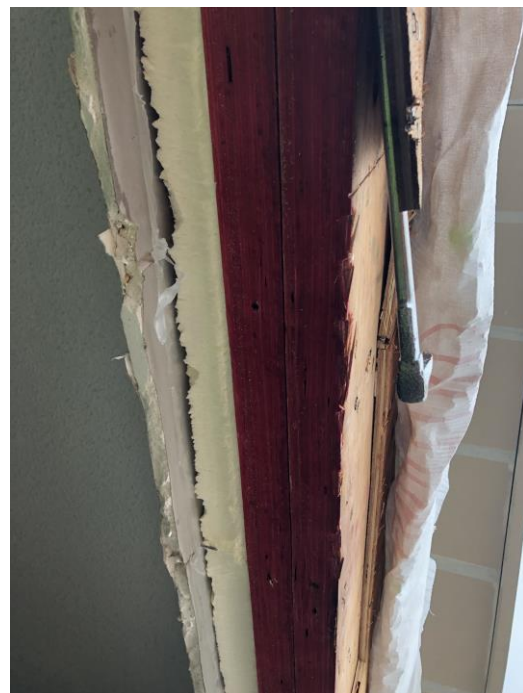
Bldg E3 Units #25 Window Head Exposed

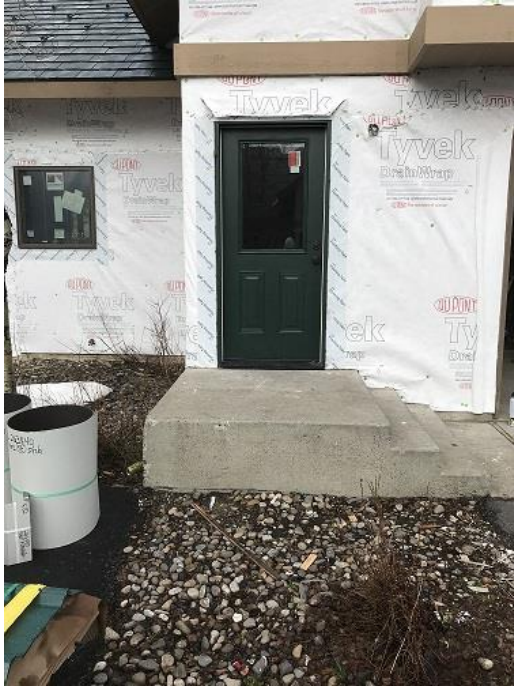
UNRESOLVED ISSUES/FACTORS CONTRIBUTING TO DELAY – Requested Contractor to submit RFI for threshold pans that cannot be installed per plan because stoop removal was declined at new front doors.

Bldg E4 Unit #31 Front Door & Hardware

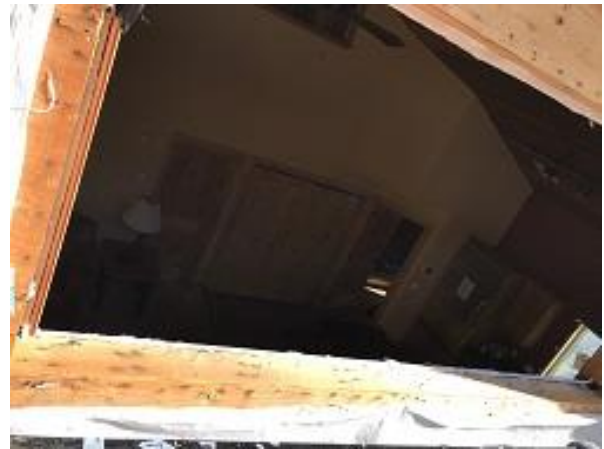
OBSERVATIONS – 1) E1: Progress of Unit #10 windows were underway. Sill pan has been verified. **2)** E4: Progress of Unit #28 & Unit 31 windows were underway. Sill pans have been verified. **3)** E2: Unit #23 front door installation commenced.

Bldg E4 Unit #31 Upper Window Sill
