## Daily Observation Report

Date of Report: June 7, 2021  
 Prepared By: Jim Goveia

**PROJECT:** BIG HORN CONDO SIDING REPLACEMENT & EXTERIOR UPGRADES PHASE 1

**REPORT #:** 032

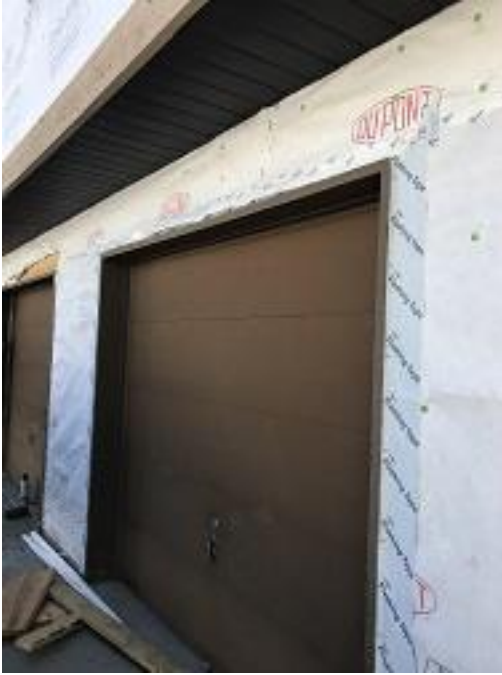
**Building E3 Unit 25 Flashing Tape Applied**

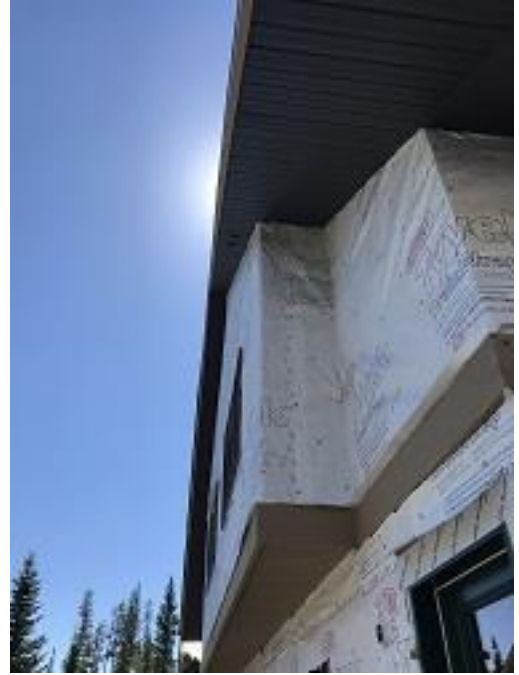
**Building E1 Unit 11 & 12 Soffit Installed**

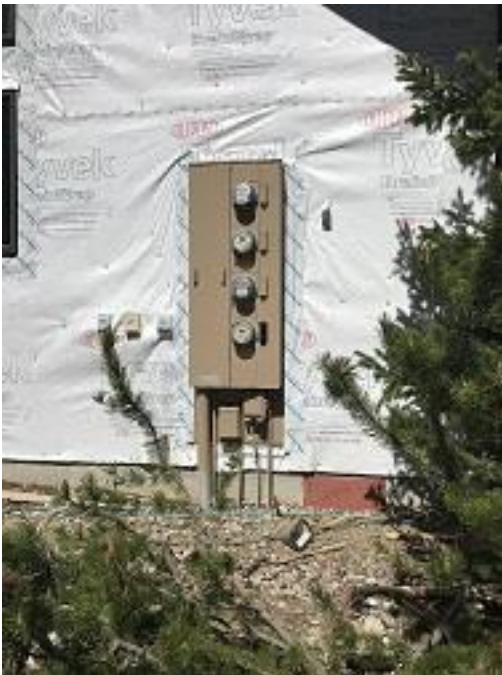
**Building E1 Unit 8 Flashing Tape Applied**

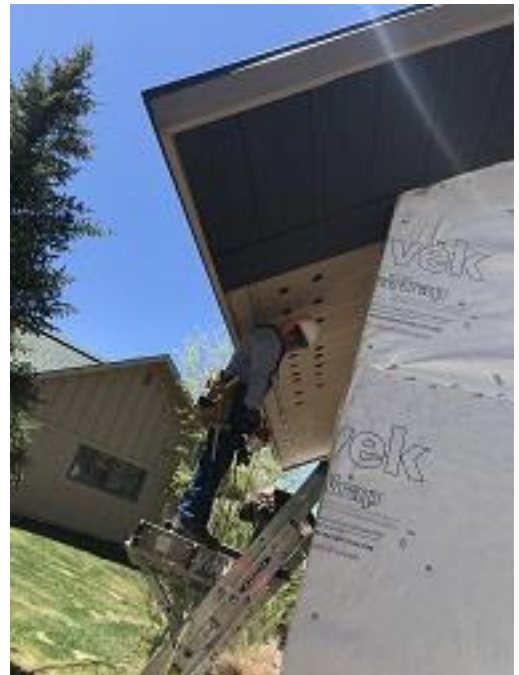
**Building E1 Unit 8 Venting Drilled**

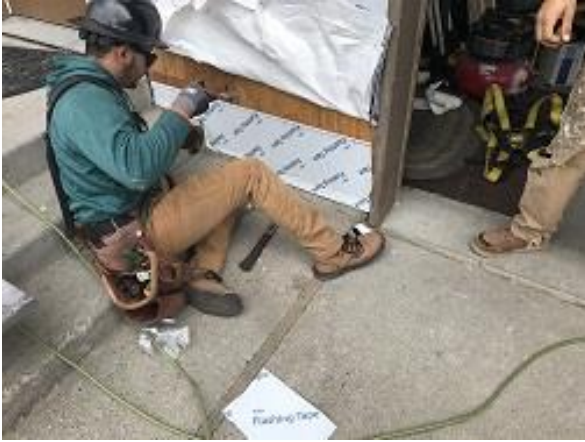
**Building E3 Unit 24 Setup Flashing Tape**

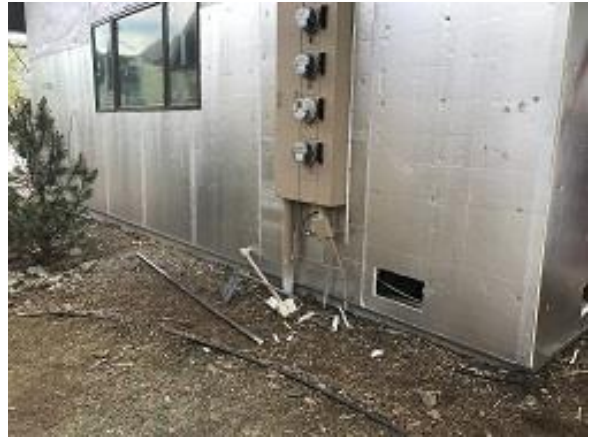
**Building E3 Unit 24 Insulation Board Installation**

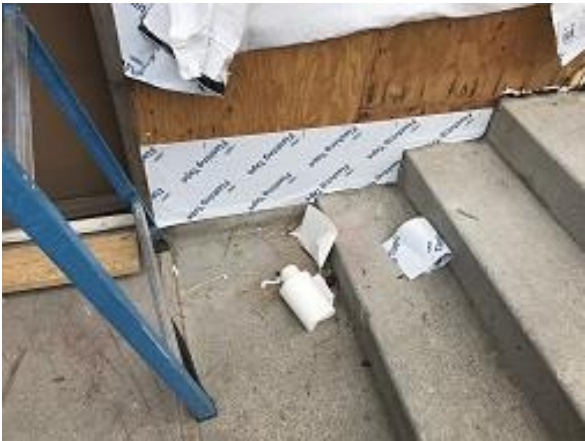
**Building E3 Unit 27 Setup Flashing Tape**

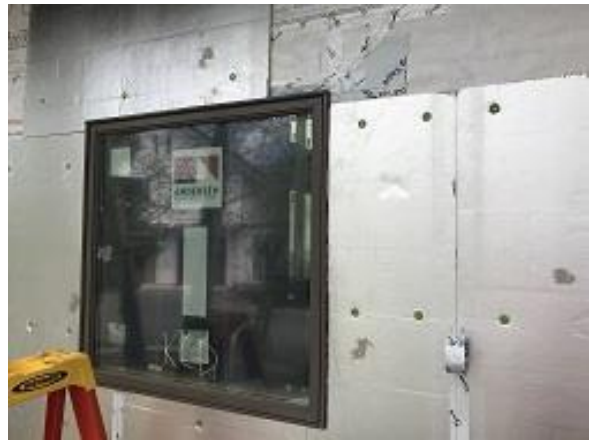
**Building E3 Unit 24 Kitchen Window Flashing and Insulation Foam Board Installation**

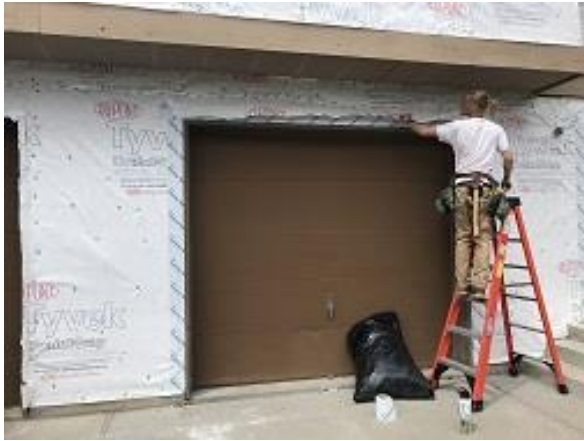
**Building E2 Unit 20 Garage  
Flashing Tape Application**

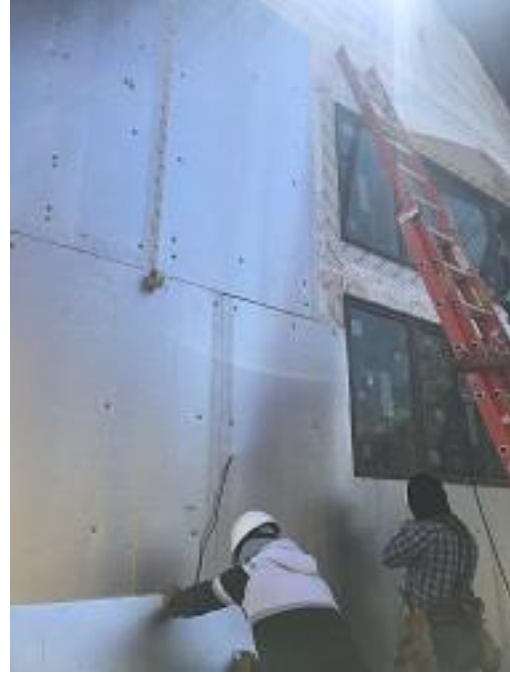
**Building E3 Unit 24 Window Drip  
Flashing & Insulation Board Installation**

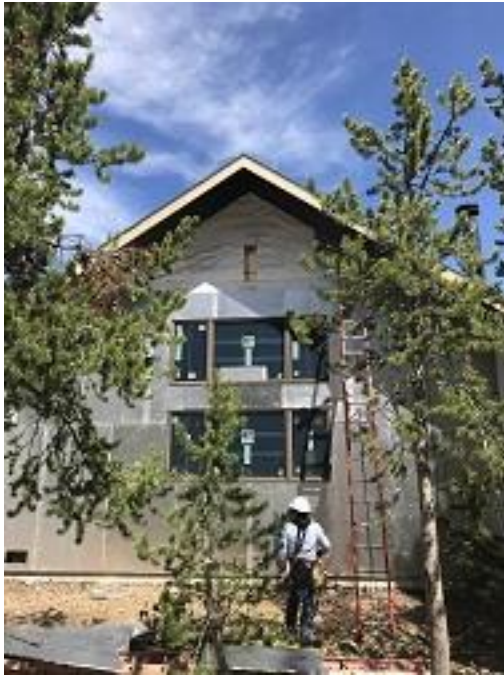
Building E3 Unit 27 New Gable Vent Location

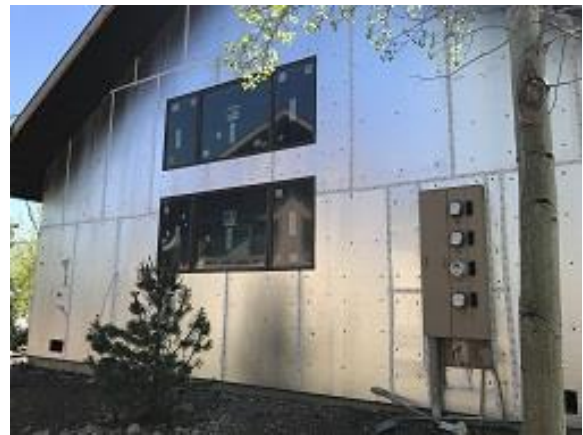
Building E3 Unit 24 Foam Board Installation

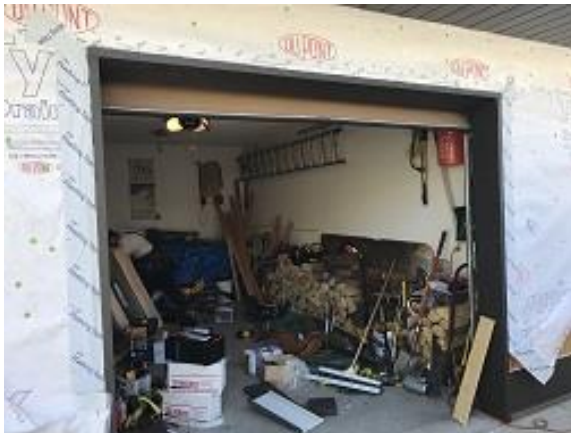
Building E3 Unit 24 Garage Door  
Trim Metal Installation

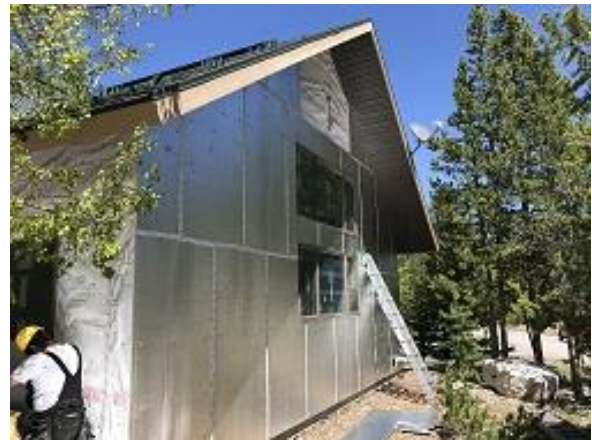
Building E3 Unit 27 Foam Board Installation

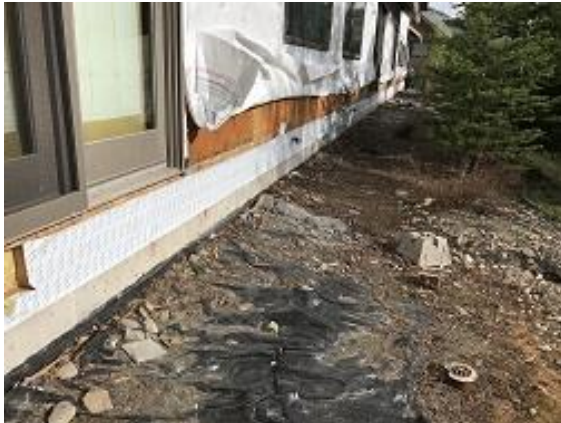
**Building E3 Unit 27 Flashing Tape Installation**

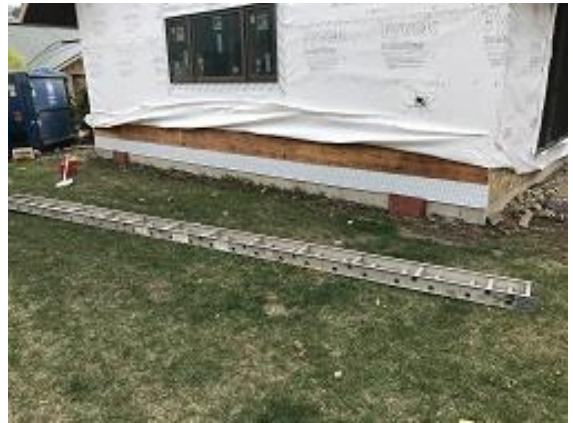
**Building E1 Unit 11 Flashing Tape Installation**

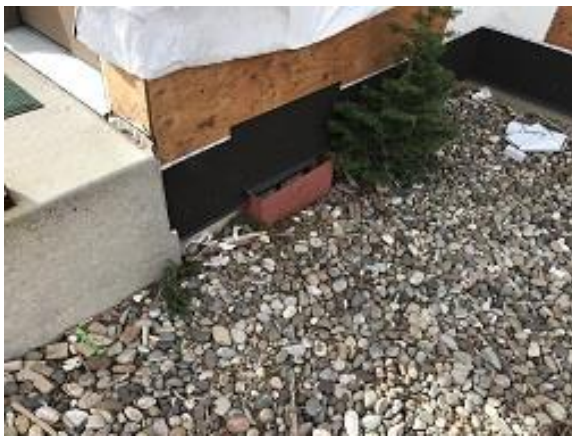
**Building E1 Unit 9 Metal Flashing Installation**

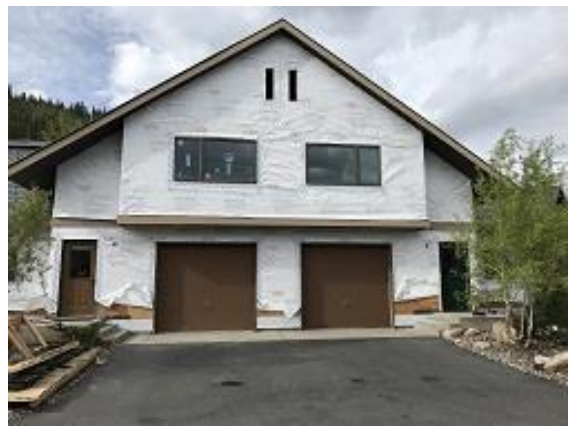
**Building E1 Unit 10 & 11 Gable Vents**

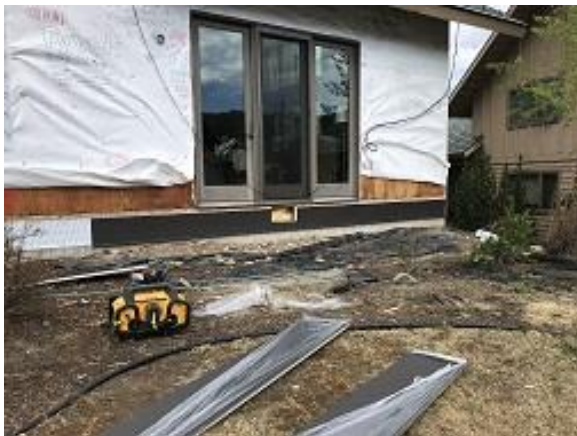
**Building E3 Unit 24 Metal Flashing Installation**

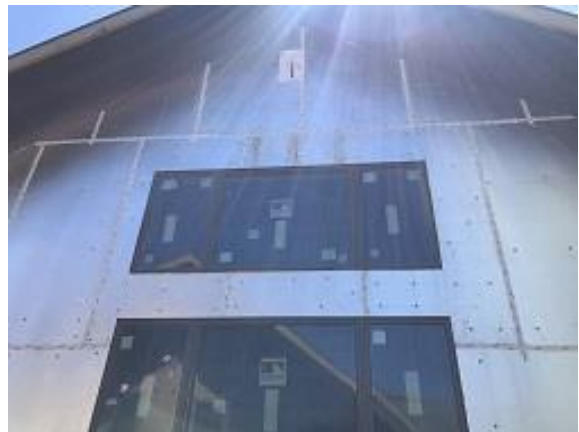
**TESTS/INSPECTIONS –** E3: MCM observed that there is metal flashing missing in two locations as detailed on architectural plans dated 02.05.21 page A1-7 detail 9 and 2. This condition can be seen on picture below Building E3 Unit 24. There should be metal flashing at 37" above the bottom flashing and above each window trim. MCM will notify the contractor to immediately correct.

**Building E3 Unit 24 Metal Flashing Missing**

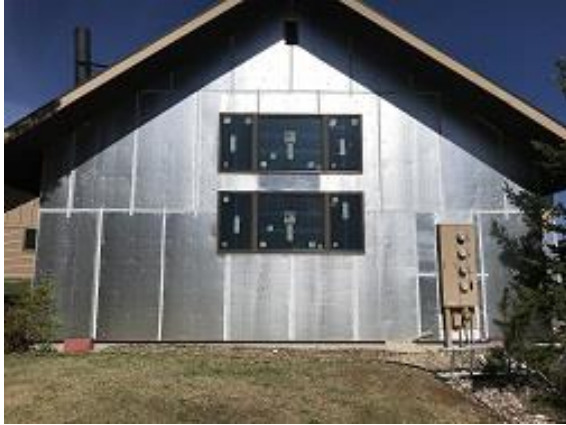
**Building E1 Unit 8 Foam Board Installation**

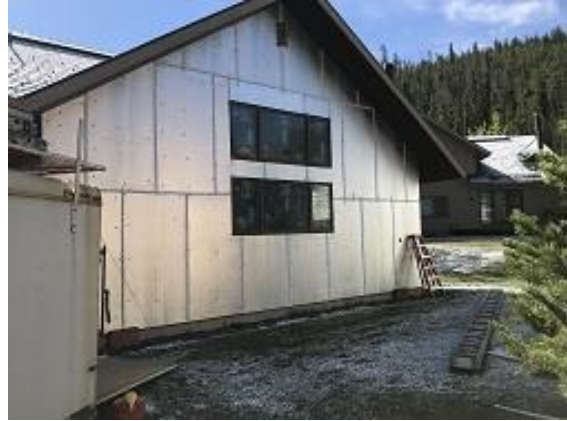
**Building E1 Unit 11 Foam Board Installation**

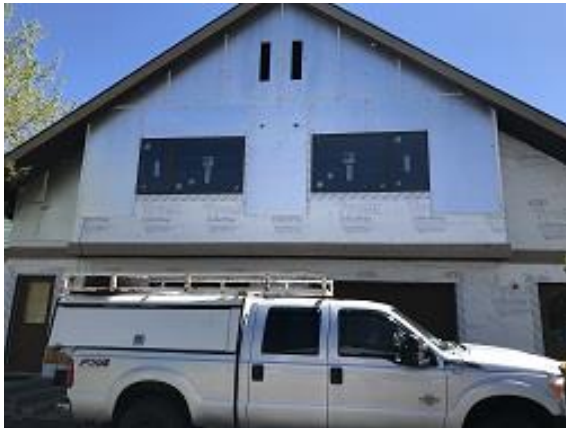
**Building E3 Unit 24 Foam Board Installation**

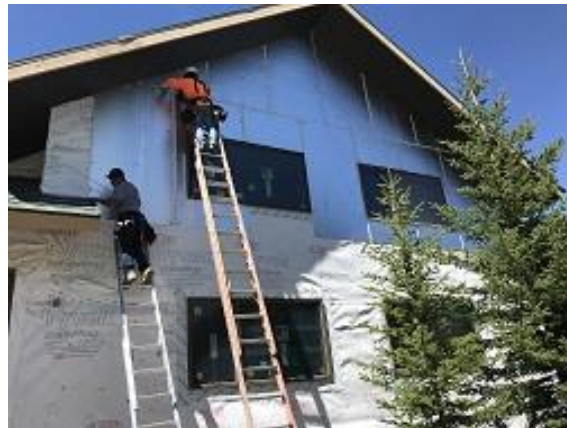
**Building E3 Unit 27 & 26 Foam Board Installation**

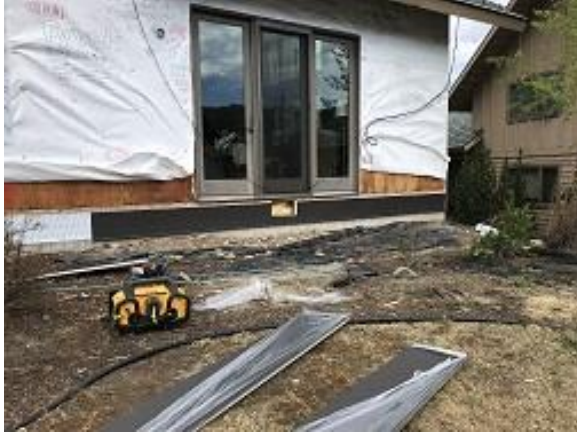
**Building E3 Unit 24 Metal Flashing Installation**

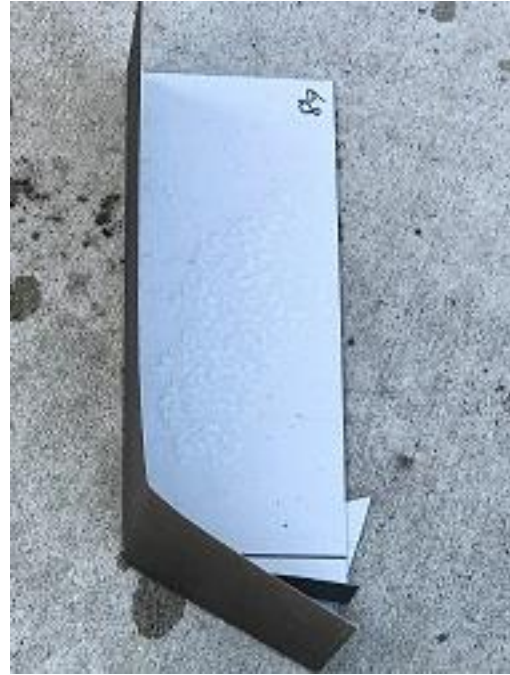
**Building E1 Unit 11 Diverter Flashing**

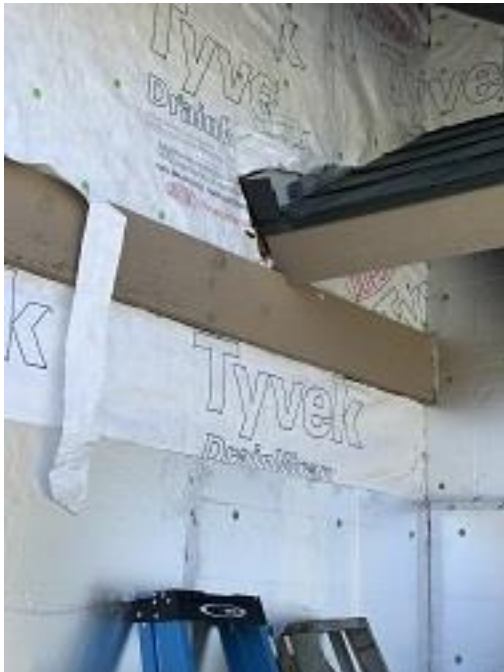
**Building E1 Unit 11 Diverter Flashing**
