Daily Observation Report

Date of Report: June 14, 2021
 Prepared By: Jim Goveia

PROJECT: BIG HORN CONDO SIDING REPLACEMENT & EXTERIOR UPGRADES PHASE 1

REPORT #: 037

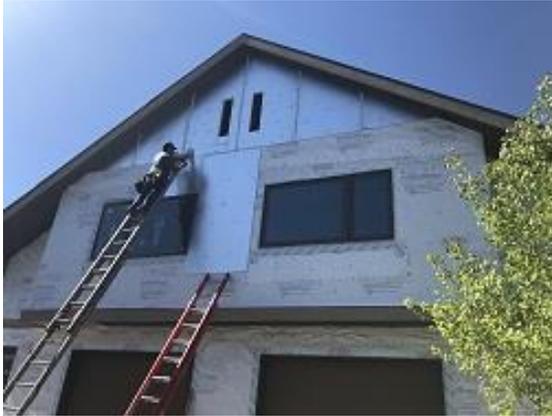
Building E1 Unit 10 & 11 Foam Board Install

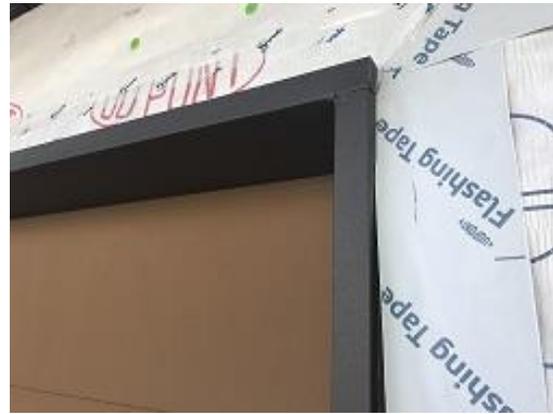
Building E3 Unit 27 Garage Door Metal Trim

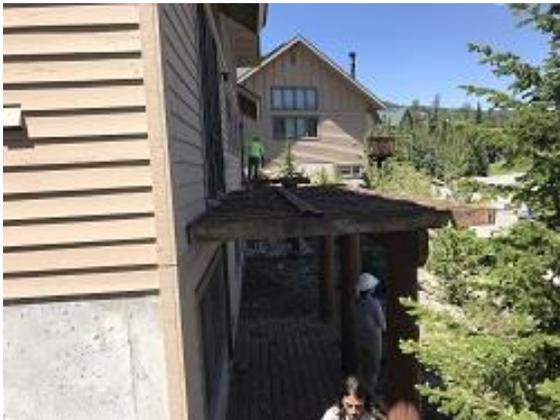
Building F1 Unit 16 Deck Demo

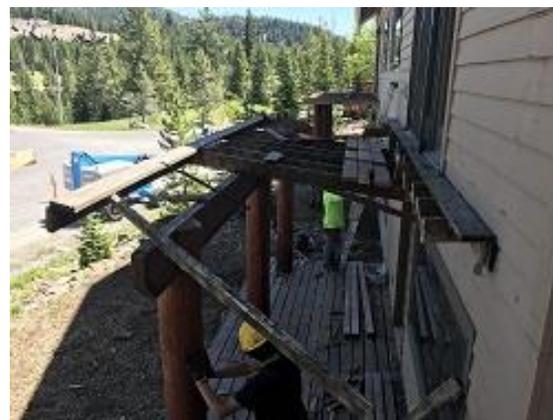
Building F1 Unit 17 Deck Demo

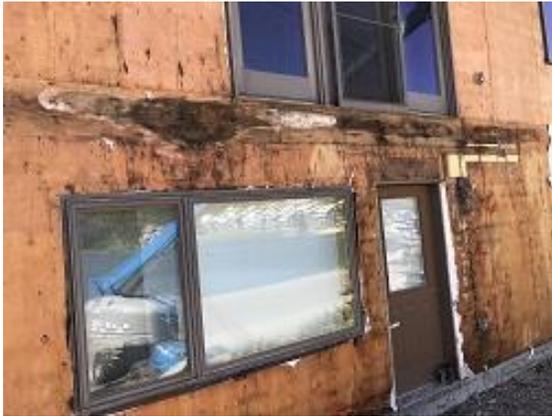
Building F1 Unit 16 Rear Lower Siding Demo

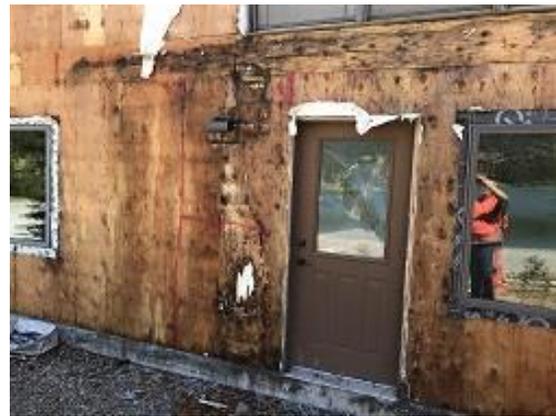
Building F1 Unit 17 Rear Lower Siding Demo

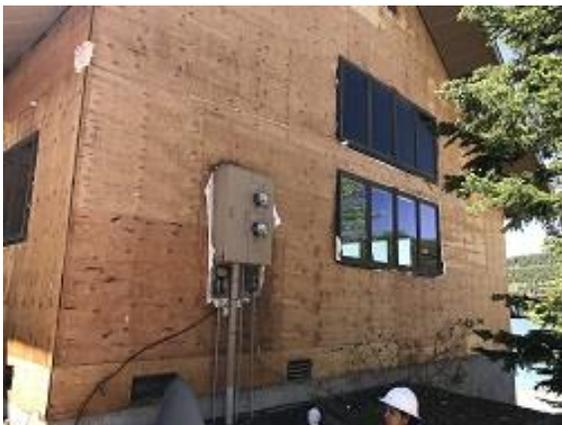
Building F1 Unit 16 Side Siding Demo

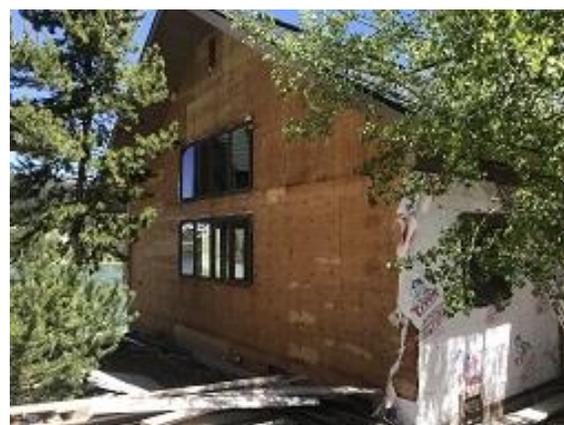
Building F1 Unit 17 Side Siding Demo

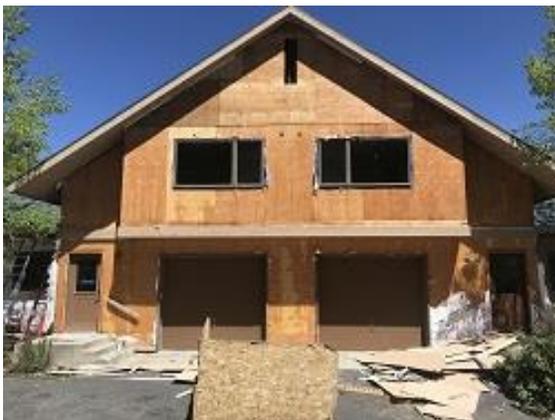
Building F1 Unit 16 & 17 Front Siding Demo

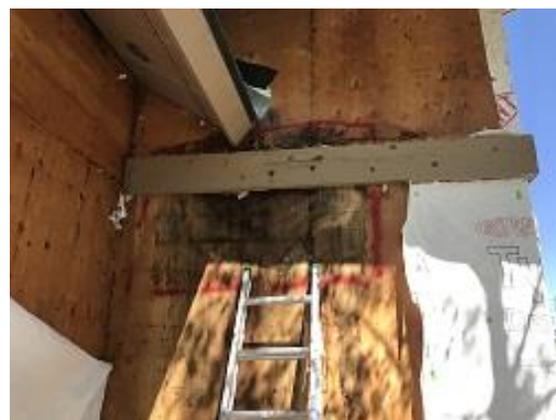
OBSERVATIONS – 1) Building F1: Continued siding demo units 17 & 16. Several areas of damage were marked for repair at deck locations of units 16 & 17 and on the side of front entry of Unit 17. **2)** E1 : Continued window & door interior foam insulation installation. **3)** E3: Continued window & door interior foam insulation installation.

Building F1 Unit 17 Side of Entry Door Damage

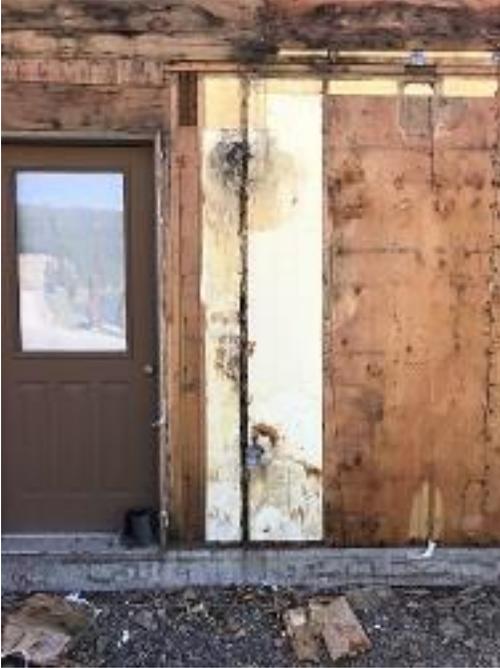
Building F1 Unit 16 Rear
Lower Sheathing Removed

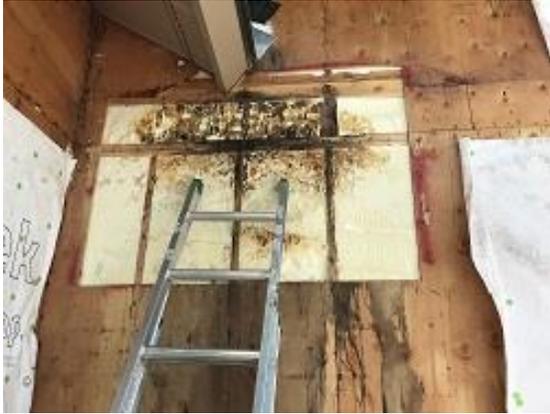
OBSERVATIONS – 1) Building F1: Continued siding demo unit 17. Damage areas were exposed for inspection and engineer was notified to inspect. Windows were removed with no visible damage concerns. Continued window installation with flashing tape installation. **2)** E3: Wainscoting flashing installation began. Observed initial method not consistent with Tyvek standard. Contractor to correct installation per Tyvek standard. Unit 24 & 25 deck footing demolition.

**Building F1 Unit 17 Damaged Sheathing
Removed For Engineer Inspection**

UNRESOLVED ISSUES/FACTORS CONTRIBUTING TO DELAY – Structural Engineer inspected damaged framing members on building F1 units 16 & 17. Determined that removal of damaged area can be planed to no more than 1/2" or be sistered or replaced if more than 1/2".

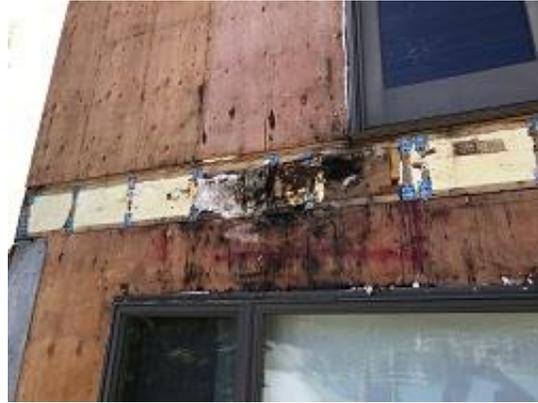
**Building F1 Unit 16 Upper Deck Ledger
Sheathing Removed**

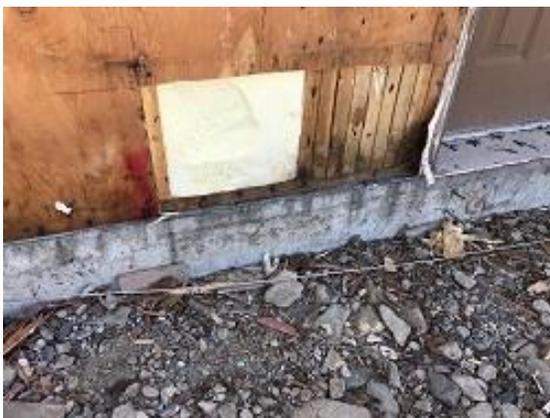
**Building F1 Unit 16 Lower Deck
Sheathing Removed**

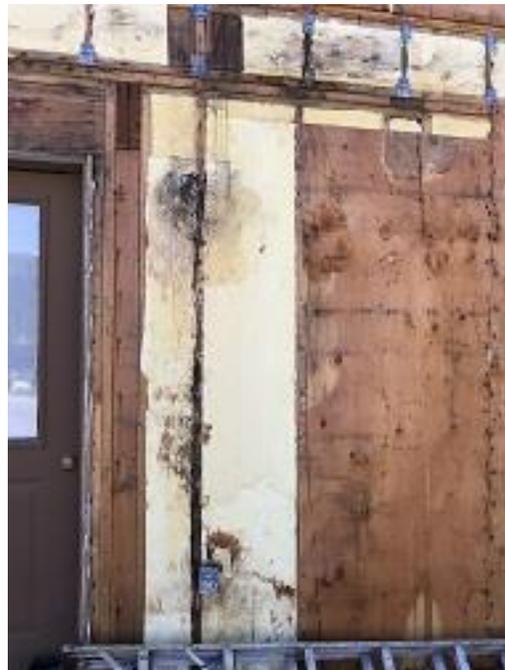
**Building F1 Unit 16 Door
Sheathing Removed**

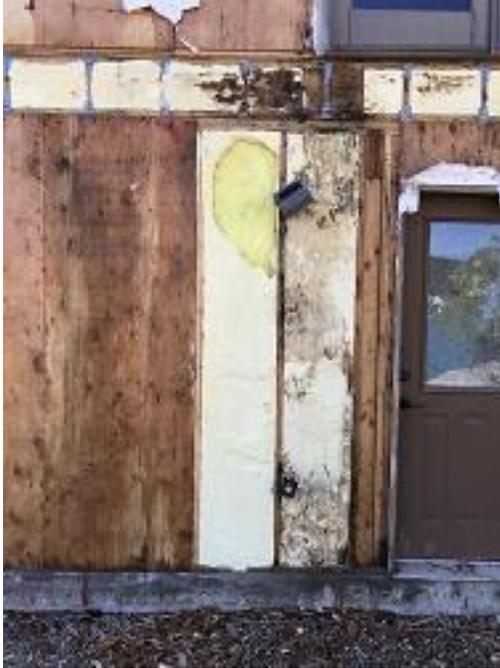
Building F1 Unit 17 Door
Sheathing Removed

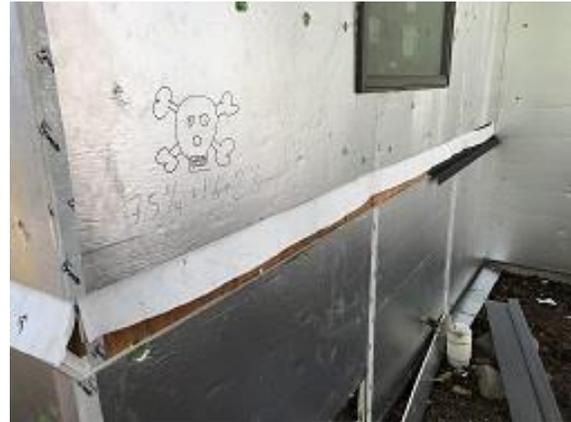
Building E3 Unit 24 Front Wainscote
Top Metal Flashing Installation

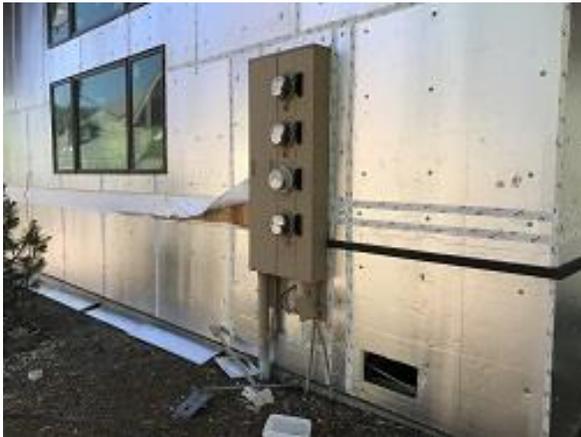
Building E3 Unit 24 Side Wainscote
Top Metal Flashing Installation

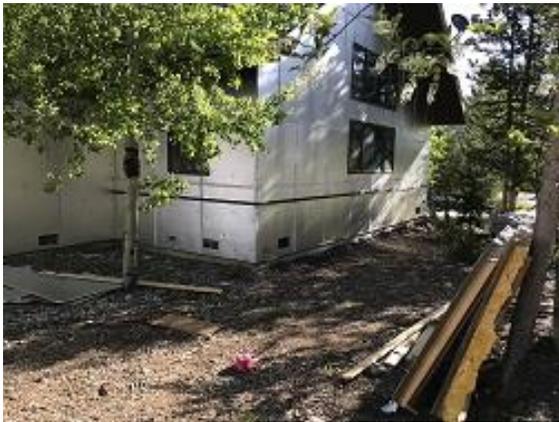
**Building E3 Unit 27 Front & Side
Wainscoting Metal Flashing**

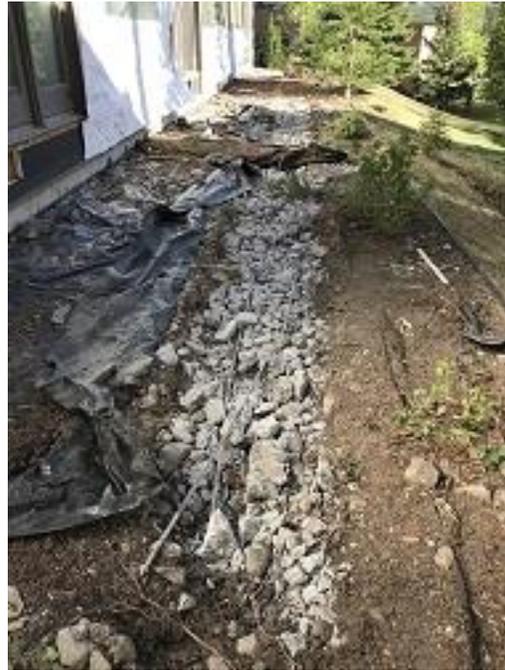
**Building E3 Unit 26 & 25
Deck Footing Removal**

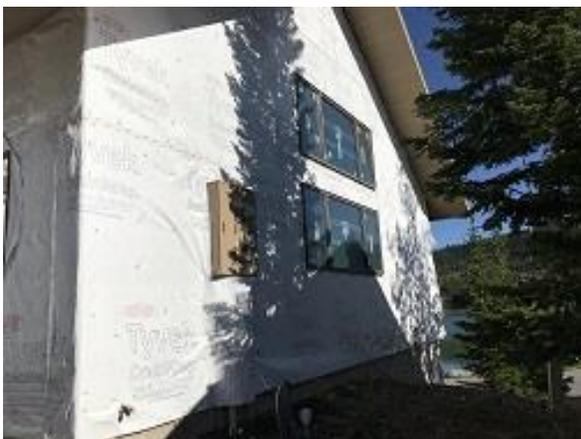
**Building F1 Unit 16 Side Upper &
Lower Window Install**

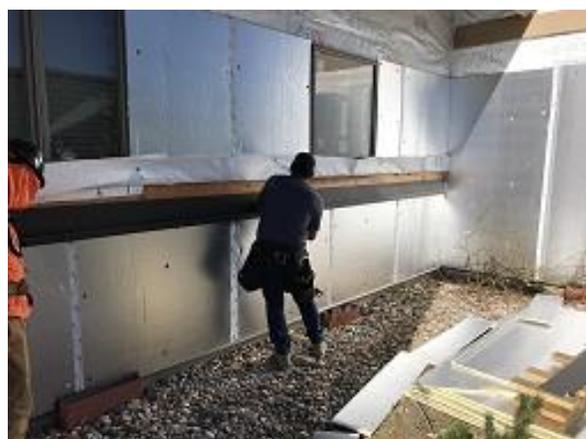
**Building E1 Unit 9 & 10 Front
Wainscoting Metal Flashing**

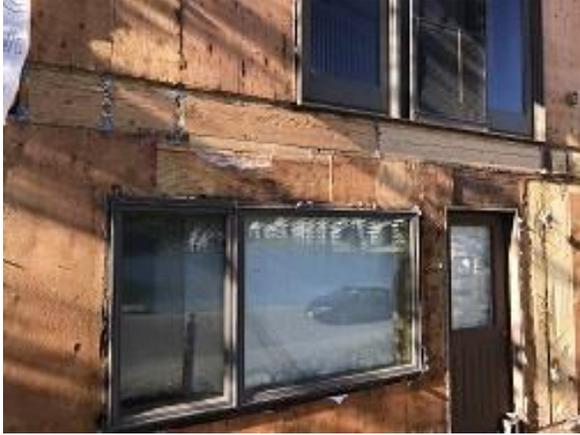
UNRESOLVED ISSUES/FACTORS CONTRIBUTING TO DELAY – Structural Engineer inspected yesterday's installation of ledger blocking for second floor deck on unit 16. Engineer accepted blocking noting that horizontal checking (cracks) was in center and only 1" deep. Considering that the blocking is 3.5" thick provides necessary structural integrity for deck ledger board.

Building F1 Unit 16 Upper Deck
Ledger Blocking Installed

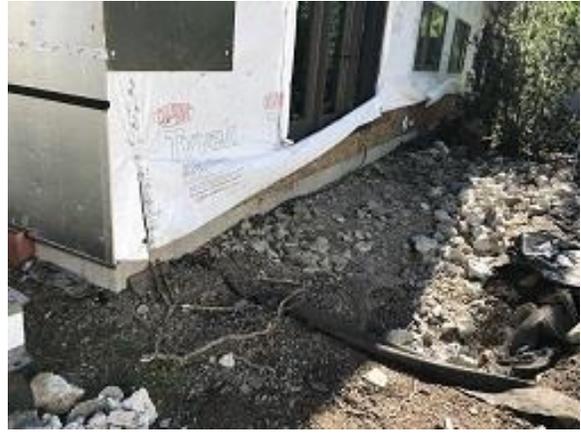
Building E1 Unit 11 Deck
Footing Demo

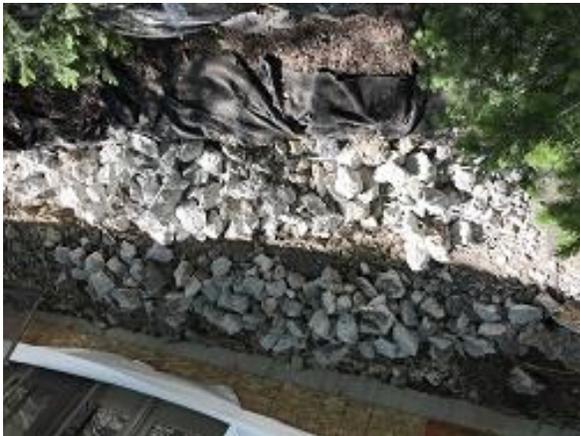
Building E1 Unit 10 Deck Footing Demo

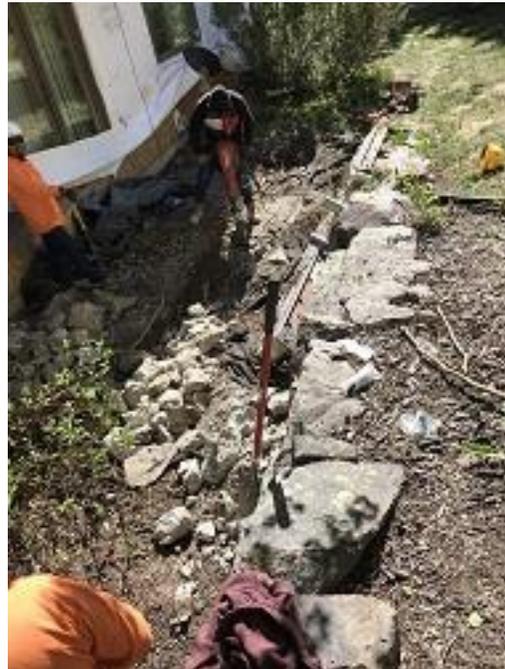
Building E1 Unit 9 Deck Footing Demo

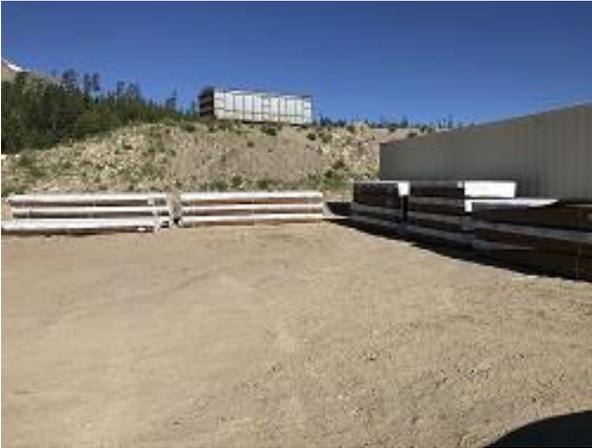
Deck Framing Material Delivered
