### **Daily Observation Report**

**PROJECT:** BIG HORN CONDO SIDING REPLACEMENT & EXTERIOR UPGRADES PHASE 1

**Report #**: 042

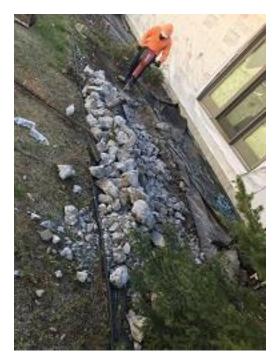
Building E4 Unit 30 Deck Footing Demo

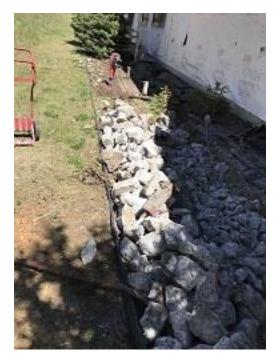
Building E4 Units 29 & 28 Deck Footing Demo

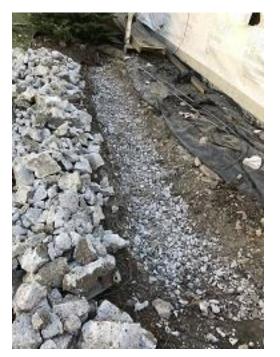
Building E4 Unit 28 Deck Foundation Removal

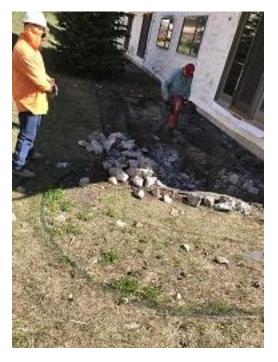
Buidling E2 Unit 23 Deck Foundation Demo
