Daily Observation Report

Date of Report: July 19, 2021
 Prepared By: Jim Goveia

PROJECT: BIG HORN CONDO SIDING REPLACEMENT & EXTERIOR UPGRADES PHASE 1

REPORT #: 062

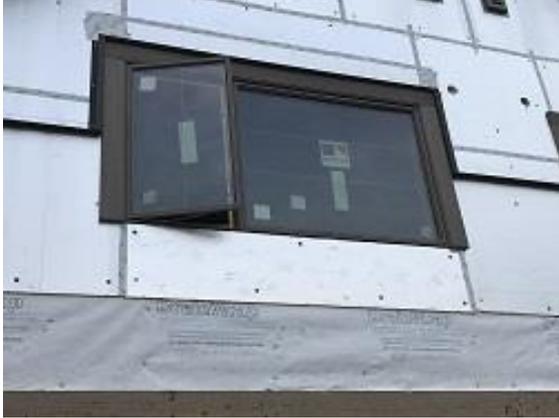
Building E3 Unit 24 Front Upper Window Flashing Installation

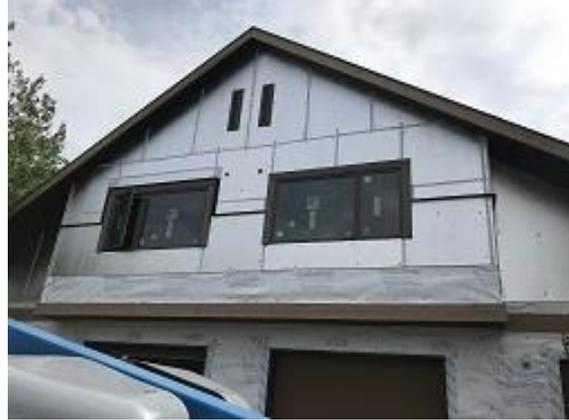
Building E3 Unit 24 & 25 Front Upper Window Flashing and Gable Vent Installation

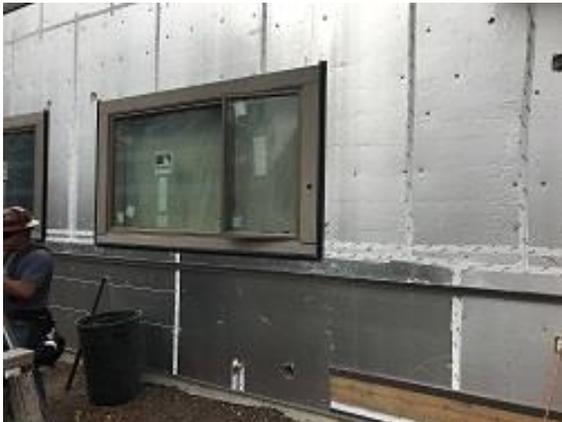
Building E3 Unit 24 Back Bedroom Window Trim & Flashing

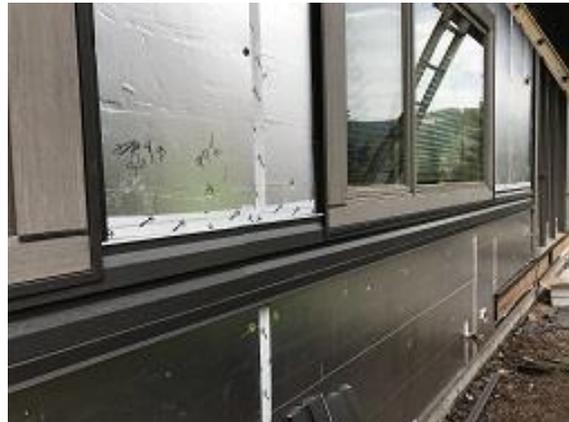
Building E3 Unit 27 & 26 Lap Siding Installed

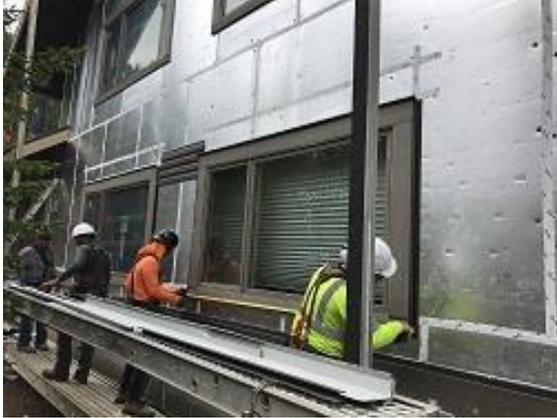
Observations – 1) E3: Unit 24 - 27 yesterday's J channel installation was incorrect. Today corrected installation of J channel around windows and blocking. Continued lap siding installation. 2) E1: Unit 8 - 11 Final urethane finish applied.

Building E3 Unit 26 Window Trim Detail

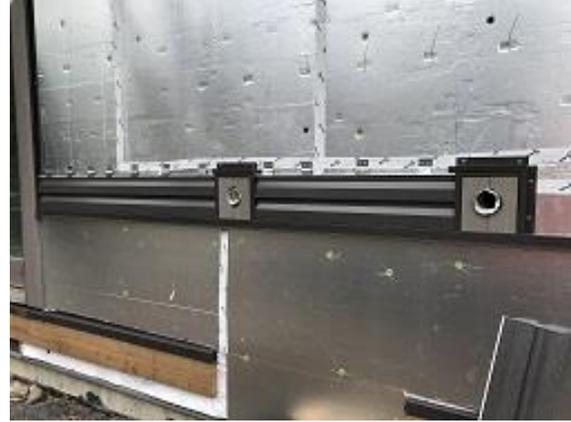
**Building E3 Unit 26 & 27 Lap Siding and
Vent Blocking**

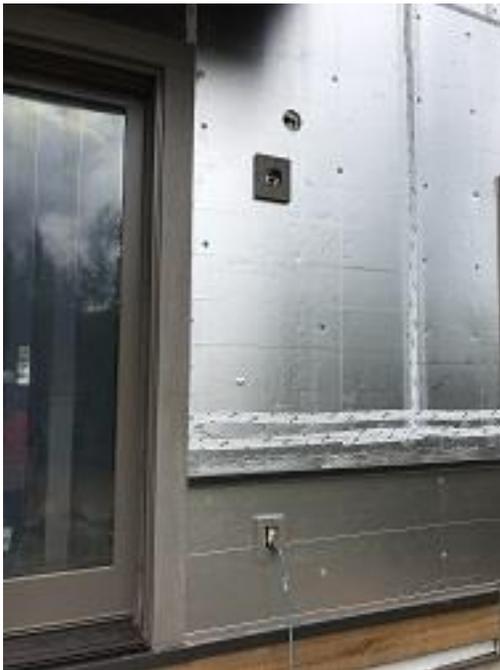
Building E3 Unit 25 Blocking Detail

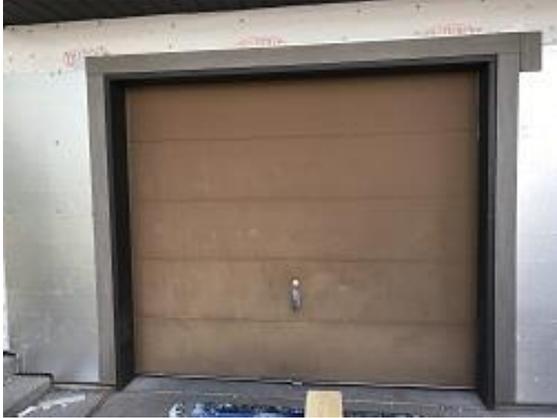
Building E3 Unit 24 Garage Door Trim Installation

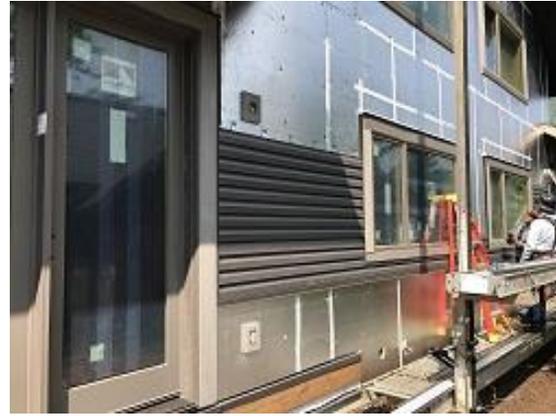
Building E3 Unit 27 Patio Lap Siding Installation

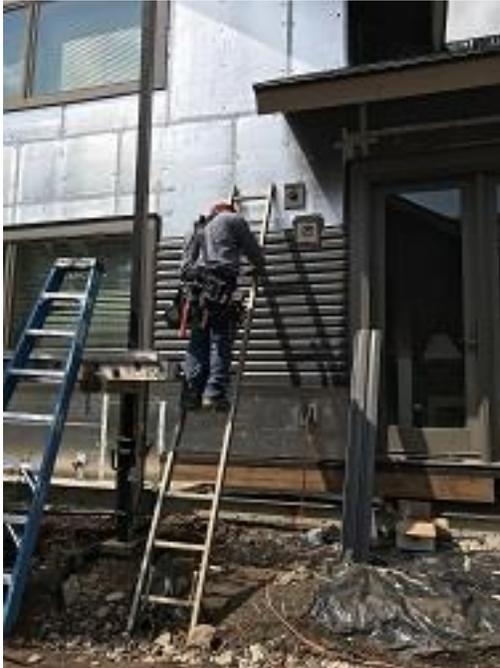
Building E3 Unit 26 Patio Lap Siding Installation

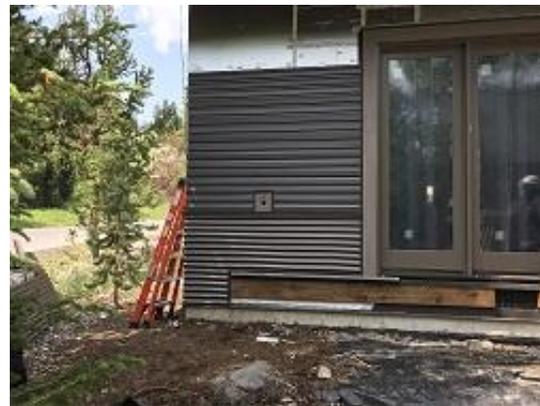
Building E3 Unit 27 Patio Corrugated Siding Installation

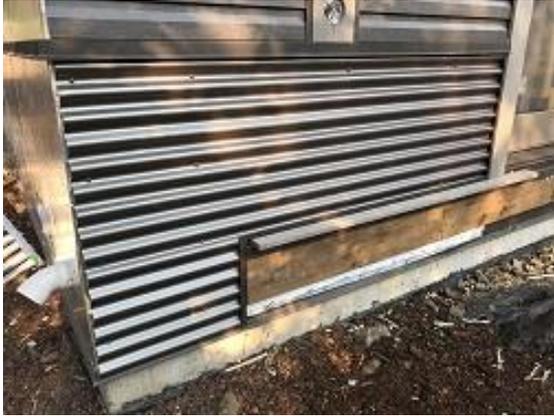
TESTS/INSPECTIONS – Bridger Steel Sales Rep and installation advisor met on site with Jeff, Kit & Jim. Currently installed flashing and siding was determined to be done in accordance with manufacturing standards with the exception of some clips were not within the 8" horizontal distance recommended. When considering how siding should be flashed at roofing Bridger Steel recommends use of base flashing rather than J channel flashing detailed by architect per Kit.

Building E3 Unit 27 Patio Corrugated Siding Screw Pattern

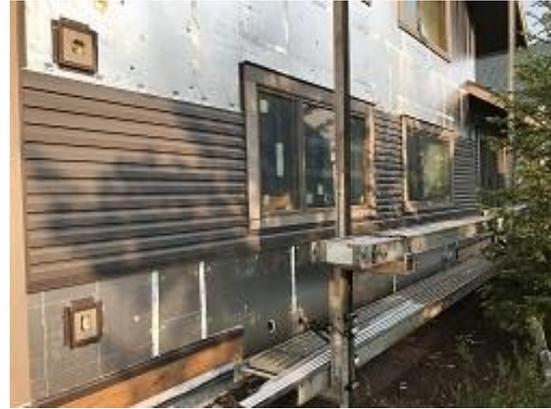
Building E3 Unit 27 & 28 Patio Lap Siding Installation

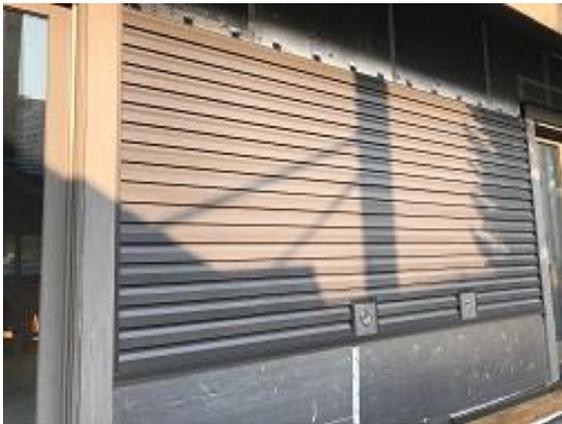
Building E3 Unit 25 & 26 Patio Lap Siding Installation

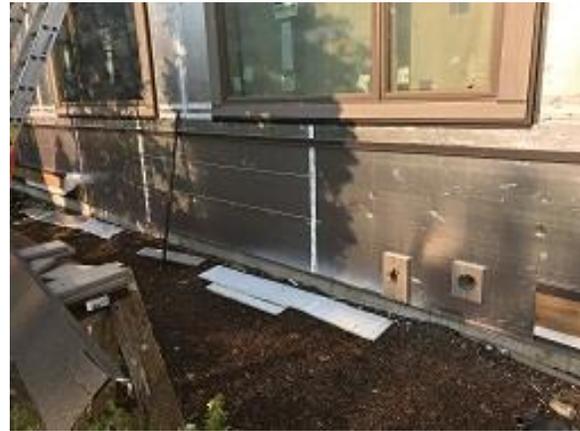
Building E3 Unit 26 & 27 Patio Vent & Spigot Blocking Installation

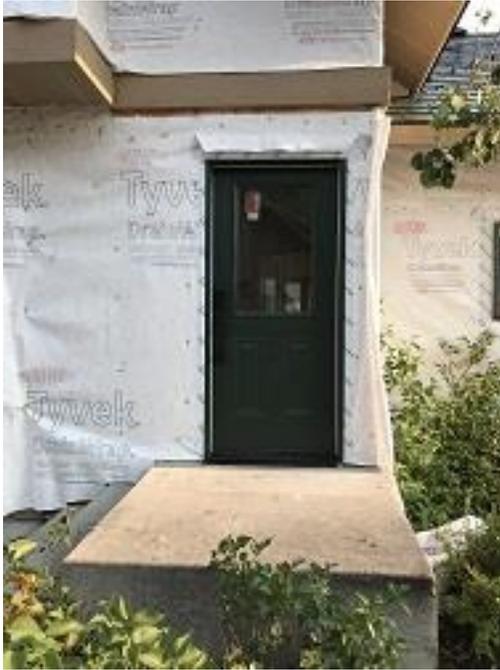
Building F1 Unit 16 Front Door Installation

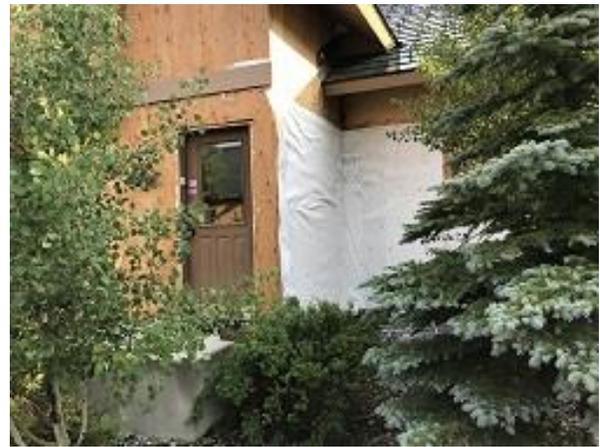
Observations – 1) E3: Units 24 - 27 Continued lap & corrugated siding installation on back of building.
2) E7: Units 49 - 50 Sheathing in front reapplied to damaged areas. Tyvek applied was backwards and will need to be reapplied.

Building E7 Unit 49 Tyvek Installation

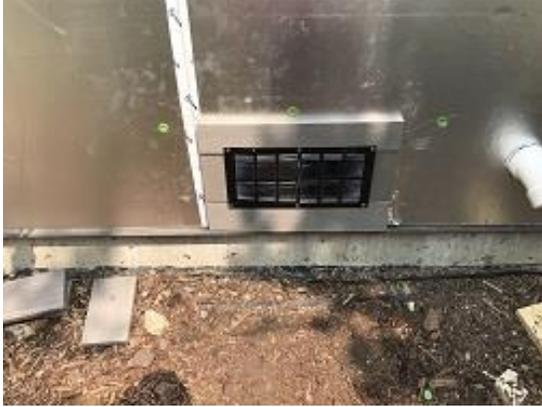
Building E3 Unit 27 Side Vent Trim Installation

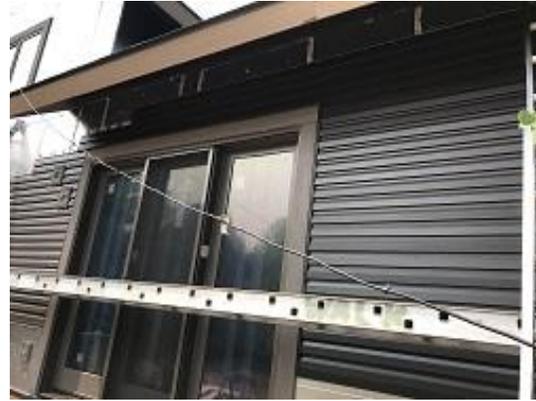
Building E3 Unit 25 Back Siding Installation

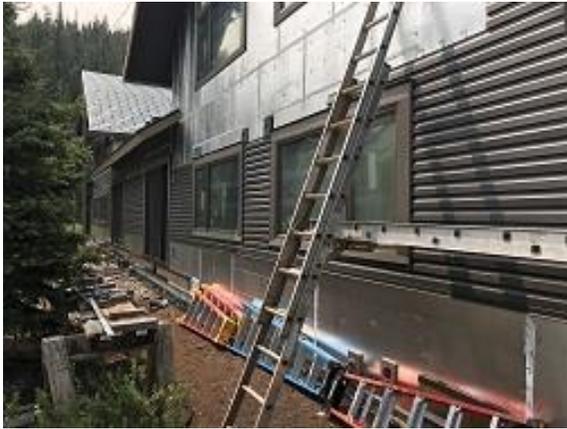
Building E3 Unit 24 & 25 Back Siding Installation

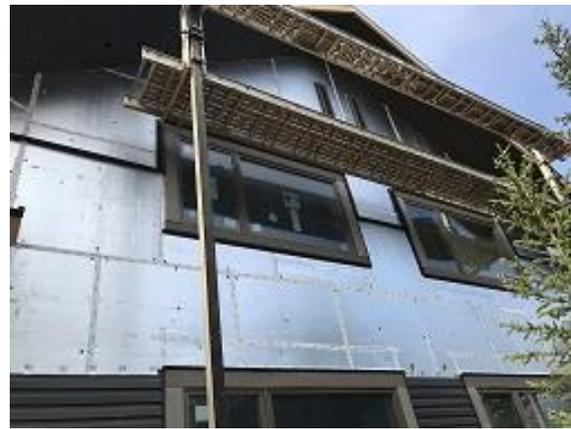
Building E3 Unit 26 & 27 Back Gable
Flashing & Vent Installation
