Daily Observation Report

PROJECT: BIG HORN CONDO SIDING REPLACEMENT & EXTERIOR UPGRADES PHASE 1

REPORT #: 057

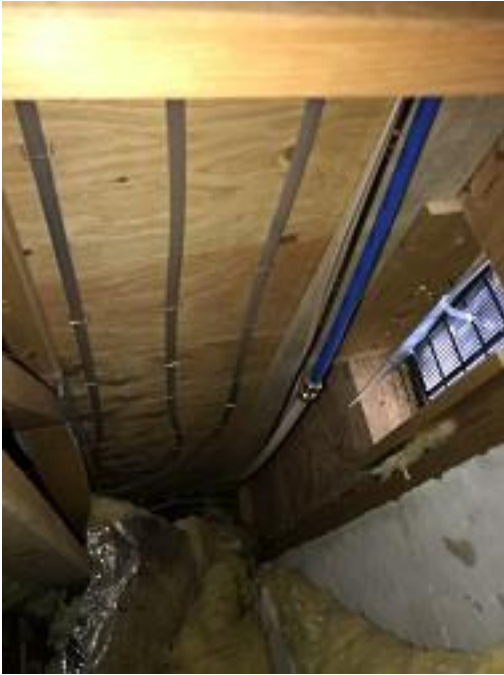
UNRESOLVED ISSUES/FACTORS CONTRIBUTING TO DELAY – Unit 27 when KCD cut out subfloor for patio door installation they accidentally cut a radiant heat tube under subfloor and repaired that tube.

**Building E3 Unit 27 Patio Door Subfloor
and Repaired Radiant Heat Tubing**

UNRESOLVED ISSUES/FACTORS CONTRIBUTING TO DELAY – Building E3 Units 25 & 27 Under subfloor blocking repair at subfloor cut for patio door installation. Radiant heat tubing repair test needed.

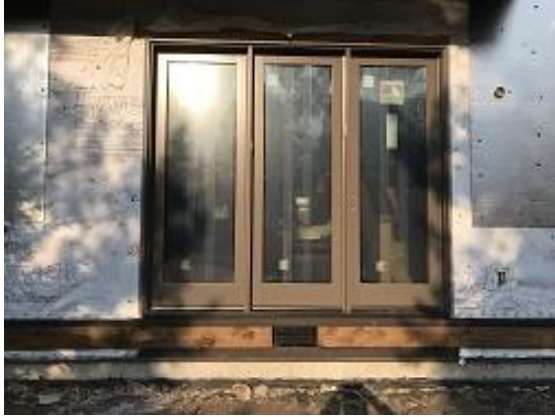
UNRESOLVED ISSUES/FACTORS CONTRIBUTING TO DELAY – Board Member Kim Hanson viewed Unit 27 patio door installation. Kenyon Noble Anderson window rep, Taylor informed us the need for the flooring cut back, existing doors were 2 x 4 with jam extensions. He said doors installed have been done in the appropriate manner with regard to the depth into the rough opening.

Building E3 Unit 27 Patio Door Installation

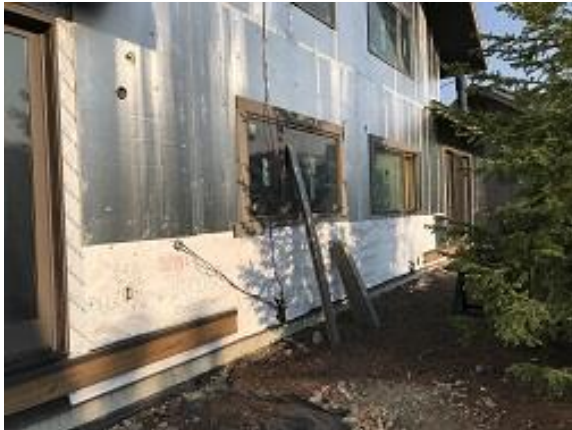
Building E3 Unit 24 & 25 Lower Back Bedroom Window Trim Installed

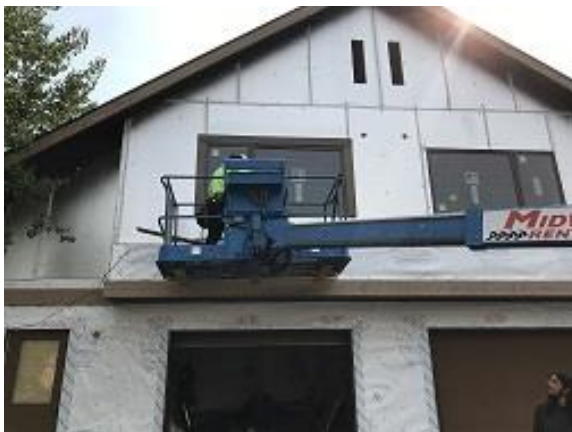
Kim also inspected unit 24 kitchen interior trim to verify new window does not allow appropriate original trim finish reveal. Taylor verified that new windows are larger than existing windows causing existing trim not to fit properly.

Building E3 Unit 24 Upper Front Window Trim Installed

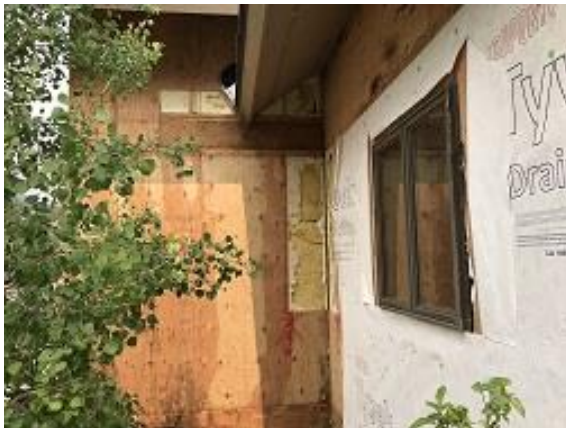
OBSERVATIONS – 1) E3: Unit 24 - 27 Timbertech trim installation, remaining flashing installation, remaining foam board insulation installation. Wain **2)** E4: Unit 31 - 28 Final urethane finish applied. **3)** E7: Unit 49 & 50 Damaged area sheathing removed and moisture levels taken less than 12%.

Building E7 Unit 49 Damaged Area

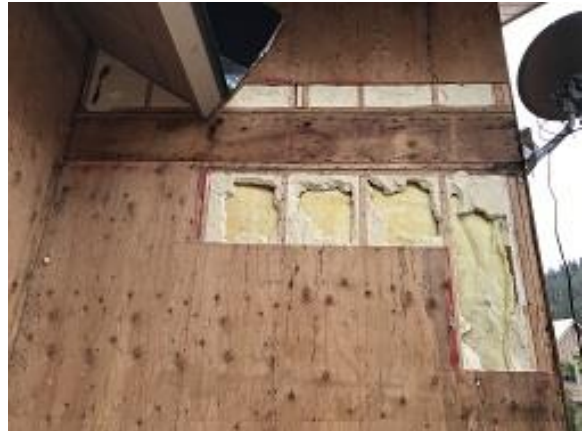
Building E7 Unit 50 Damaged Area
