## Monthly Status Report – July

Date of Report: Aug 17, 2021

The Project entitled “Big Horn Condo Siding Replacement & Exterior Upgrades” is designed by Hip & Humble Architects. The overall site consists of 24 wood-framed buildings. Of the 24 buildings, they are made up of 13 duplexes, 9 four-plexes, 1 tri-plex and 1 five-unit complex. The work is developed into two phases; Phase 1 contains 11 buildings, and Phase 2 contains 13 buildings. While the work is scheduled from April through November, physical work is limited to weather conditions. The base contract includes removal of the wood siding and replacing it with the metal siding and wainscot; and the Owner options include windows, front and patio doors, and garage doors. Deterioration rework is considered “contingency work” and is included as a part of the Base Bid through an approved Change Order. The project is being performed by Langlas & Assoc as the General Contractor, and KCD Enterprises as the main subcontractor under the contract by Langlas & Assoc. Work commenced on site beginning April 19, 2021.

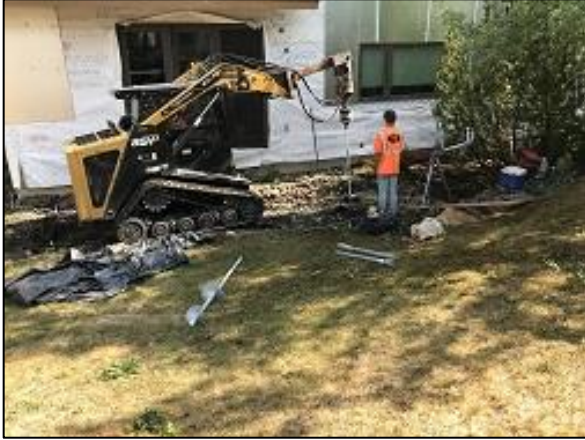
**Building E3 Unit #27 Begin Deck Helical Piers Installation**

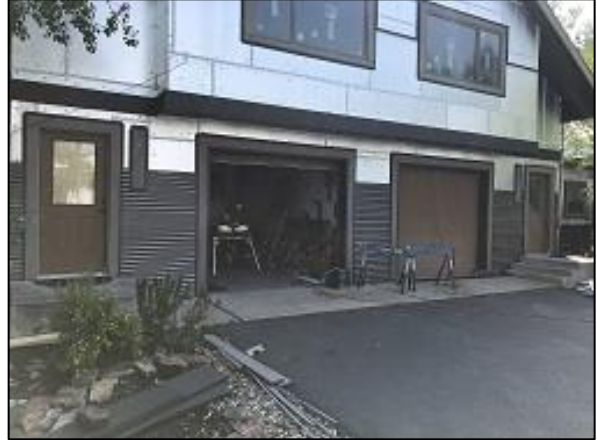
**Building E3 Units #24 & #25 Front Corrugated Installation**

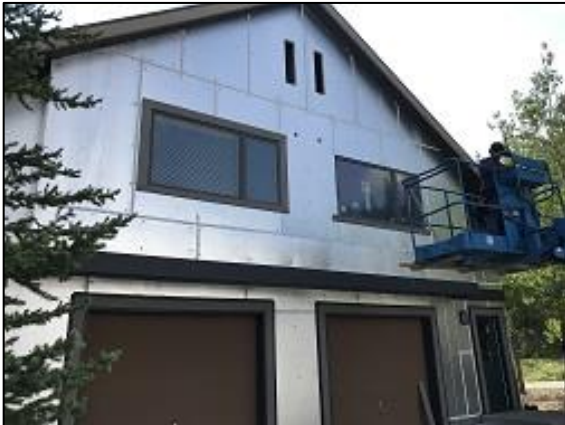
**Building E3 Unit #26 & #27 Front Upper Windows Trim Installed**

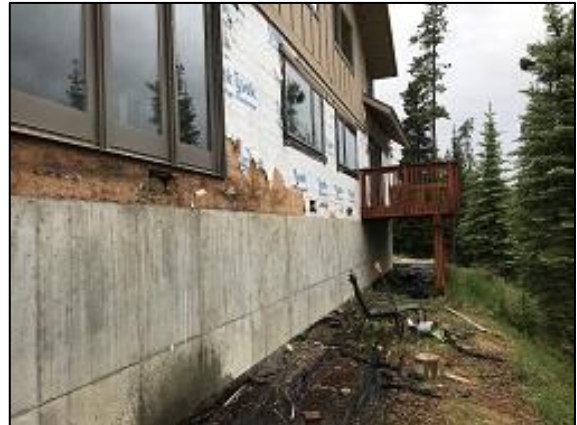
**Building E7 Units #51 & #52 Demo**

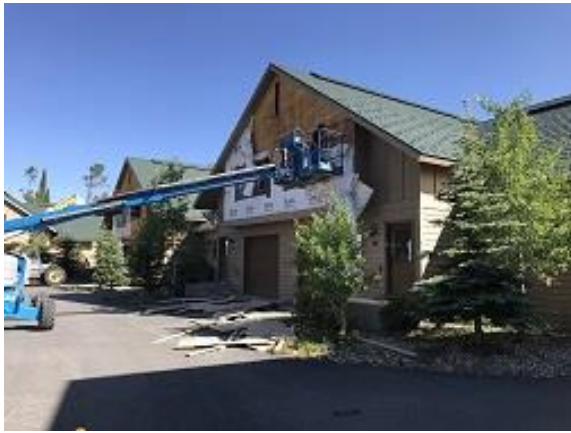
**Building E7 Unit #49 & #50 Front Upper Bedroom Demo**

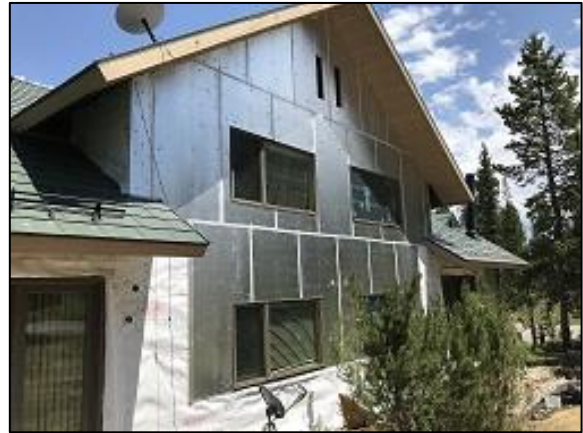
**Building E1 Unit #8 & #9 Foam Board**

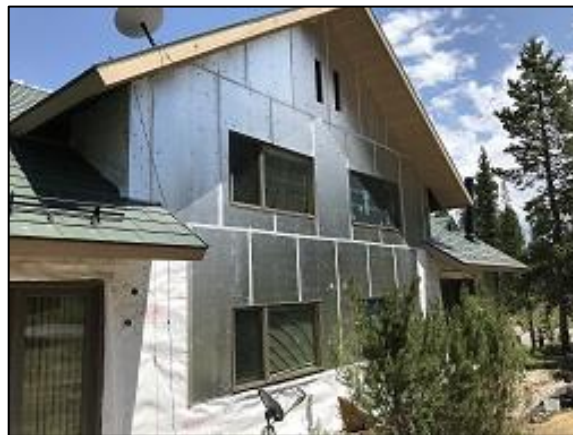
**Building E1 Unit #8 & #9 Foam Board Installation**

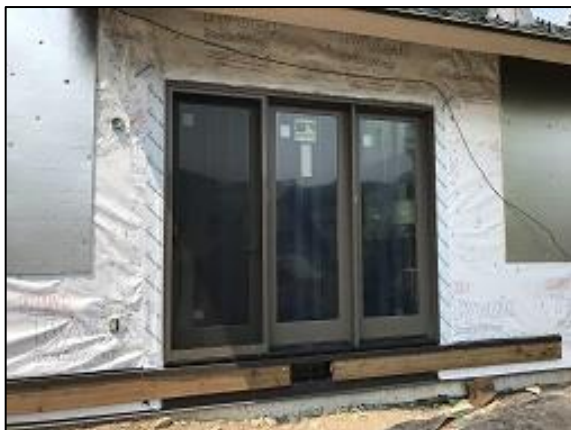
**Building E3 Unit #24 Patio Door Installed**

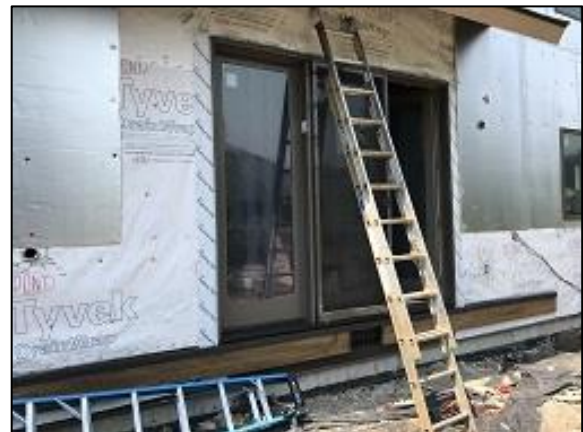
**Building E3 Unit #25 Patio Door Installed**

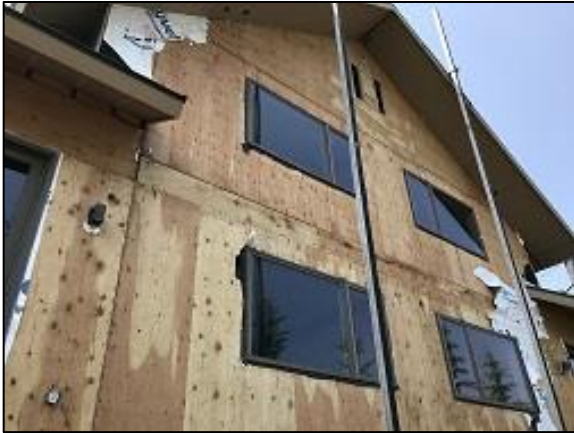
**Building E7 Units #49 & #50 Gable Vent  
Cut Outs**

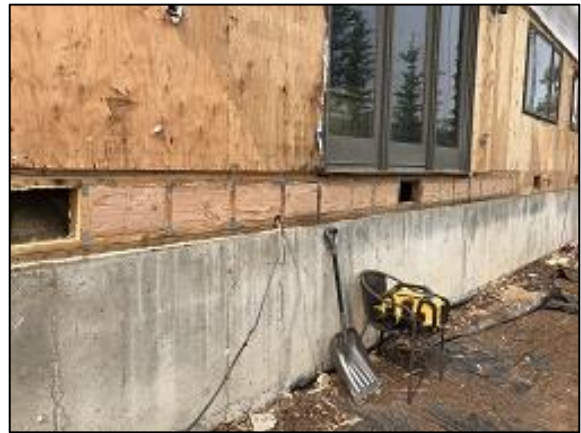
**Building E7 Unit #49 Deck Ledger Blocking**
