Daily Observation Report

Date of Report: July 26, 2021
 Prepared By: Jim Goveia

PROJECT: BIG HORN CONDO SIDING REPLACEMENT & EXTERIOR UPGRADES PHASE 1

REPORT #: 067

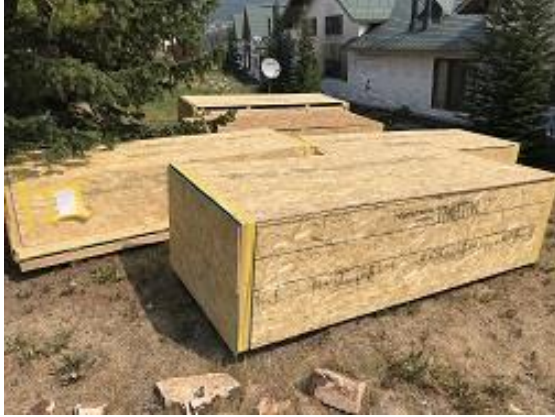
Bridger Steel Delivery

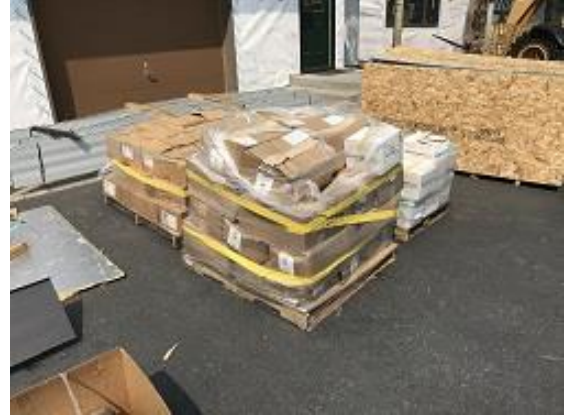
Bridger Steel Delivery

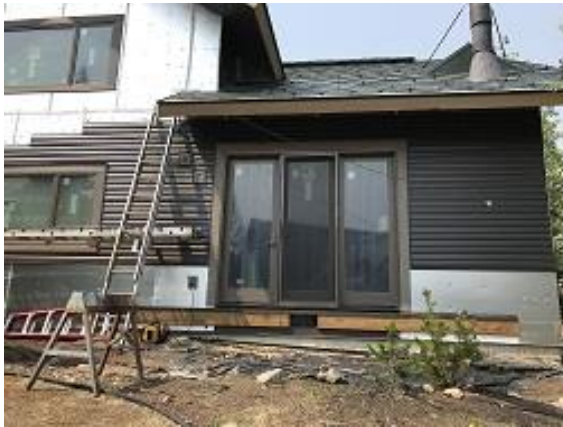
Building E3 Unit 24 Back Siding Install

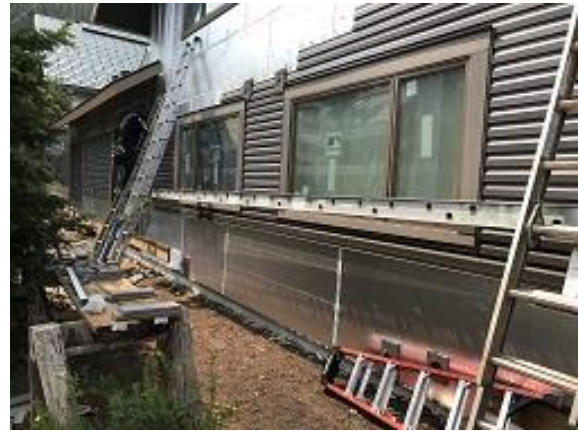
**Building E3 Units 24 & 25
Back of Building Siding**

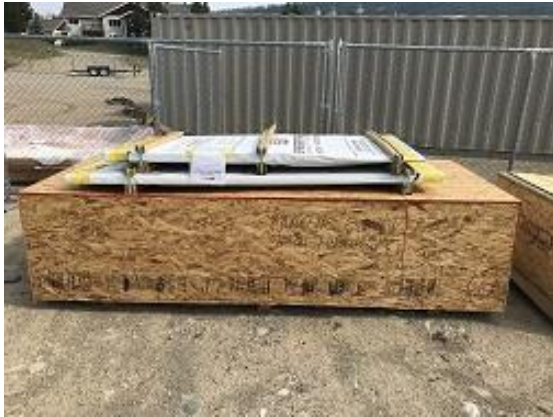
Bridger Steel Siding Delivered

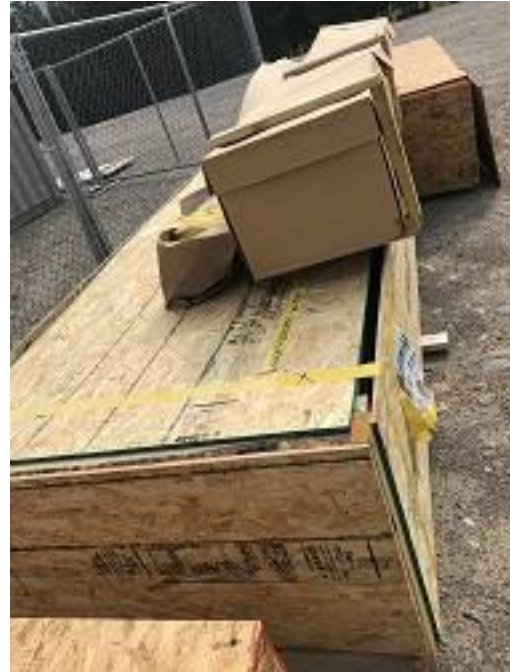
Bridger Steel Siding Delivered

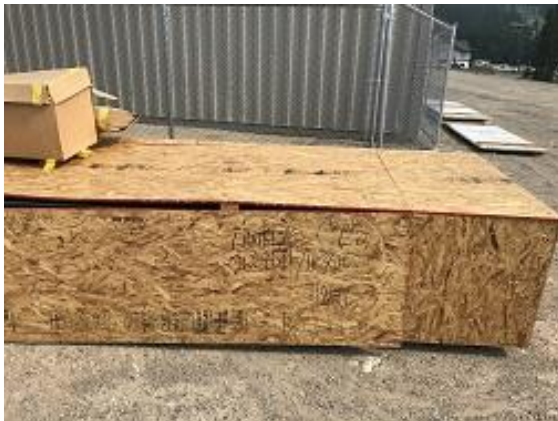
Bridger Steel Siding Delivered

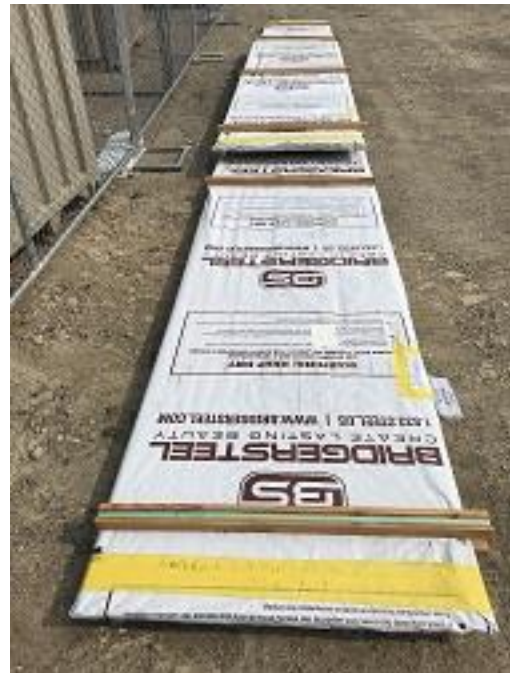
Bridger Steel Siding Delivered

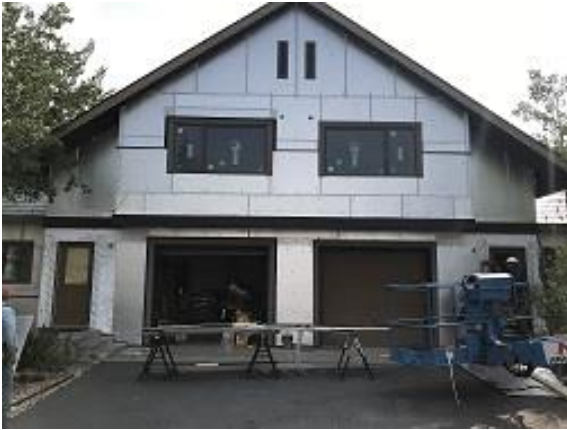
Belly Band Steel Installed and Unit 24 J Channel
Around Garage Trim Installed

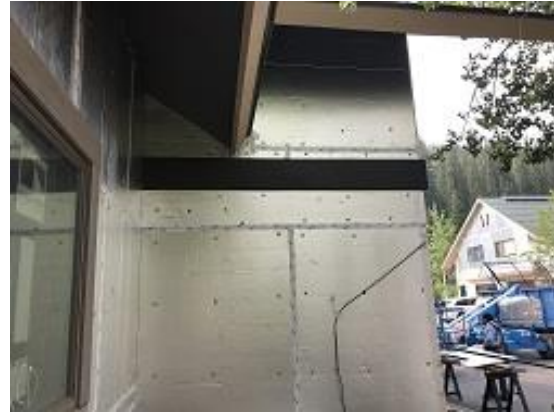
Unit 24 Belly Band Steel Installed

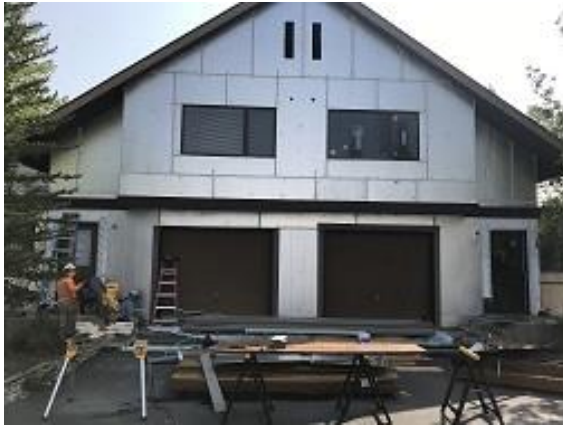
Unit 26 & 27 Garage Belly Band Installed

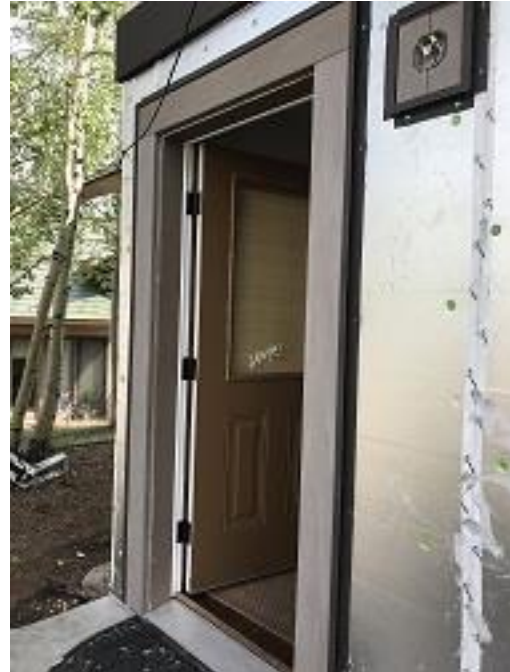
Unit 24 Front Door Timbertech Trim and J Channel Installed

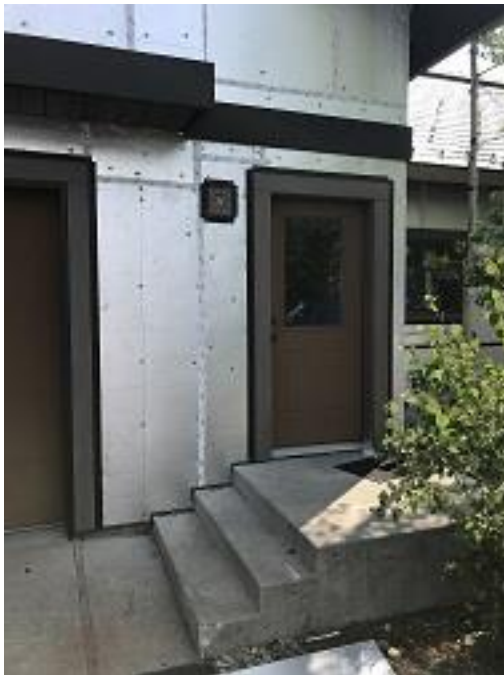
Unit 25 Front Door Timbertech Trim and J Channel Installed

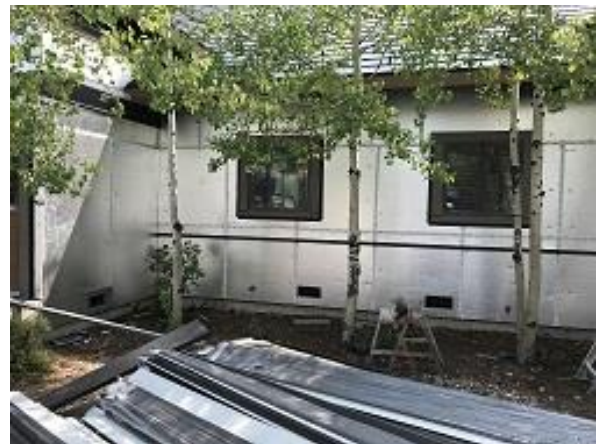
Unit 25 & 26 Kitchen Window Timbertech Trim and J Channel Installed

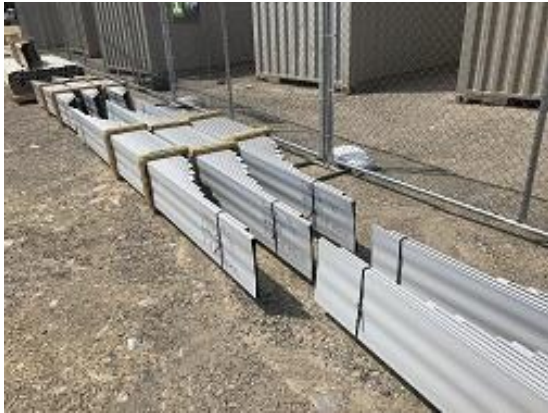
Bridger Steel Delivery

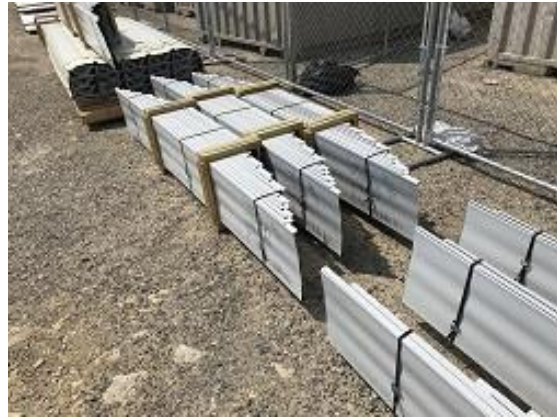
Bridger Steel Delivery

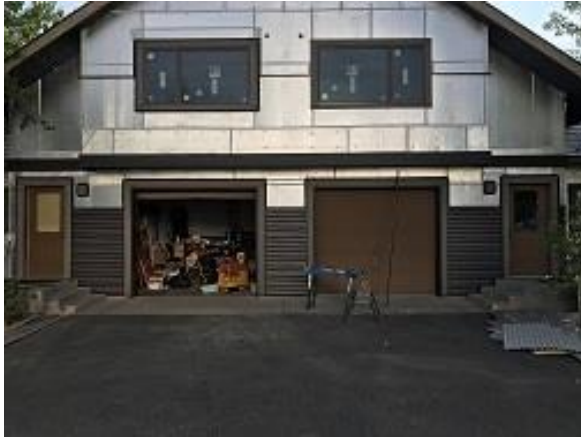
Building E3 Unit 24 & 25 Corrugated Siding Installed

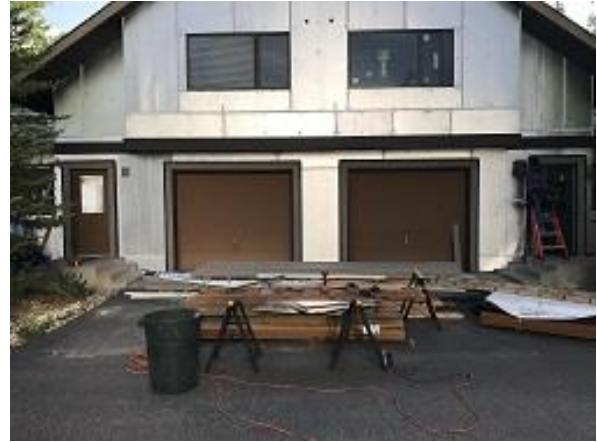
E3 Unit 26 & 27 Belly Band Steel Installed and Unit J Channel Around Garage Trim Installed

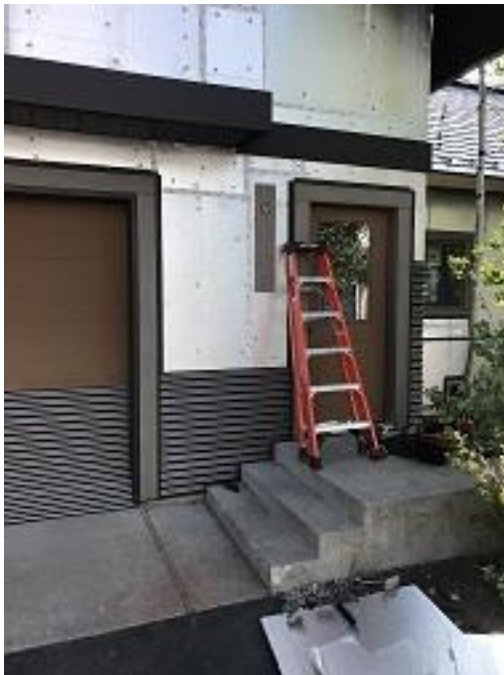
Building E3 Unit 25 Front Door Light & Address Blocking Installed

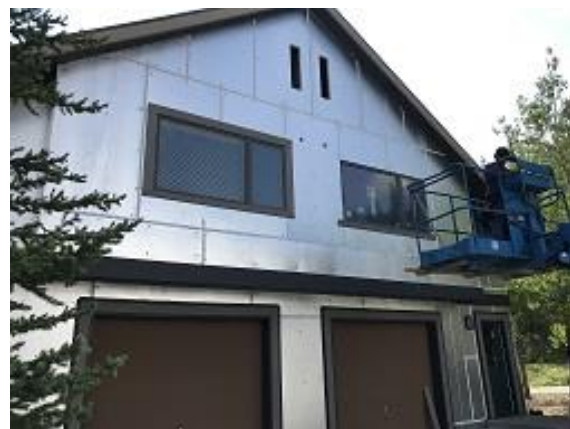
Building E3 Unit 26 & 27 Front Upper Windows Trim Installed

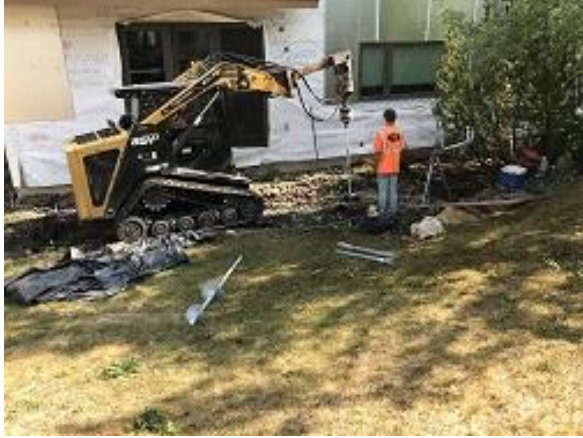
Building E3 Unit 11 Begin Deck Helical Piers Installation

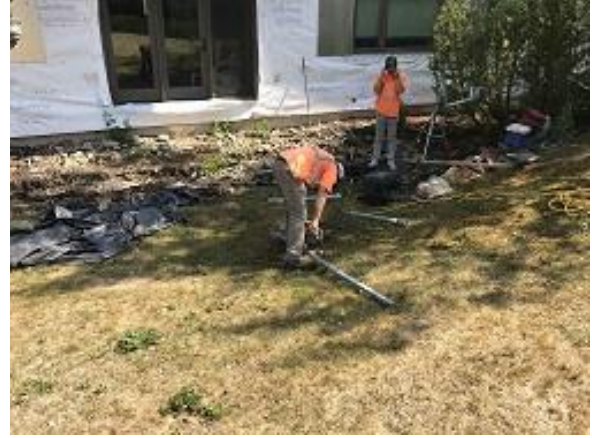
Building E3 Unit 11 Deck Helical Piers Installation

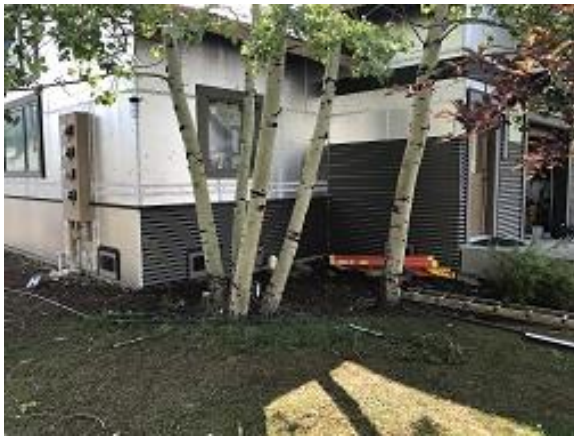
Building E3 Unit 24 Kitchen & Entry Siding Installed

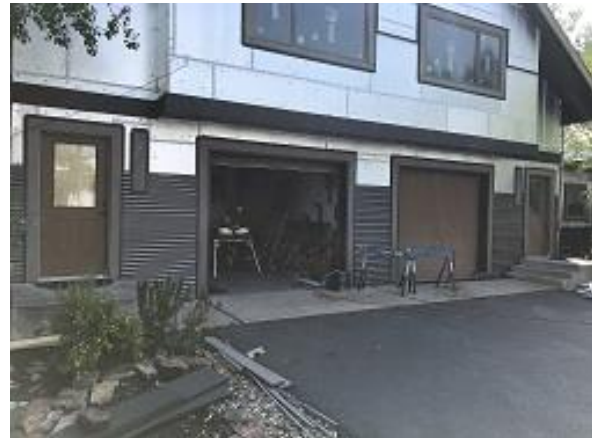
Building E3 Unit 24 & 25 Front Corrugated Installed

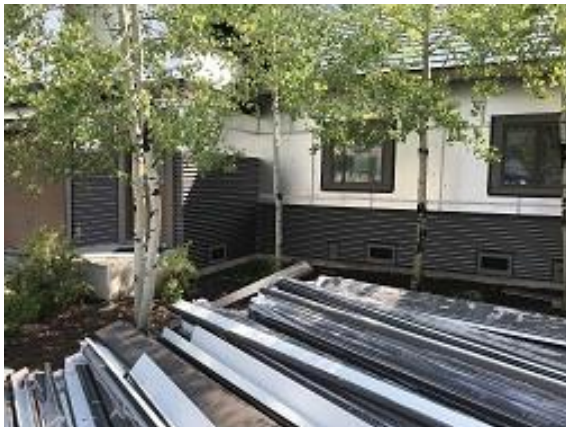
Building E3 Unit 25 & 26 Kitchen Windows Corrugated Siding Installed

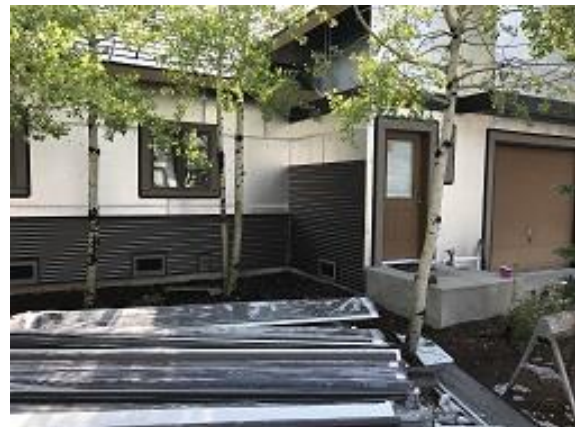
Building E3 Unit 26 Kitchen Windows Corrugated Siding Installed

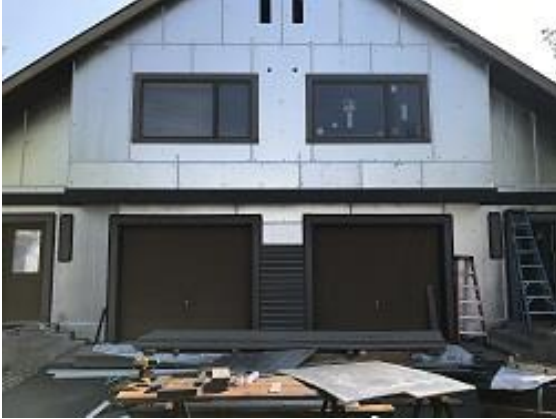
Building E3 Unit 25 & 26
Corrugated Siding Installed
