Daily Observation Report

Date of Report: Aug. 9, 2021
 Prepared By: Jim Goveia

PROJECT: BIG HORN CONDO SIDING REPLACEMENT & EXTERIOR UPGRADES PHASE 1

REPORT #: 077

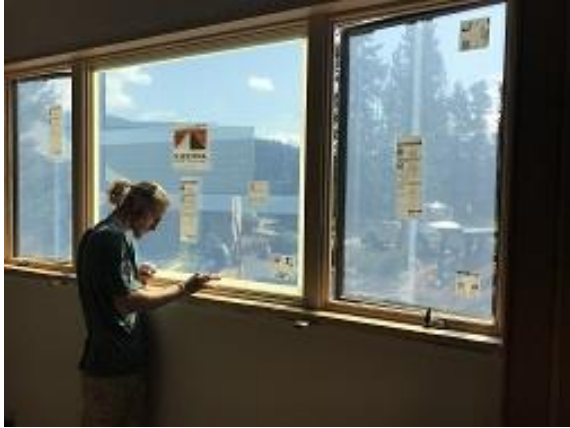
**Building E1 Unit 8 Interior Lower Living Room
Window Finish Applied**

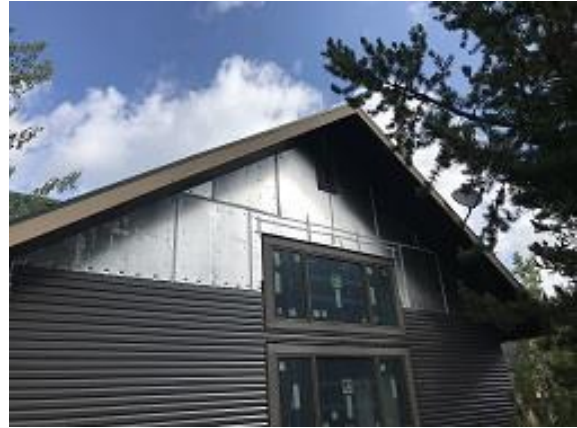
**Building E3 Unit 27 Side Board & Batten Siding
J Channel Installation**

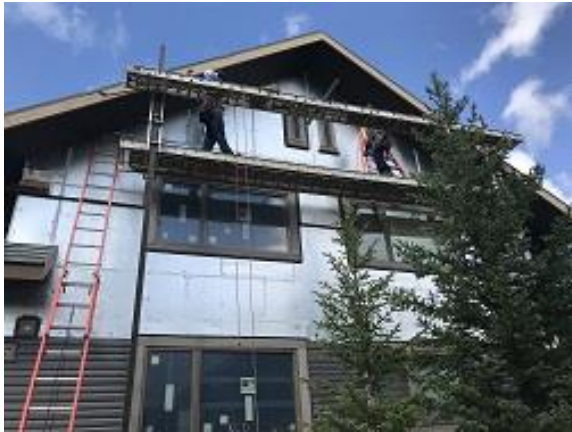
**Building E3 Unit 26 & 27 Back Board &
Batten Siding Corner Installation**

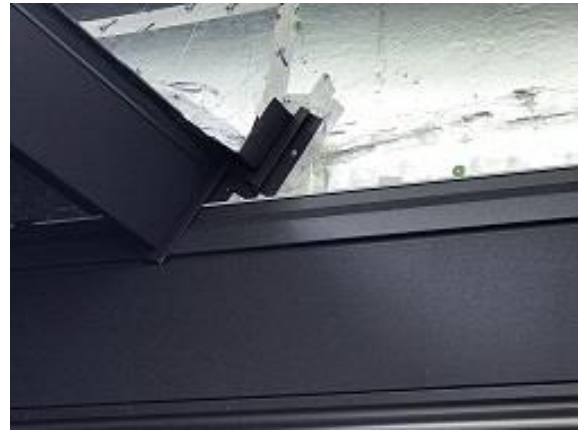
**Building E3 Unit 24 Front Diverter &
J Channel Installation**

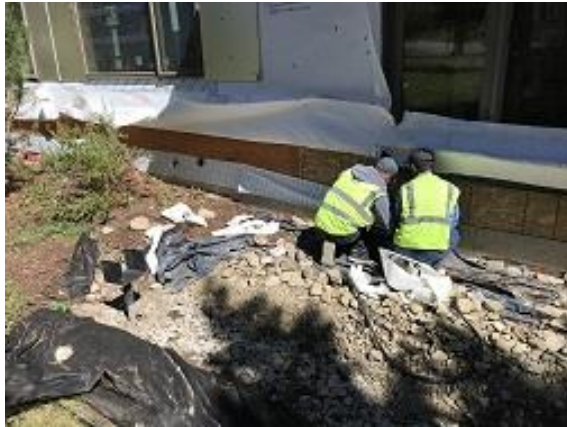
Building E1 Unit 8 base flashing tape Installed

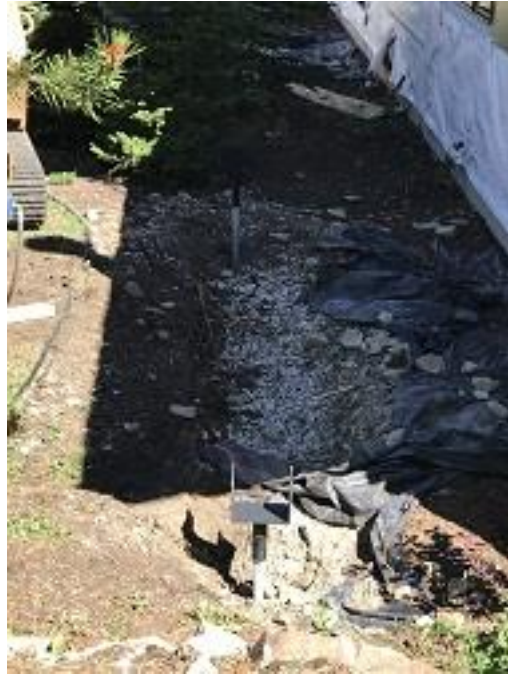
Building E4 Unit 31 Helical Piers Installed

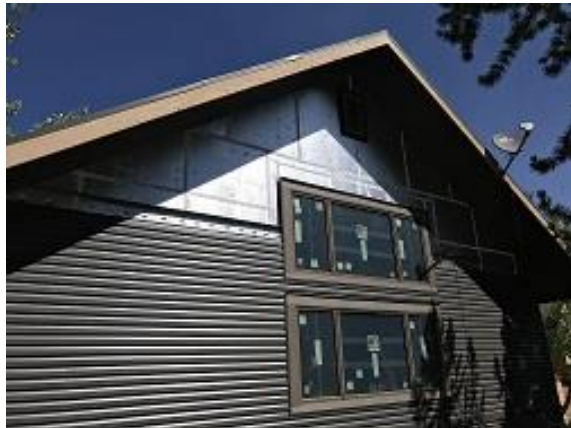
Building E3 Unit 27 Side Board & Batten J Channel Installed

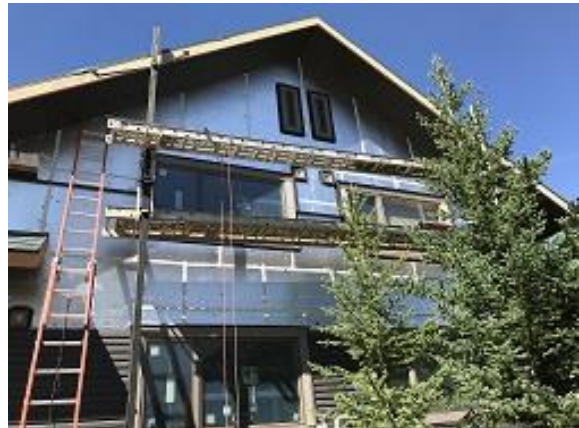
Building E3 Unit 26 & 27 Back Board & Batten J Channel Installed

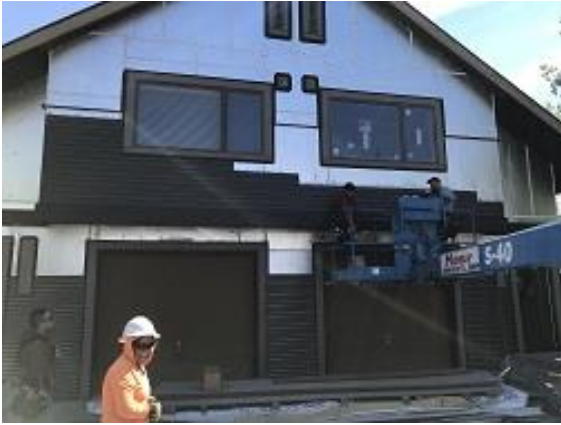
Building E3 Unit 26 & 27 Front Lap Siding Installed

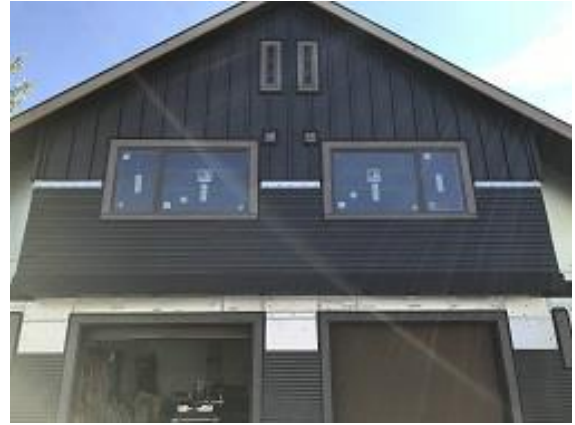
Building E3 Unit 24 & 25 Front Lap Siding Installed

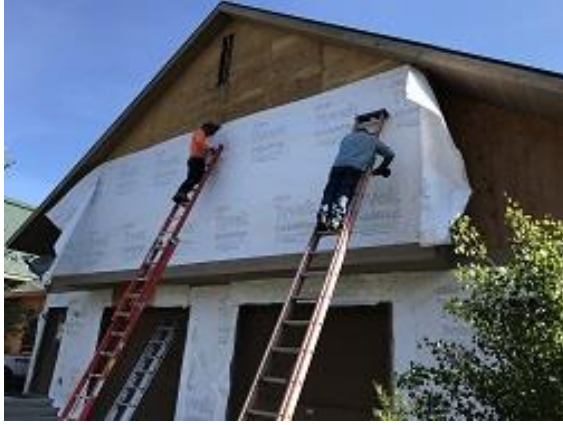
Building E7 Units 49 & 50 Tyvek Installed

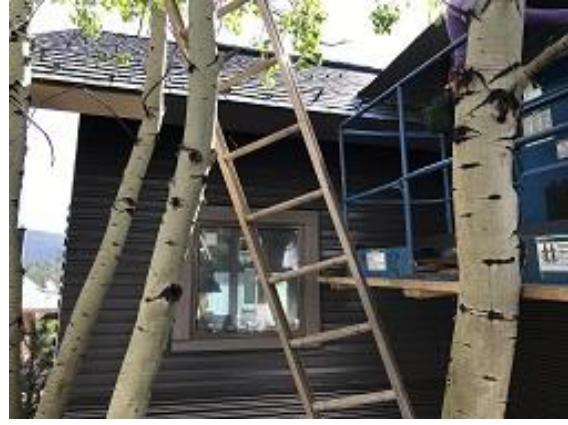
Building E3 Unit 24 Fascia Trim Installed

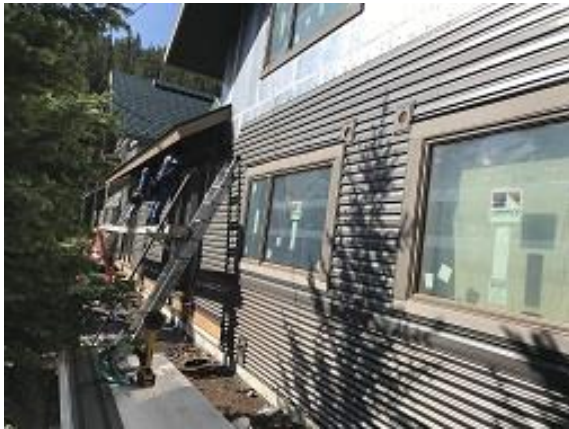
Building E3 Unit 24 & 25 Lap Siding Installed

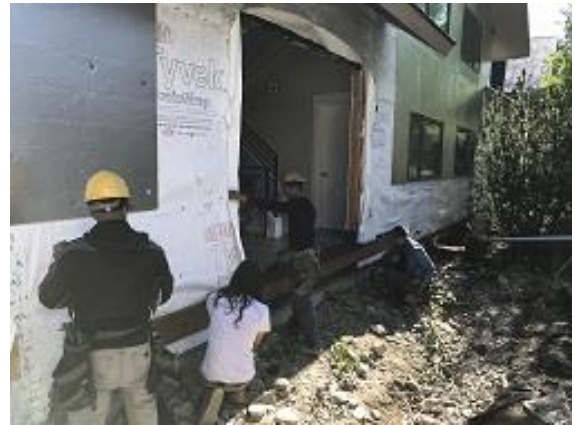
Building E1 Unit 11 Deck Ledger & Door Flashing Installed

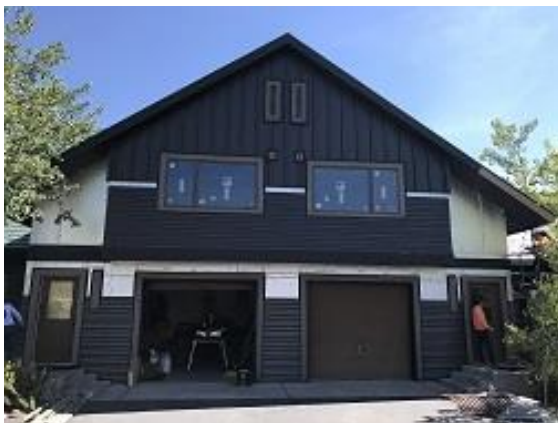
Building E3 Unit 24 & 25 Fascia Installed

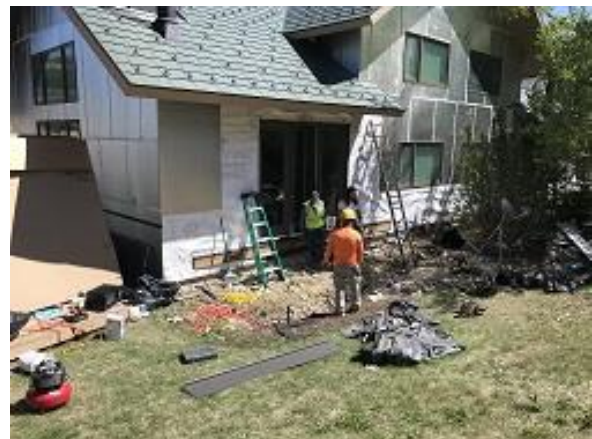
Building E1 Unit 11 Deck Door Reinstalled

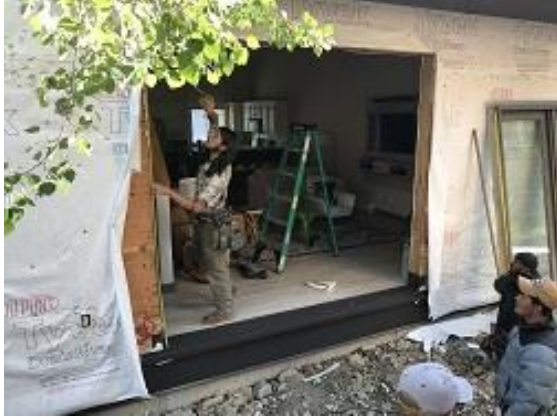
Building E1 Unit 10 Door Pan & Deck Ledger Flashing Installed

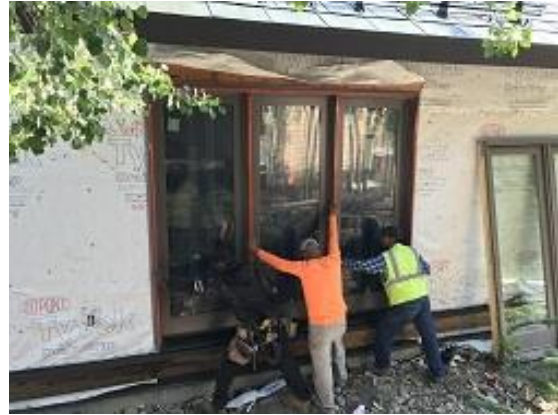
Building E1 Unit 10 Deck Door Installed

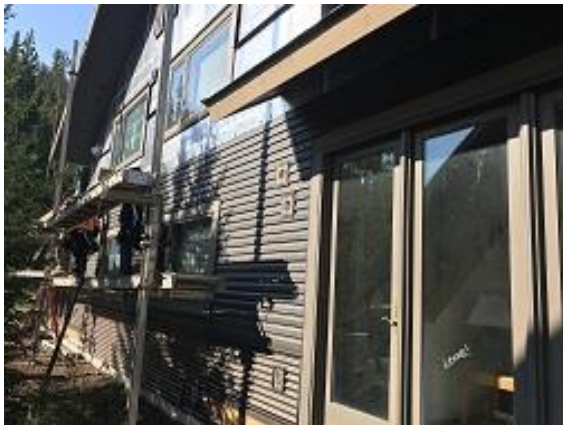
Bldg E3 Units 26 & 27 Back Lap Siding Installed

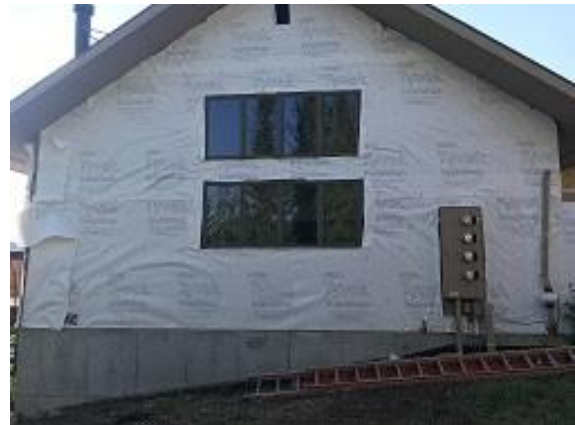
Building E7 Unit 52 Side Tyvek installed

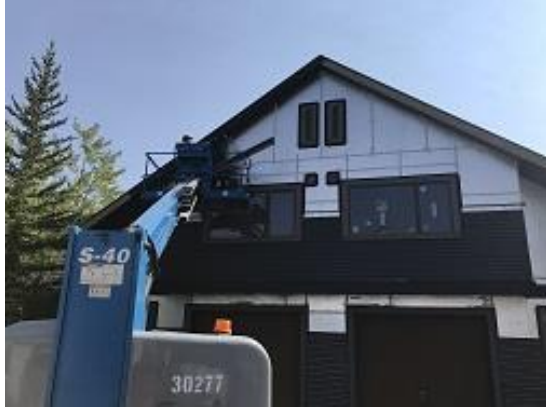
Building E3 Units 26 & 27 Front Facsia Installed

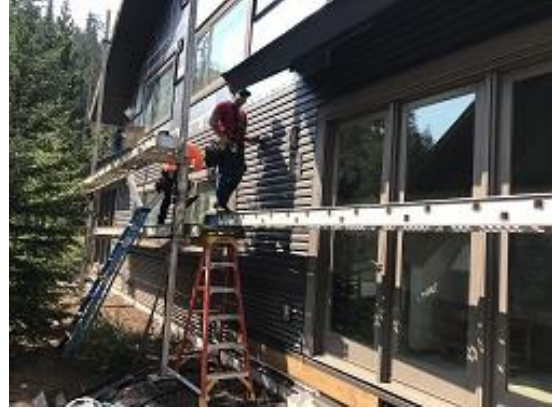
Building E3 Units 26 & 27 Back Lap Siding Installed

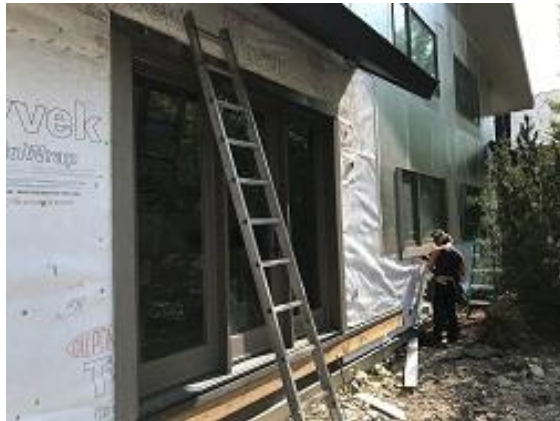
Building E1 Unit 11 Back Window & Door Trim Installed

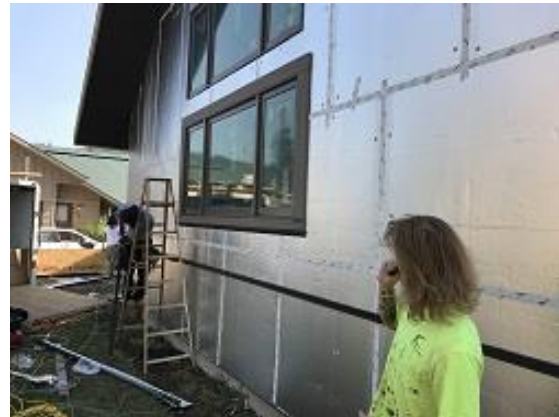
Building E1 Unit 11 Side Window Trim, J Channel Installed

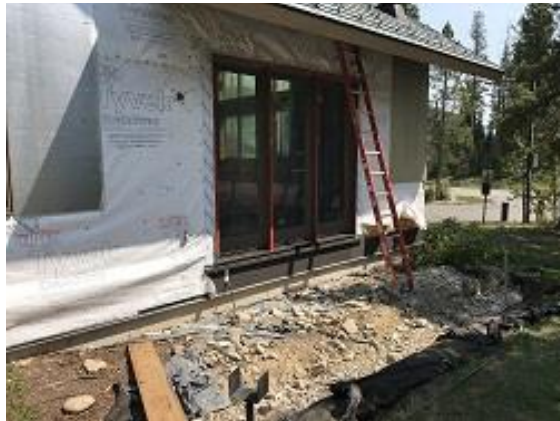
Building E1 Unit 8 Deck Door & Flashing Installed

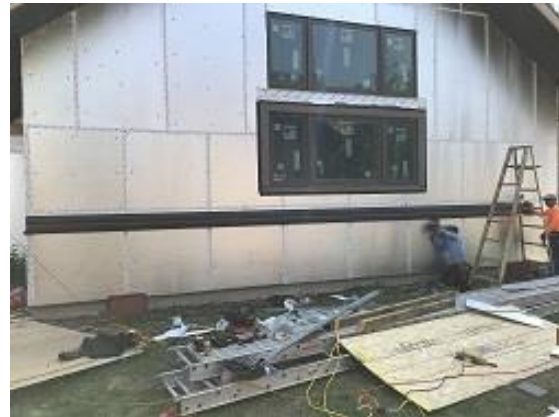
Building E1 Unit 11 Side Lap Siding Installed
