Daily Observation Report

PROJECT: BIG HORN CONDO SIDING REPLACEMENT & EXTERIOR UPGRADES PHASE 1

REPORT #: 072

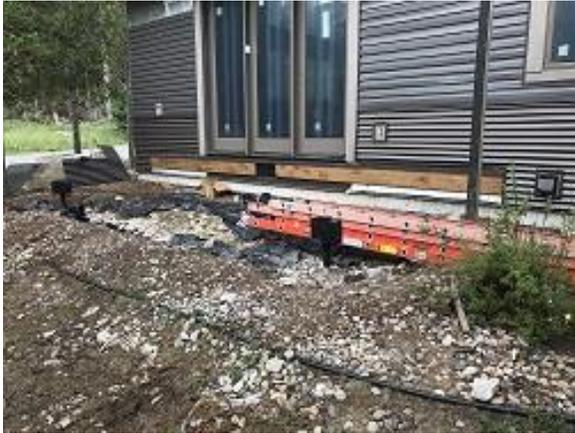
Building E3 Unit 27 Helical Pier Installation

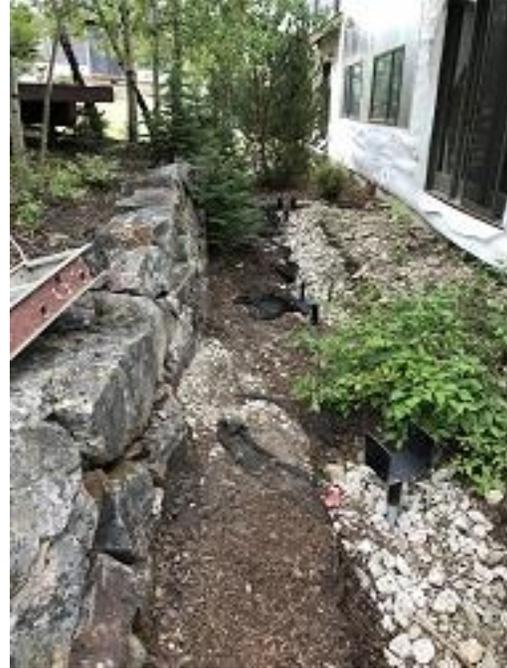
Building E1 Unit 10 Helical Pier Installation

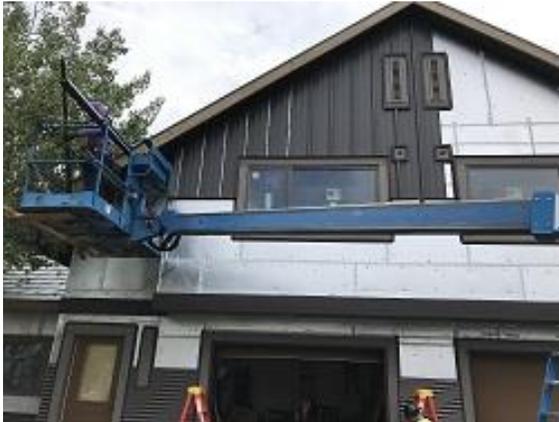
Building E3 Unit 24 Board & Batten Siding Installation

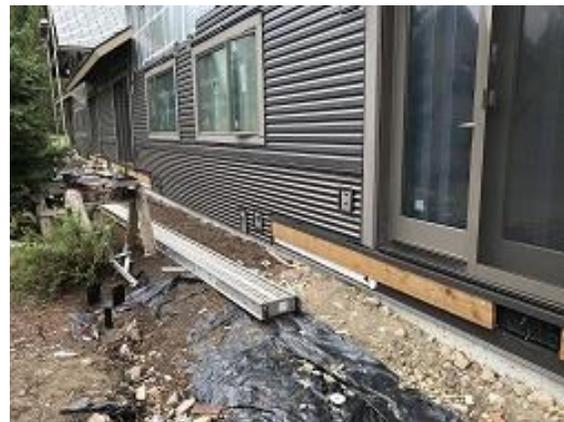
Building E3 Unit 24 & 25 Wainscote Siding Installation

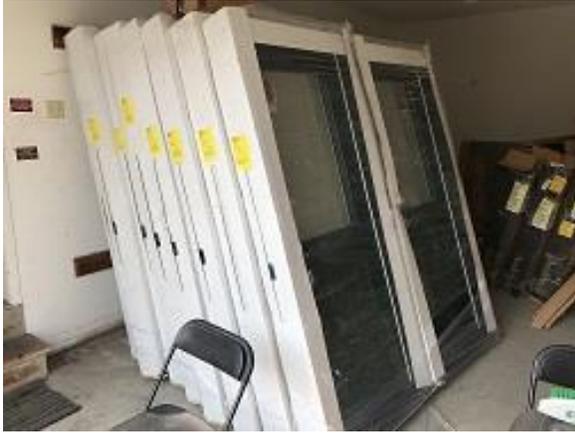
Balance of Doors Delivery

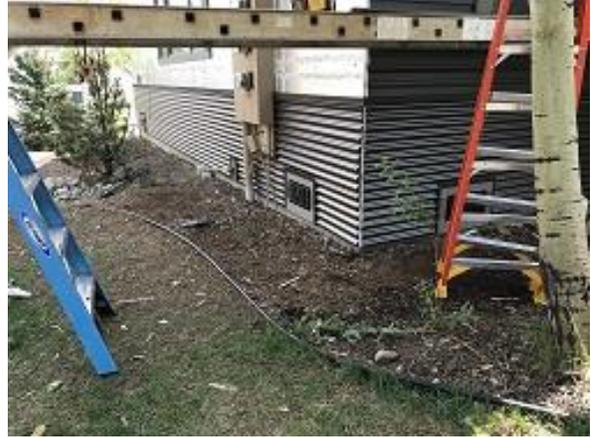
Building E3 Unit 24 Side Wainscote
Siding Installation

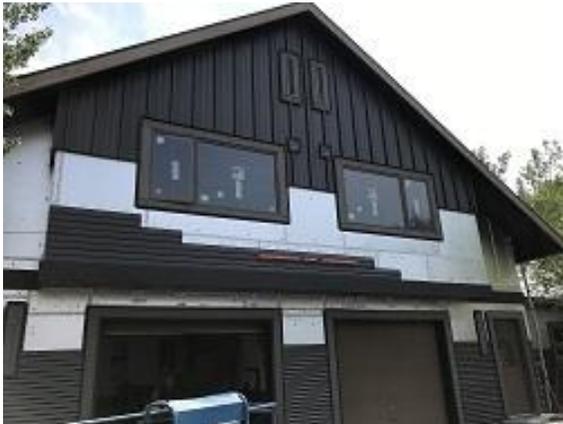
Building E3 Unit 24 Front Upper Lap
Siding Installation

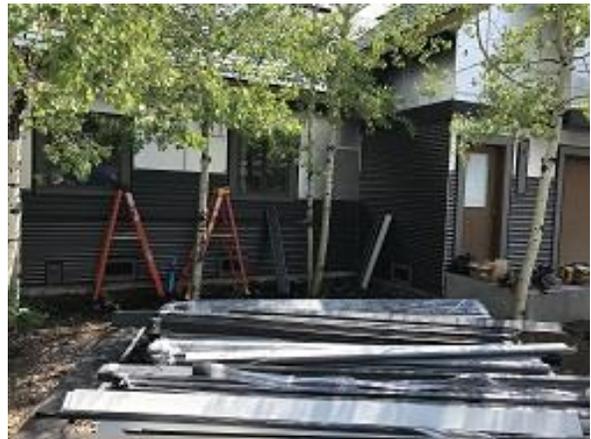
Building E3 Unit 26 Kitchen Lap &
Corrugated Siding Installation

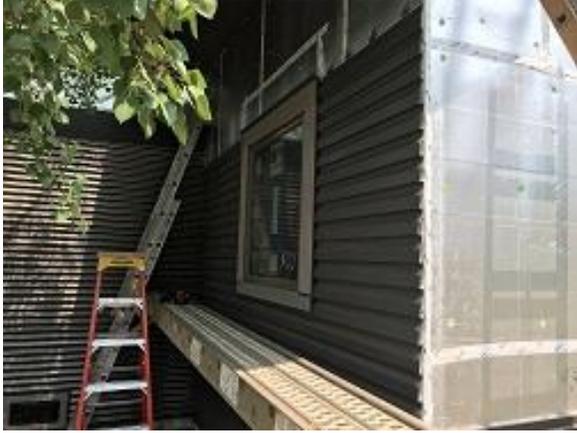
Building E3 Unit 27 Kitchen Lap Siding Installation

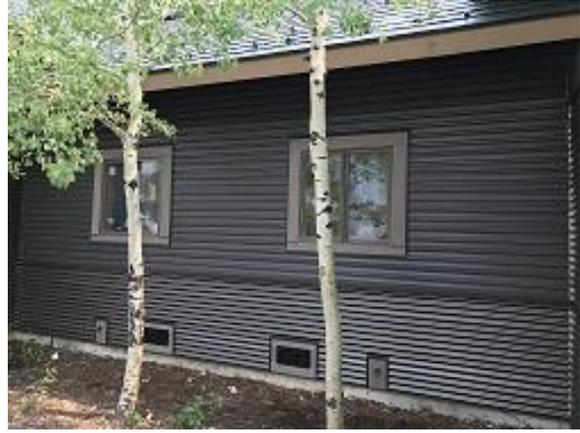
Building E3 Unit 25 & 26 Kitchen Lap Siding Installation

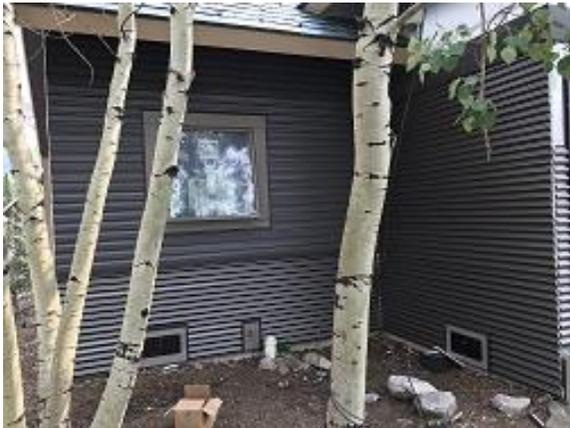
Building E3 Unit 24 Kitchen Lap Siding Installation

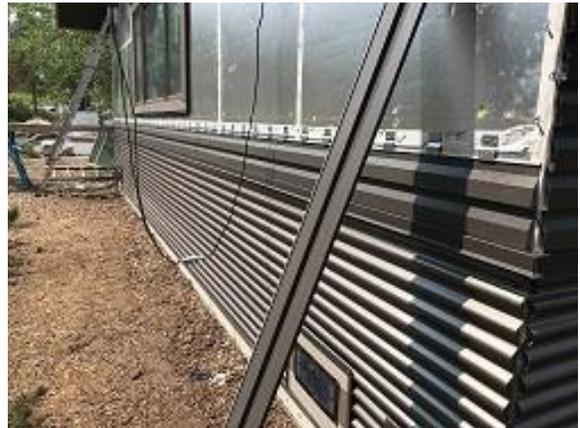
Building E3 Unit 27 Side Lap Siding Installation

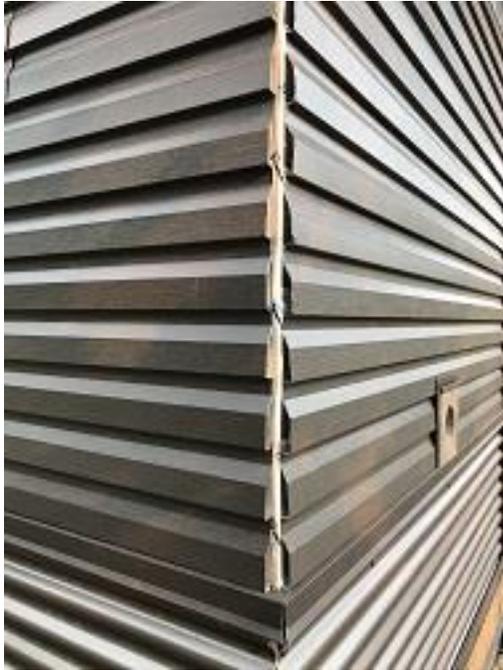
Building E3 Unit 27 Lap Siding Corner

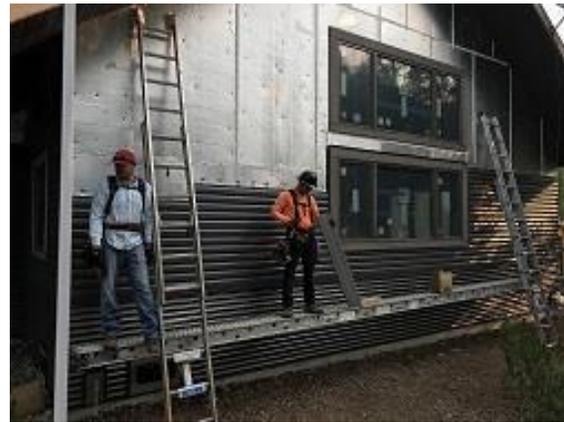
Building E3 Unit 27 Side Lap Siding Installation

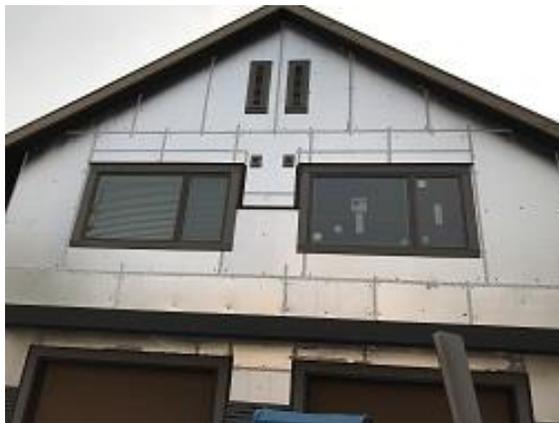
Building E3 Unit 26 & 27 Head Trim and J Channel for Board & Batten Siding Installation

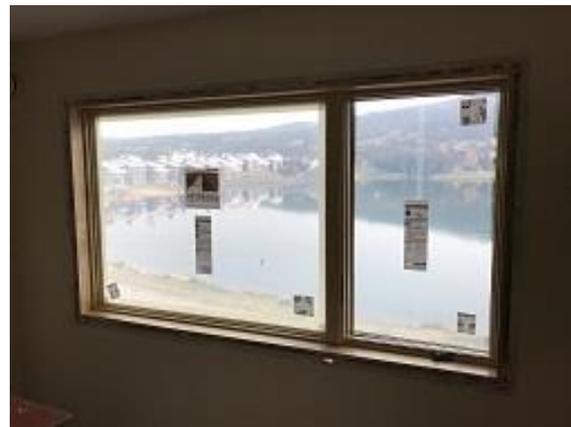
Building F1 Unit 16 Interior Window Finish

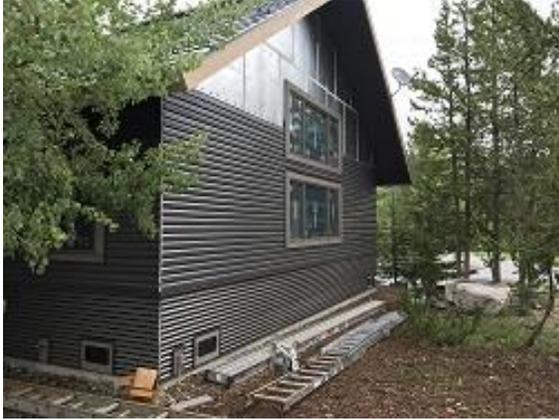
Building E3 Unit 27 Side Lap Siding Installed

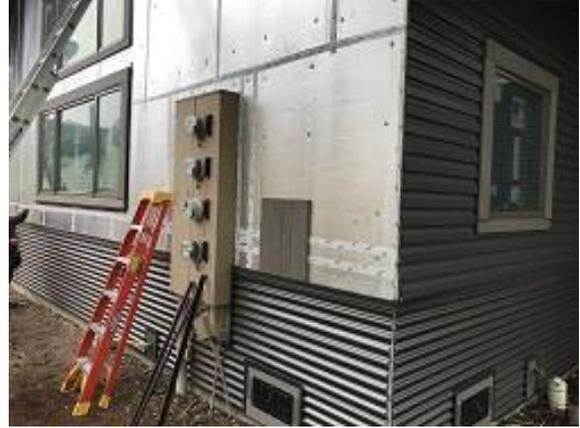
**Building E3 Unit 24 Side Lap Siding
3 Rivers Blocking Installed**
