Monthly Status Report – Aug

Date of Report: Sept 14, 2021

The Project entitled “Big Horn Condo Siding Replacement & Exterior Upgrades” is designed by Hip & Humble Architects. The overall site consists of 24 wood-framed buildings. Of the 24 buildings, they are made up of 13 duplexes, 9 four-plexes, 1 tri-plex and 1 five-unit complex. The work is developed into two phases; Phase 1 contains 11 buildings, and Phase 2 contains 13 buildings. While the work is scheduled from April through November, physical work is limited to weather conditions. The base contract includes removal of the wood siding and replacing it with the metal siding and wainscot; and the Owner options include windows, front and patio doors, and garage doors. Deterioration rework is considered “contingency work” and is included as a part of the Base Bid through an approved Change Order. The project is being performed by Langlas & Assoc as the General Contractor, and KCD Enterprises as the main subcontractor under the contract by Langlas & Assoc. Work commenced on site beginning April 19, 2021.

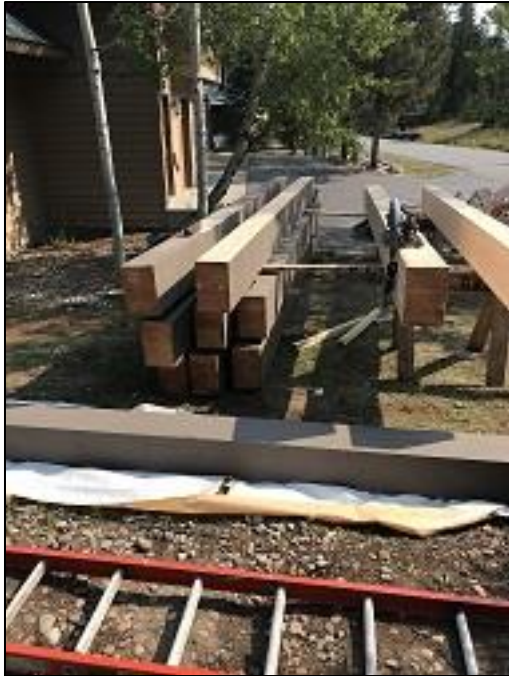
Painting of Deck Beams

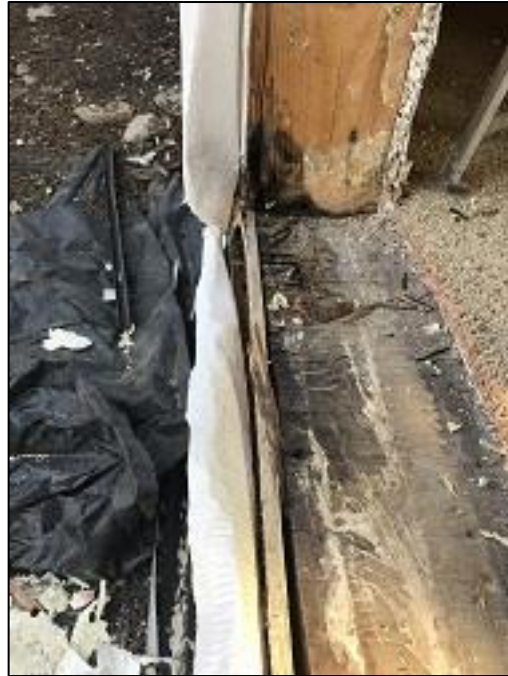
- Unit #31
 - Base and wainscot flashing installation is in progress;
 - Front exterior window trim has been installed;
 - Exterior gable side window trim installation has been completed;
 - Front foamboard, window trim and J-channel installation continues;
 - Patio door removal, flashing installation and deck door installation has been complete;
 - Damage was found in the framing at the patio door location and has been repaired.

Bldg E4 Unit #31 Patio Door Framing Damage

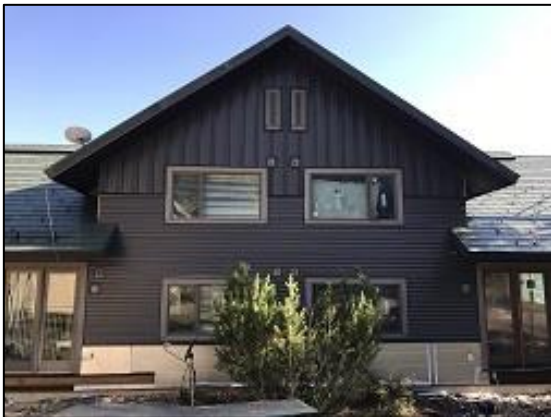
Bldg E1 Units #8 & #9 Rear Board & Batten Siding

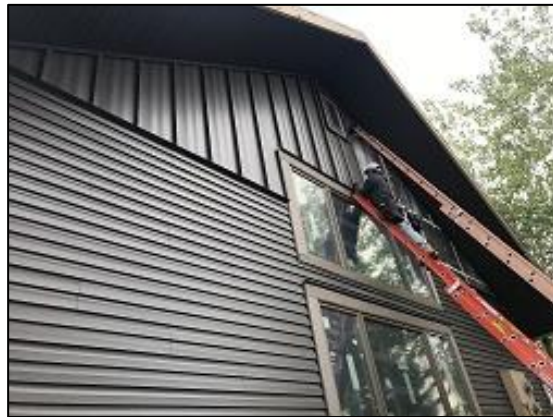
Bldg E3 Unit #24 Board and Batten Installed

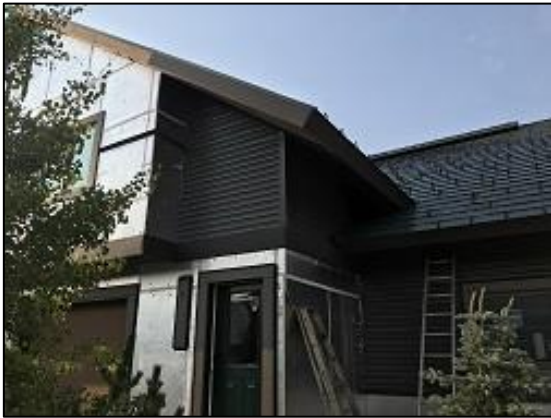
Bldg E1 Unit #11 Front Lap Siding Installed

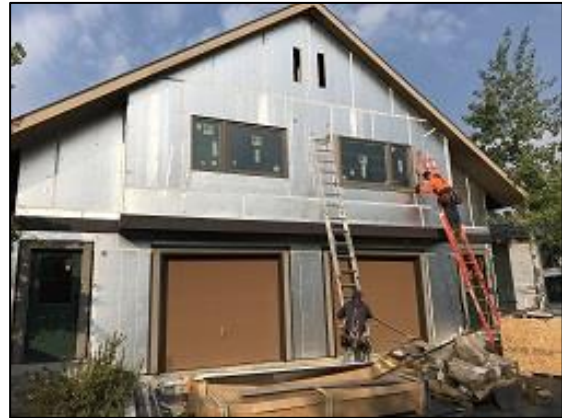
Bldg E4 Units #28 & #29 J-Channel Installation

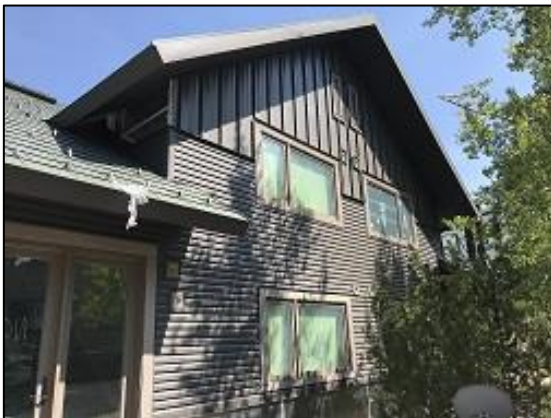
Bldg E1 Units #10 & #11 Rear Board & Batten

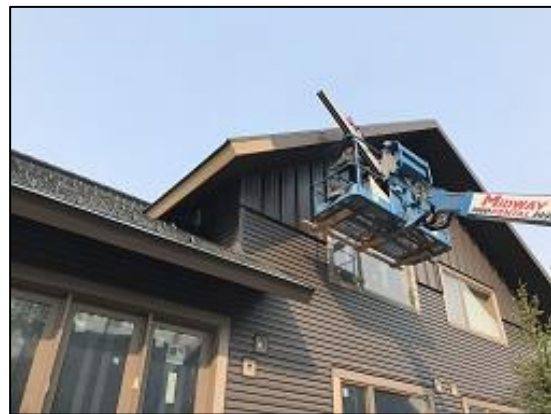
Bldg E3 Unit #27 Rear Fascia Installation

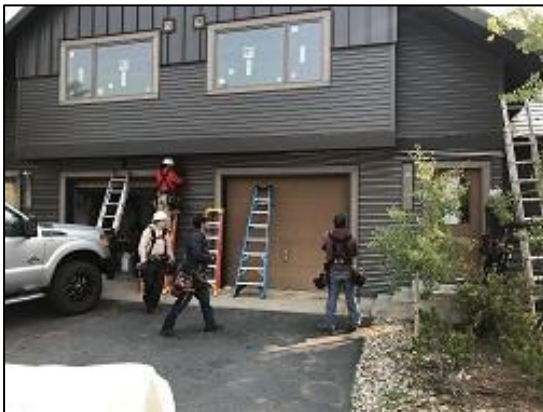
Bldg E3 Units #24 & #25 Front Corrugated Siding

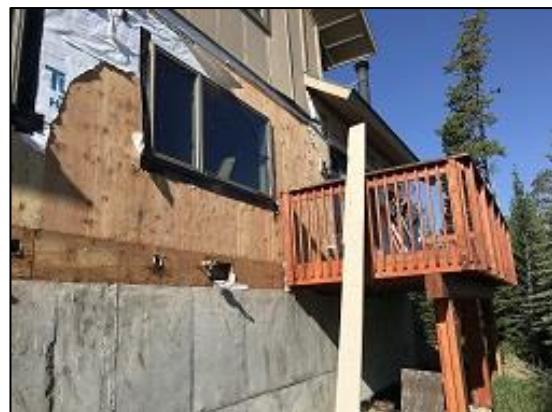
Bldg E7 Unit #52 Siding Demo In Progress

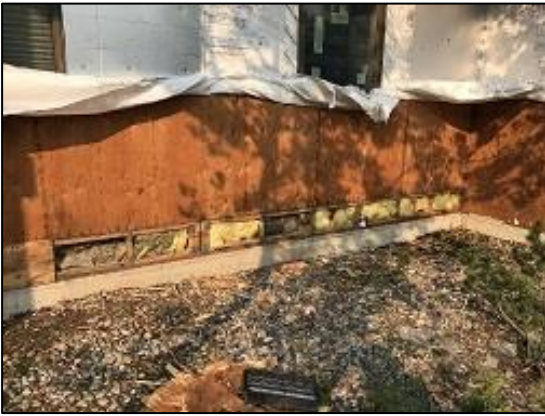
Bldg E4 Units #29 & #30 Front Sheathing Repair

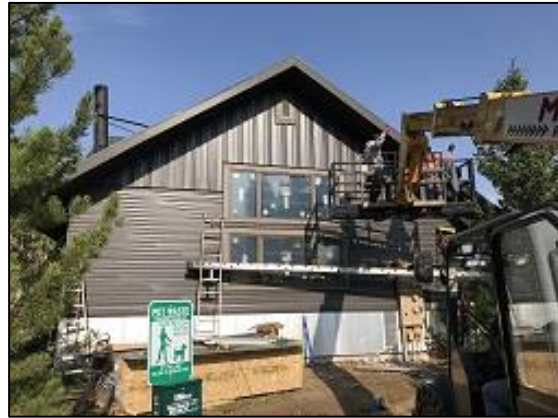
Bldg E1 Unit #8 Board & Batten

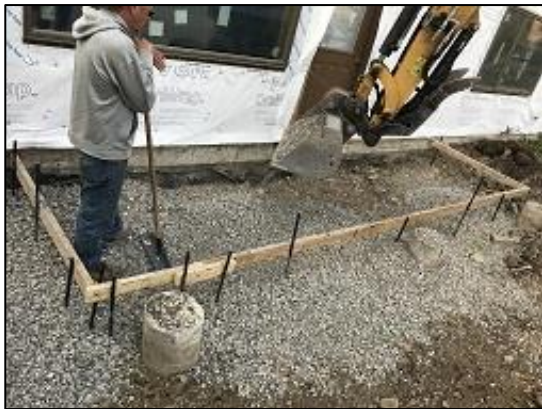
Bldg F1 Unit #16 Concrete Patio Prep

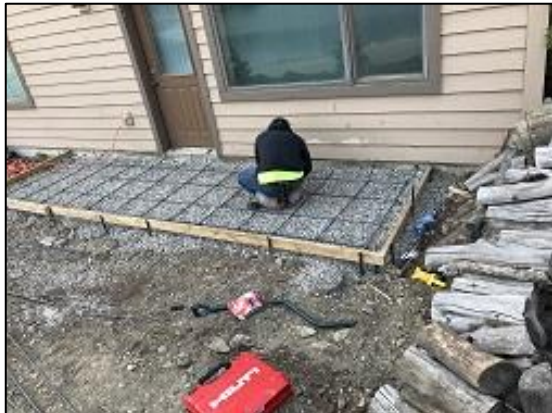
Bldg F2 Unit #19 Concrete Patio Prep

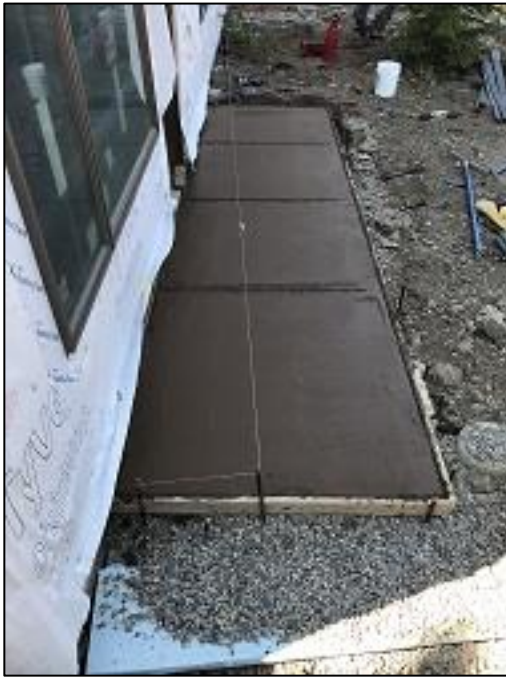
Bldg F1 Units #16 & #17 Concrete
Patios Installed

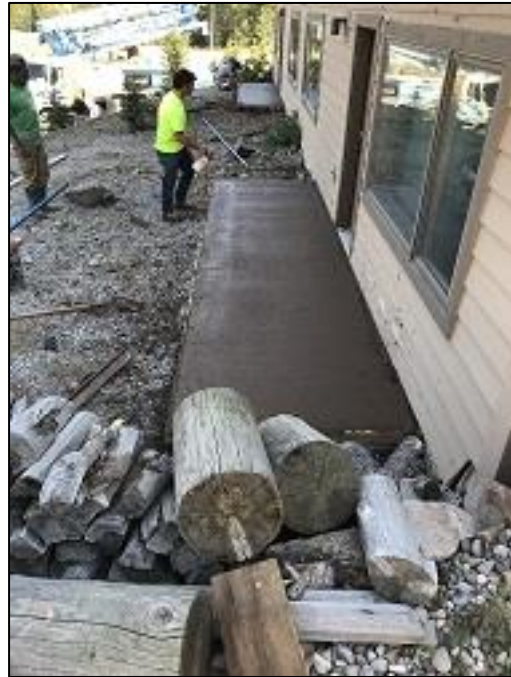
Bldg F2 Units #18 & #19 Concrete
Patios Installed
