Daily Observation Report

PROJECT: BIG HORN CONDO SIDING REPLACEMENT & EXTERIOR UPGRADES PHASE 1

REPORT #: 101

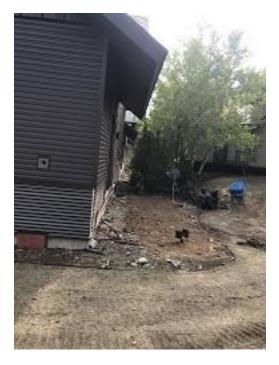
Building E1 Unit 11 Deck Back Fill Installed

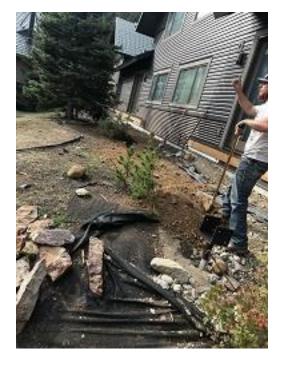
Building E3 Unit 24 Deck Back Fill Installed

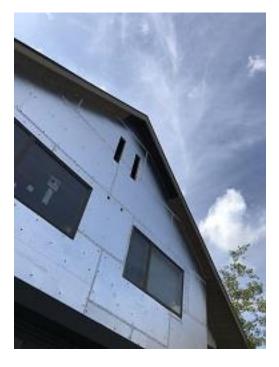
Building E2 Units 20 & 21 Front Soffit Installed

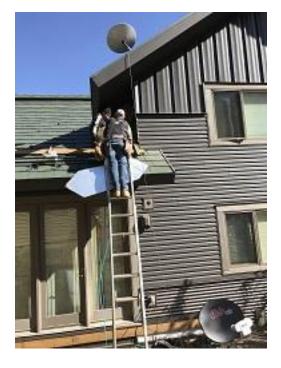
Building E1 Unit 9 Back Lap & Board and Batten Siding Installed
