## Daily Observation Report

Date of Report: Oct 4, 2021  
 Prepared By: Jim Goveia

**PROJECT:** BIG HORN CONDO SIDING REPLACEMENT & EXTERIOR UPGRADES PHASE 1

**REPORT #:** 116

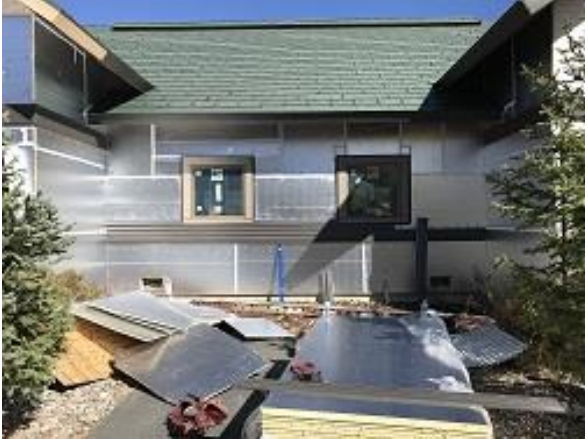
**Building E7 Units 50 & 51 Front Lap Siding Installed**

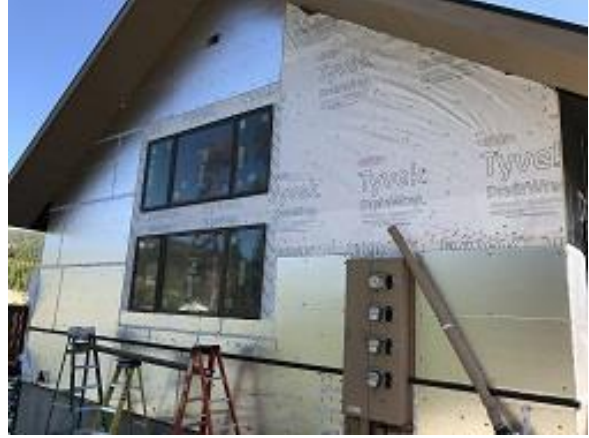
**Building E7 Unit 52 Side Foam Board Installed**

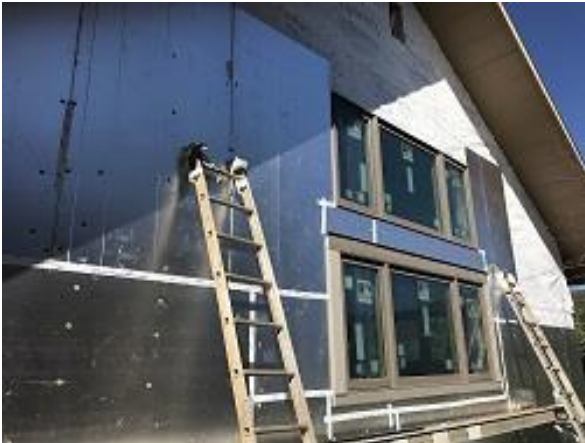
**Building E7 Unit 49 Side Foam Board Installed**

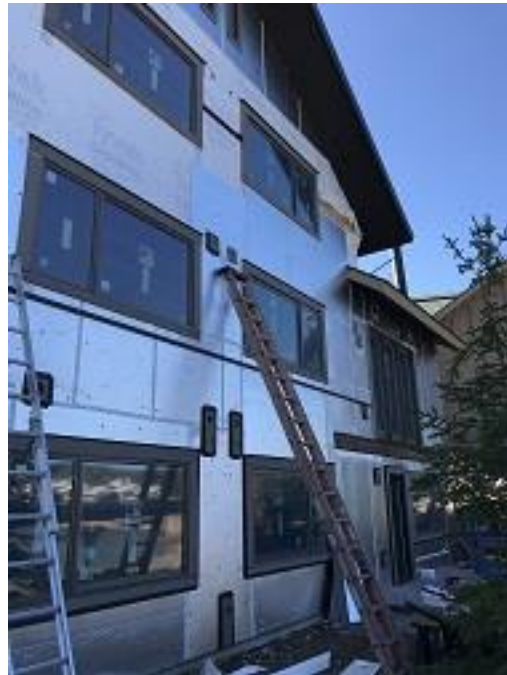
**Building F1 Unit 16 & 17 J Channel Blocking Installed**

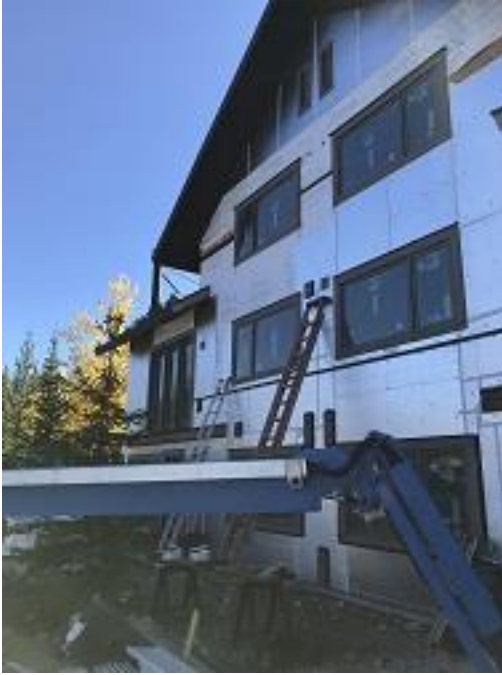
**Building F1 Unit 16 & 17 J Channel,**  
**Blocking Installed**

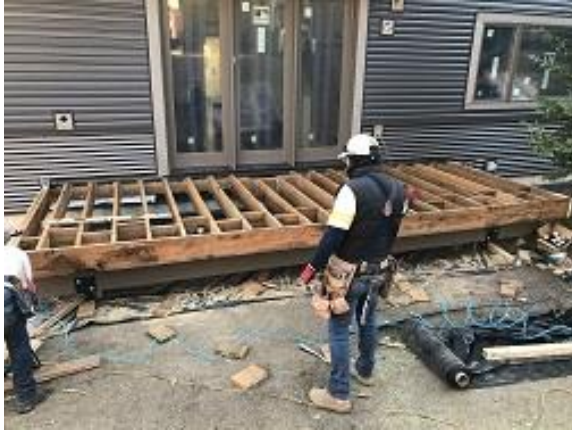
**Building E4 Unit 28 Deck Framing Completed**

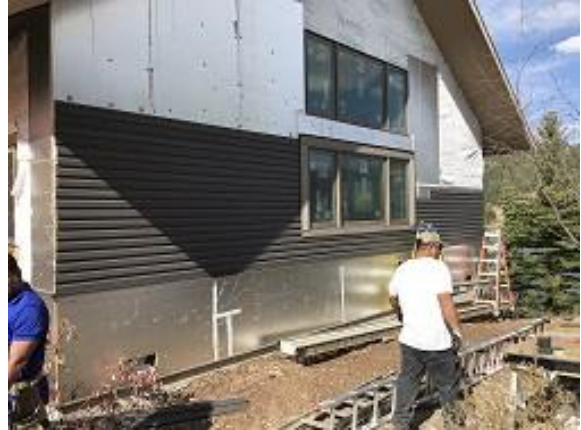
**Building E7 Unit 49 Lap Siding Installed**

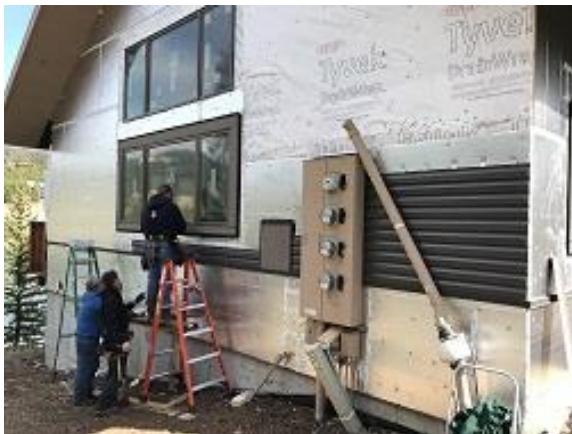
**Building E7 Unit 52 Lap Siding Installed**

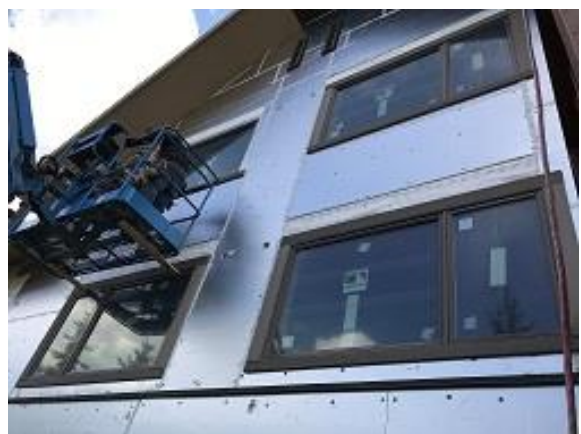
**Building E7 Units 51 & 52 Window Trim Installed**

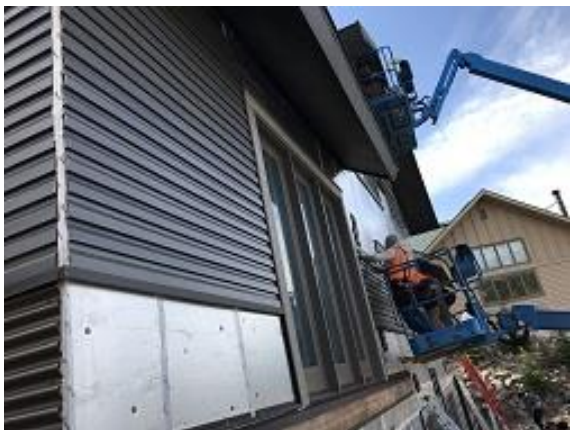
**Building F1 Unit 16 Lap Siding Installed**

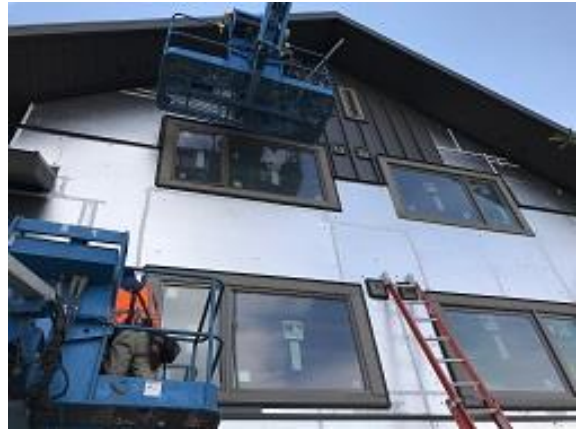
**Building F1 Units 16 & 17 Board and Batten Siding Installed**

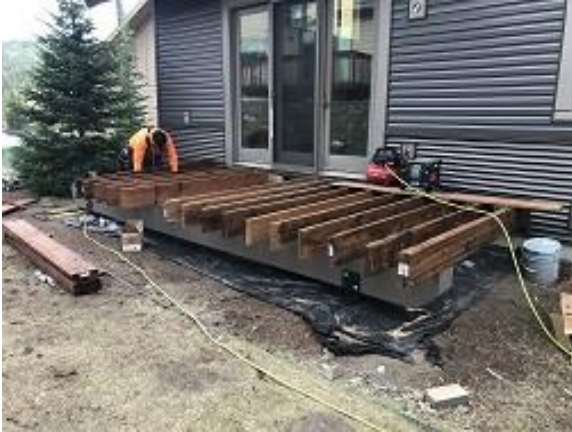
**Building E2 Unit 20 Deck Framing**

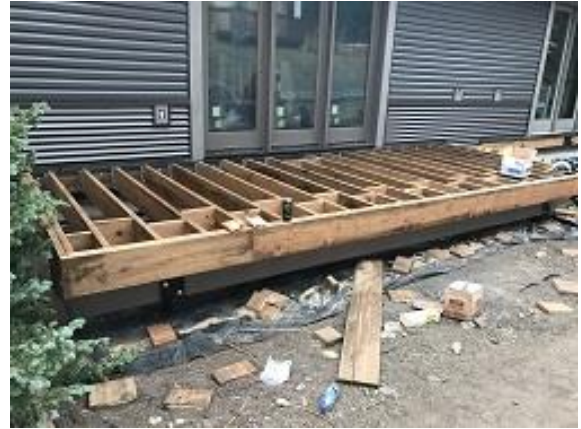
**Building E4 Unit 29 Deck Framing Completed**

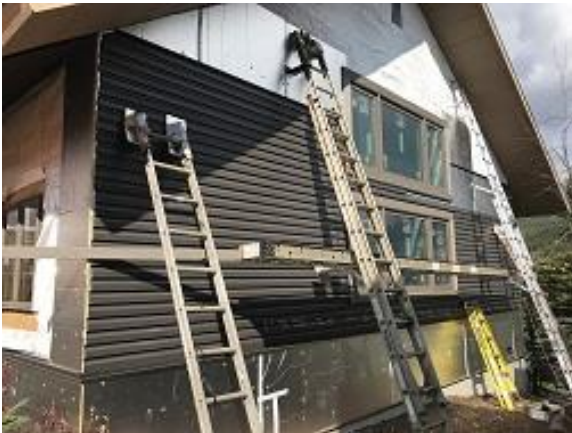
**Building E7 Unit 49 Side Lap Siding Installed**

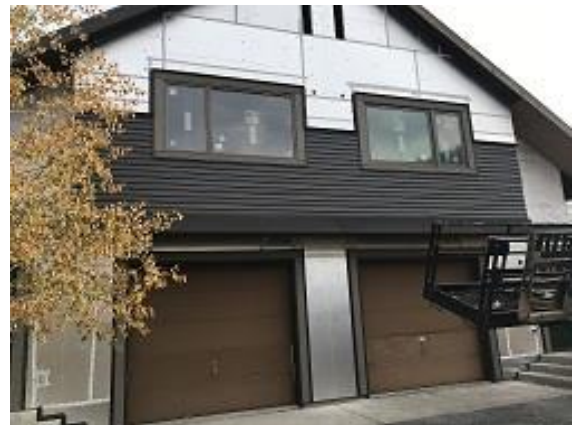
**Building E7 Units 49 & 50 Front Lap Siding Installed**

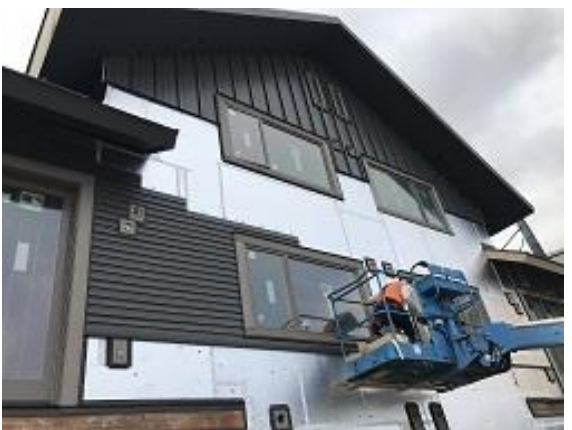
**Building F1 Units 16 & 17 Back Lap Siding Installed**

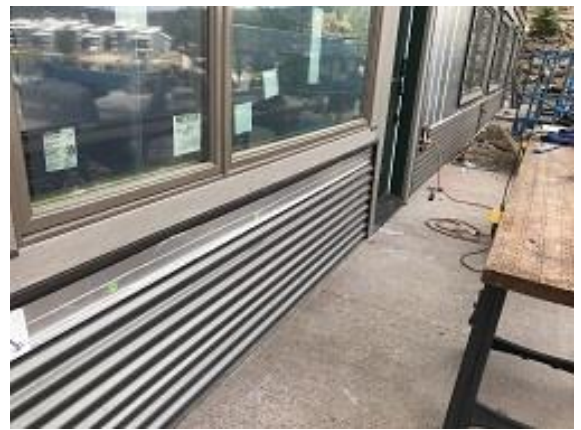
**Building F1 Unit 16 Back Corrugated Siding Installed**

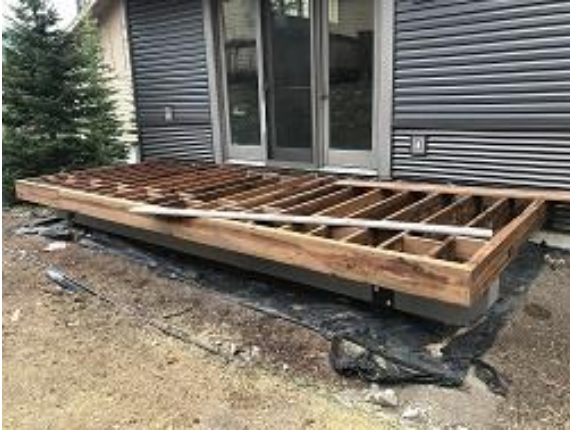
**Building E2 Unit 20 Deck Framing Completed**

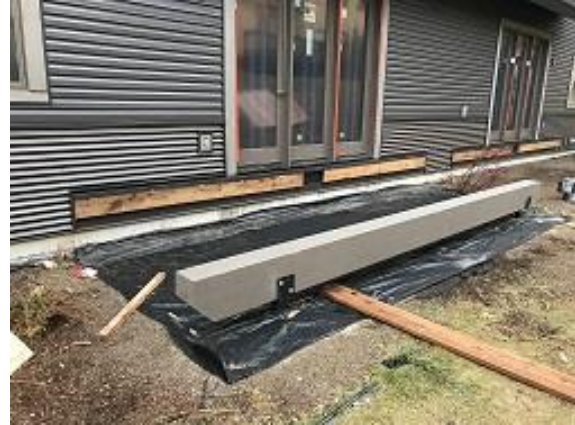
**Building E2 Unit 21 Deck Framing Began**

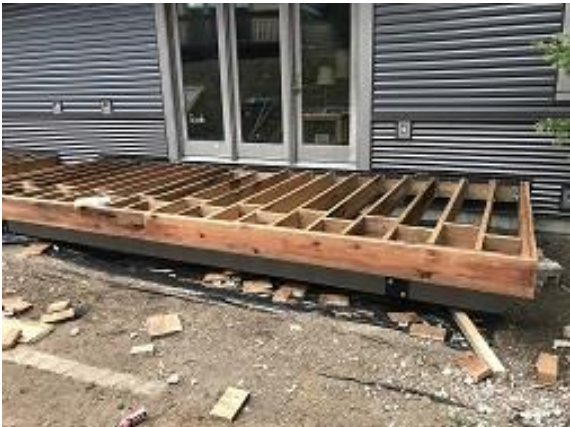
**Building E4 Unit 30 Deck Framing Completed**

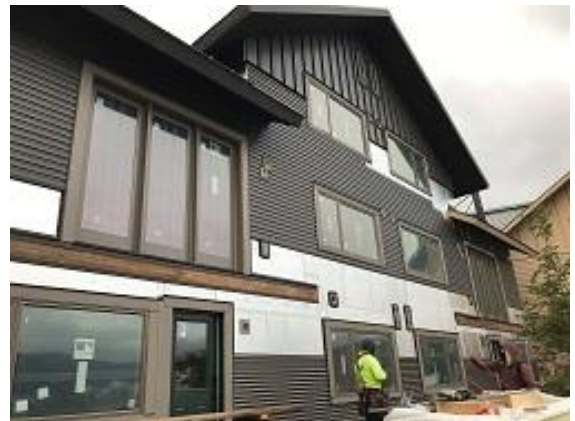
**Building F1 Units 16 & 17 Back Lap & Corrugated Siding Installed**

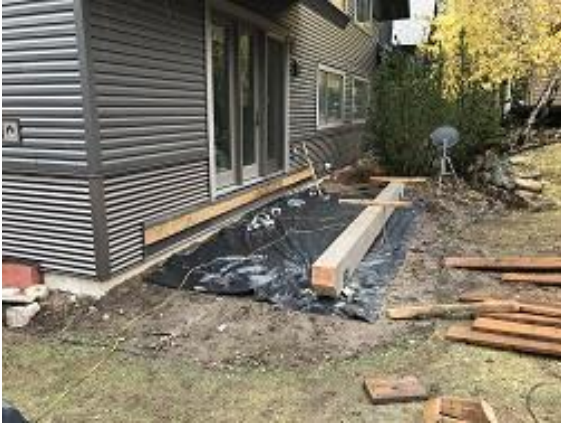
**Building E1 Unit 11 Deck Framing Began**

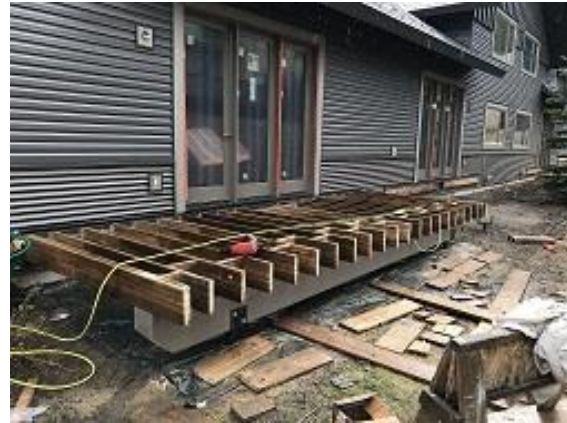
**Building E2 Unit 21 Deck Framing Installed**

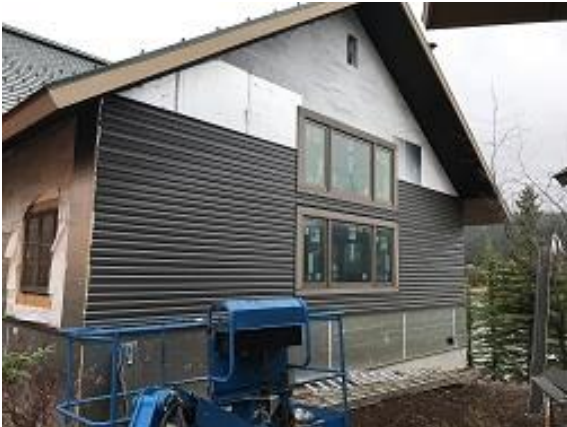
**Building E7 Unit 49 Side Lap Siding Installed**

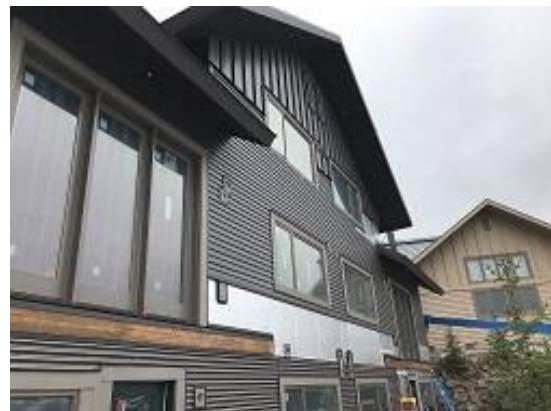
**Building F1 Units 16 & 17 Lap and Corrugated Siding Installed**
