Daily Observation Report

PROJECT: BIG HORN CONDO SIDING REPLACEMENT & EXTERIOR UPGRADES PHASE 1

REPORT #: 127

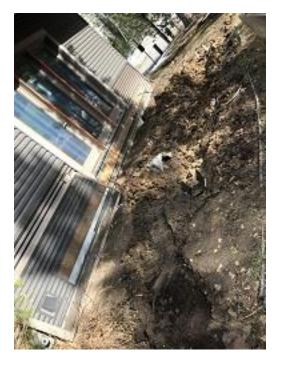
Building E1 Unit 8 Deck Area Grading

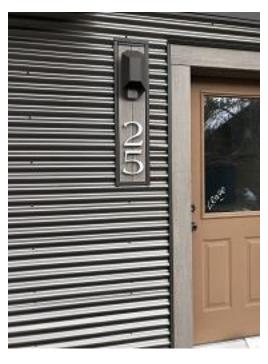
Building E3 Address Numbers Applied
