#### **Daily Observation Report**

montanaconstmgmt@gmail.com			
PROJECT: BIG HORN CONDO SIDING REPLACEMENT &	EXTERIOR UPGRADES PHASE 1	Re	PORT #: 141
Address: Running Bear Road			
WEATHER			
TEMPERATURE	A.M	P.M	
Low Temperature: 18*	Snow	Windy	
High Temperature: 45*	X Sunny	Clear	
	Clear	Snow	
CONDITIONS	Other	X Sunny	
CREW ON SITE			
Plasterers Finish Carpenters	Plumbers	Kit	1
Flooring Roofers	Caulking	Dakota	1
Ceiling Sheet rockers/Tapers	Concrete Finishers	Siding Crew	6
Landscapers Tile Setters	Electricians	Interior Trim Carpe	nter 1
Carpenter Others:			
To	TALS: 9		
Observations – 1) E3: Unit 8 Interior trim in		og posts installed <b>3)</b> F	2: Units 18
& 19 Back deck ledger and flashing installe	α.		
TESTS/INSPECTIONS —			
Unresolved Issues/Factors Contributing to	O DELAY -		
	1		
	1

**PROJECT:** BIG HORN CONDO SIDING REPLACEMENT & EXTERIOR UPGRADES PHASE 1

**R**EPORT #: 144

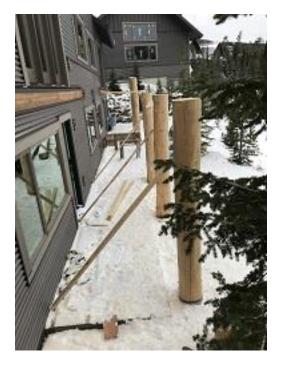
Building F1 Units 18 & 19 Deck Framing
Installation Continued

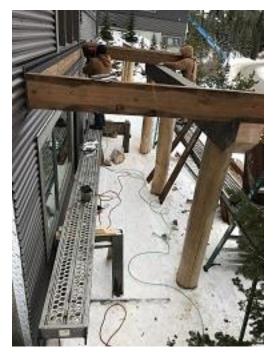
Building F1 Units 18 & 19 Deck Framing Installation Continued
