#### **Daily Observation Report**

Date of Report: Nov 15, 2021 Prepared By: Jim Goveia

PROJECT: BIG HORN CONDO SIDING REPLACEMENT & EXTERIOR UPGRADES PHASE 1

REPORT #: 146

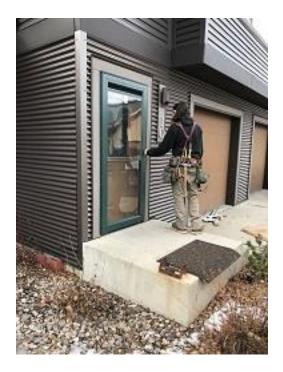
**Building E1 Unit 10 Storm Door Installed**

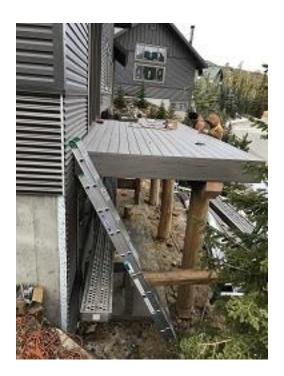
**Building F1 Unit 16 Decking Installed**

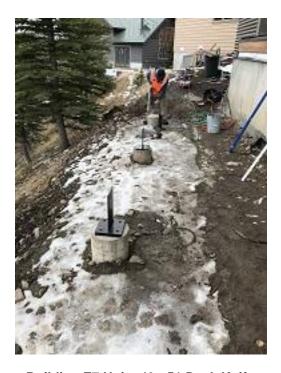
Building E7 Units 49 - 51 Deck Knife Plates Installed

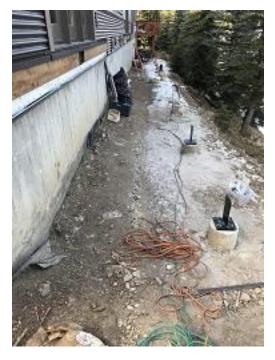
Building E7 Units 49 -51 Deck Knife Plates Installed

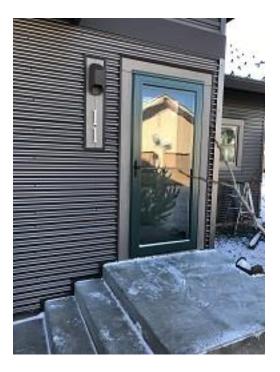
**Building E1 Unit 11 Storm Door Installed**

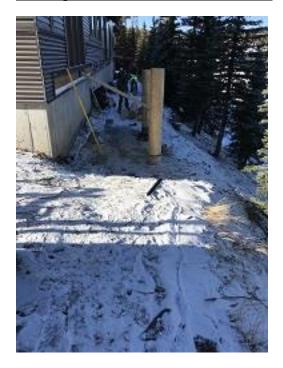
Building E7 Units 49 -51 Deck Posts Installation

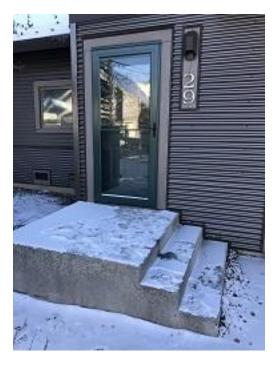
**Building E4 Unit 29 Storm Door Installed**

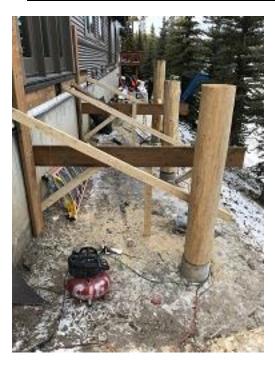
Building E7 Units 49 Deck Log Post Installation
