## **Daily Observation Report**

Date of Report: Nov 1, 2021 Prepared By: Jim Goveia

PROJECT: BIG HORN CONDO SIDING REPLACEMENT & EXTERIO	OR UPGRADES PHASE 1		<b>REPORT #</b> : 136
Address: Running Bear Road			
WEATHER			
TEMPERATURE	A.M	P.M	
Low Temperature: 25*	Snow	Windy	
High Temperature: 39*	X Foggy	Clear	
	Clear	Snow	
CONDITIONS	Other	X Partly	Cloudy
CREW ON SITE			
Plasterers Finish Carpenters F	Plumbers	Kit	
Flooring Roofers (	Caulking	Dakota	1
Ceiling Sheet rockers/Tapers (	Concrete Finishers	Siding Crew	13
Landscapers Tile Setters E	Electricians _	,	
Carpenter Others:			
Totals:	14		
Observations – 1) E7: Unit 52 deck door installation began, threshold mold and high moisture was detected. Units 49 & 50 back lap siding installation continued. 2) F1: Units 16 & 17 Deck materials were staged. 3) F2: Units 18 Side board and batten siding installation continued. Units 18 & 19 Back window trim and foam board installation continued. Unit 18 back upper window installed.  TESTS/INSPECTIONS –  UNRESOLVED ISSUES/FACTORS CONTRIBUTING TO DELAY –

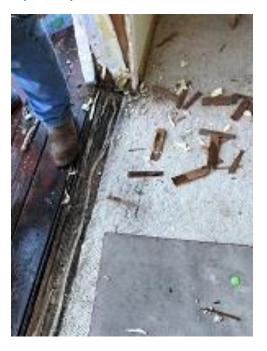
Building E7 Unit 52 Deck Door Threshold Damage

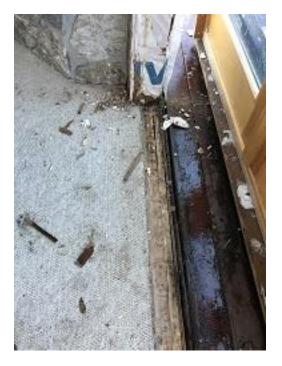
Building E7 Unit 52 Deck Door Threshold Damage
