Daily Observation Report

Date of Report: May 23, 2022
 Prepared By: Jim Goveia

PROJECT: BIG HORN CONDO SIDING REPLACEMENT & EXTERIOR UPGRADES PHASE 2

REPORT #: P2-183

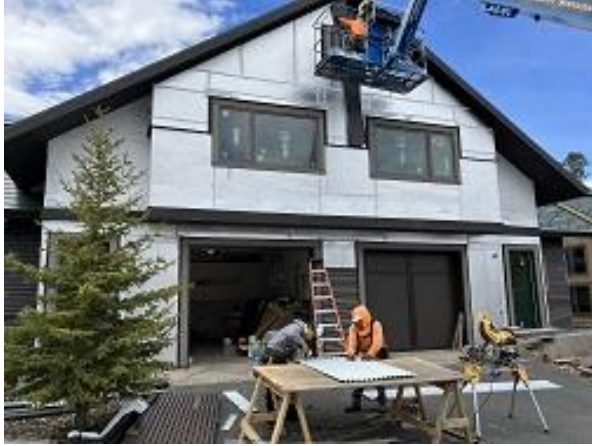
Building E8 Units 55 & 56 Front Snap Batten & Corrugated Installed

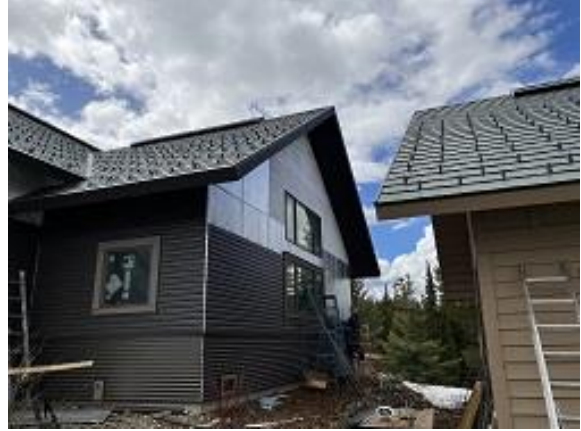
Building E9 Unit 55 Side Insulation & Lap Siding Installed

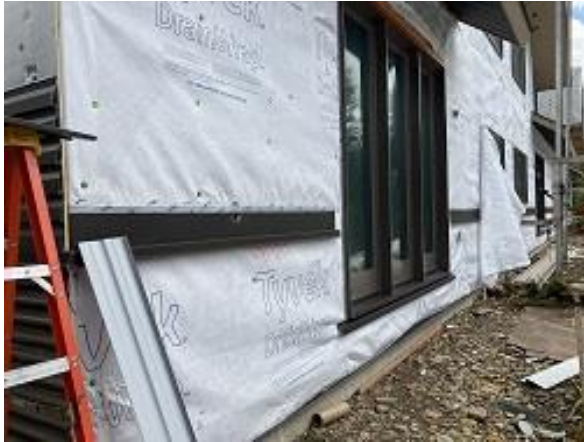
Building E8 Unit 55 & 56 Back Wainscot Flashing Installed

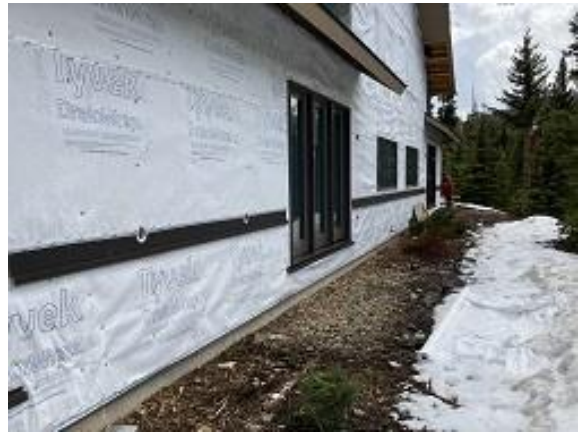
Building E8 Unit 57 & 58 Back Wainscot Flashing Installed

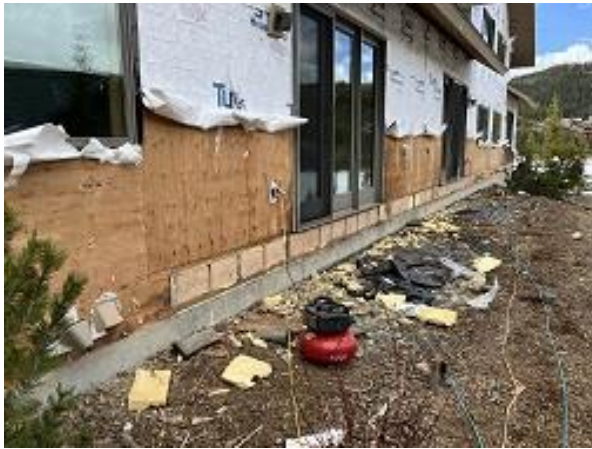
**Building E5 Units 42 & 43 Deck
Blocking Installed**

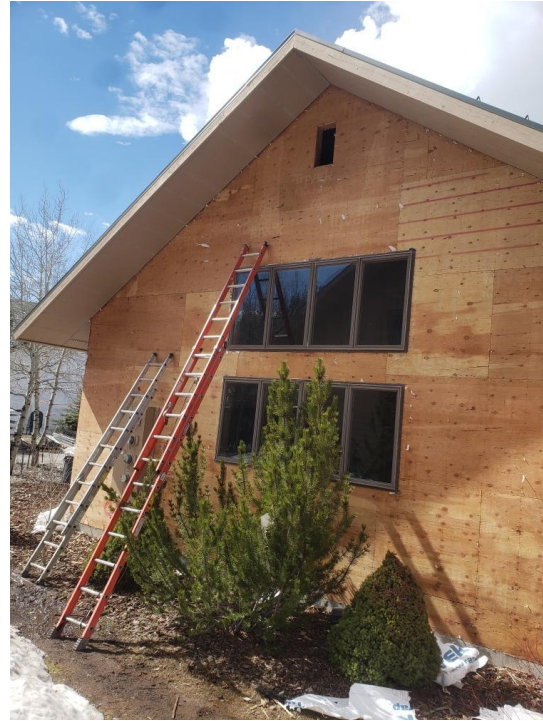
**Building E5 Units 41 Side Sheathing
Exposed**

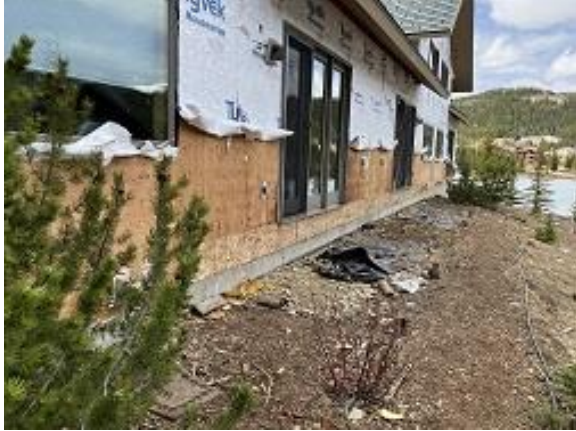
Building E5 Units 42 & 43 Deck Blocking Sheathing Installed

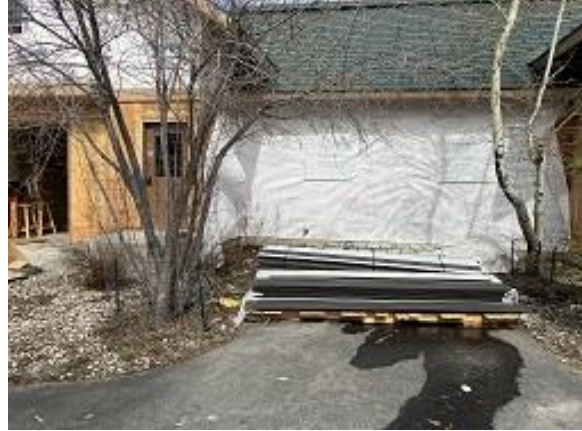
Building E5 Units 42 & 43 Front Tyvek Installed

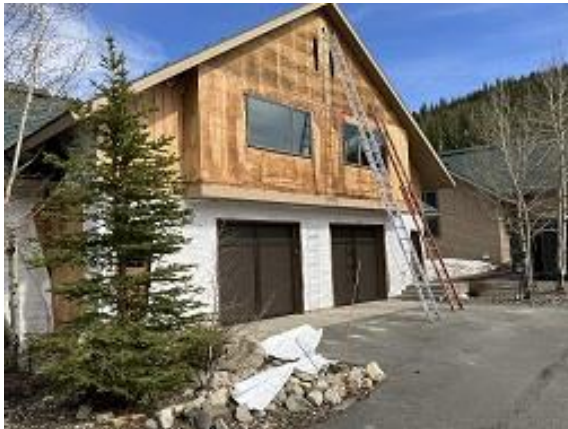
Building E5 Unit 41 & 42 Front Sheathing Exposed

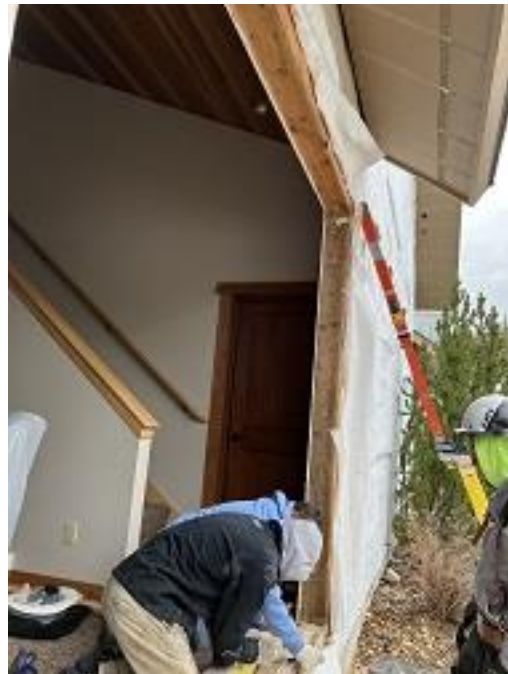
Building E6 Unit 48 Deck Door Removed

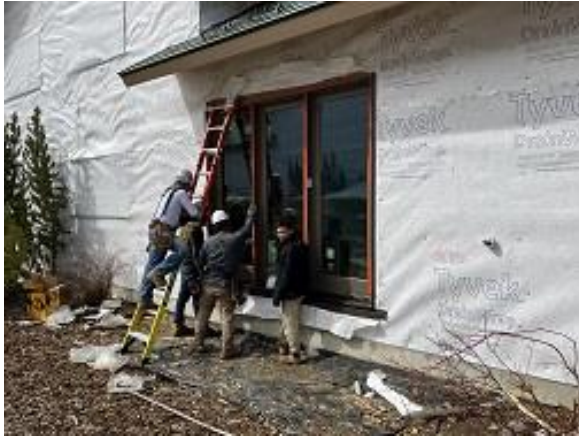
Building E6 Unit 47 Deck Door Installed

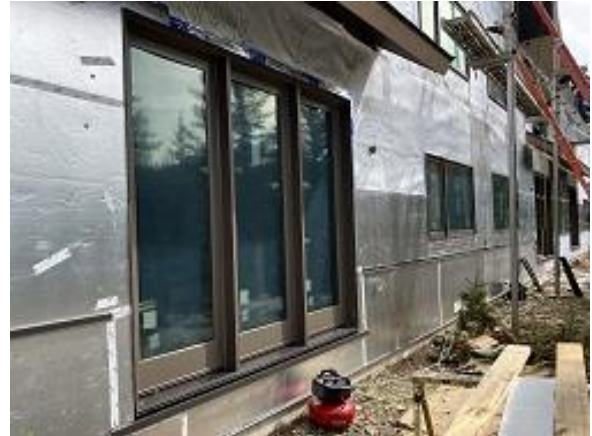
Building E8 Unit 55 & 56 Back Insulation Installed

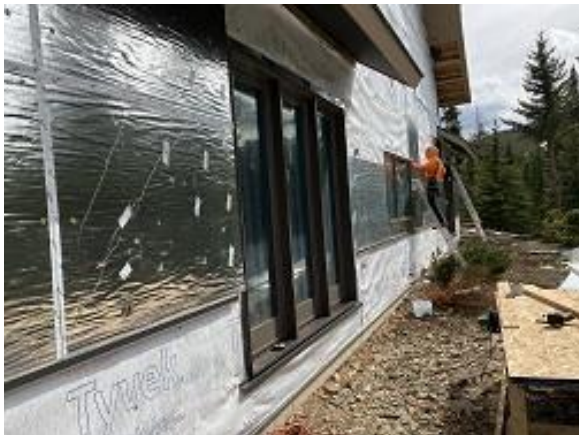
Building E8 Unit 57 & 58 Back Insulation Installed

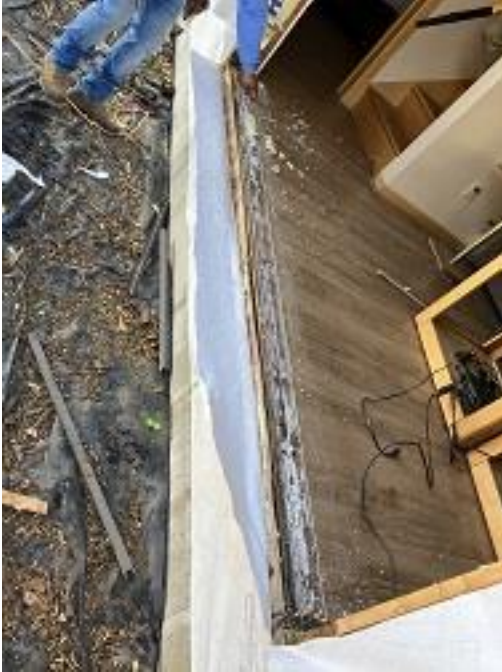
Building E6 Unit 45 Deck Door Removed

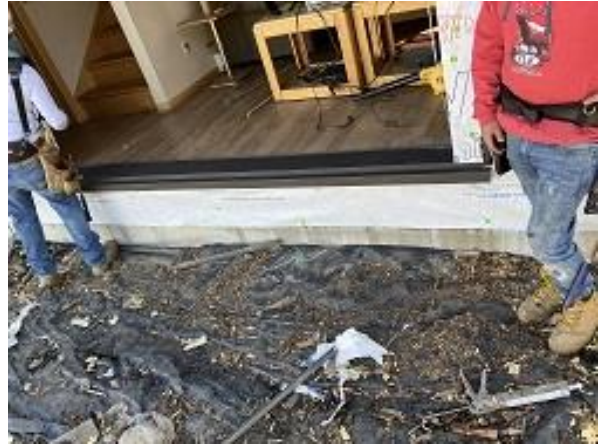
**Building E6 Unit 45 Deck Door Pan
Installed**

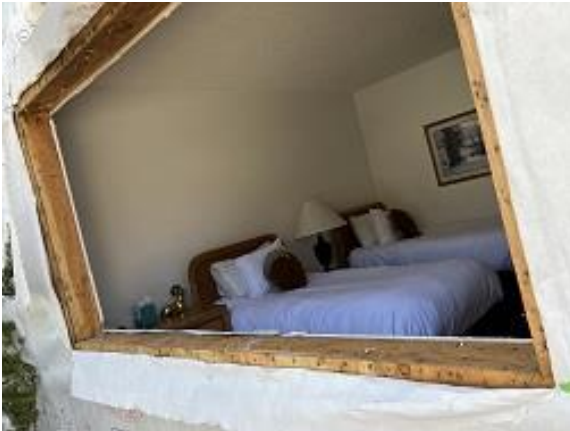
**Building E6 Unit 45 Back Lower
Window Removed**

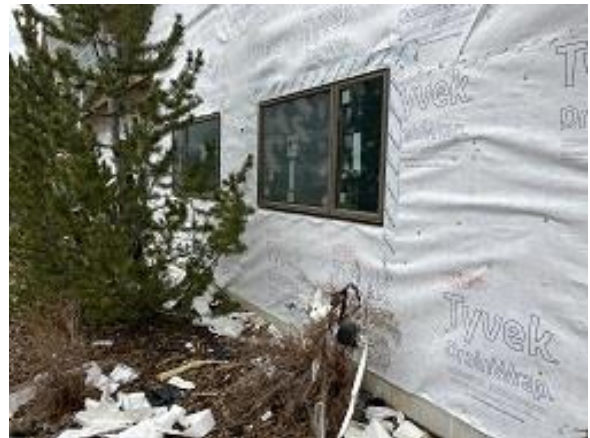
**Building E8 Units 57 & 58 Back Lower
Windows Installed**

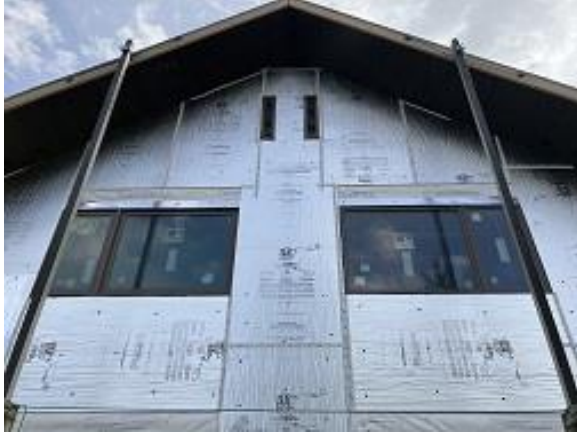
Building E8 Units 55 & 56 Back Soffit and Insulation Installed

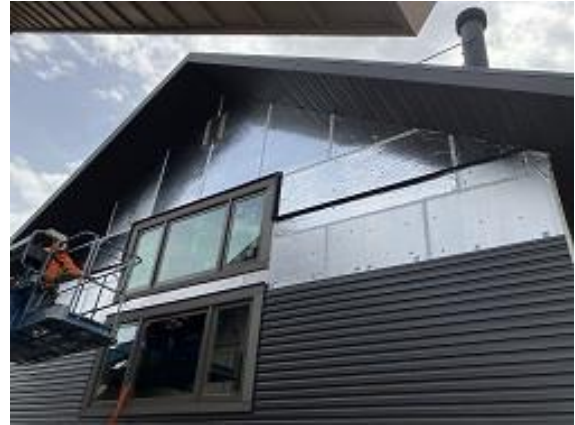
Building E8 Unit 55 Side Snap Batten Flashing Installed

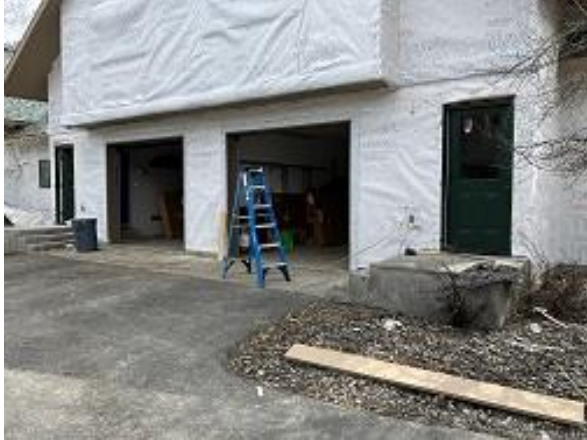
Building E6 Units 47 & 48 Front Doors Installed

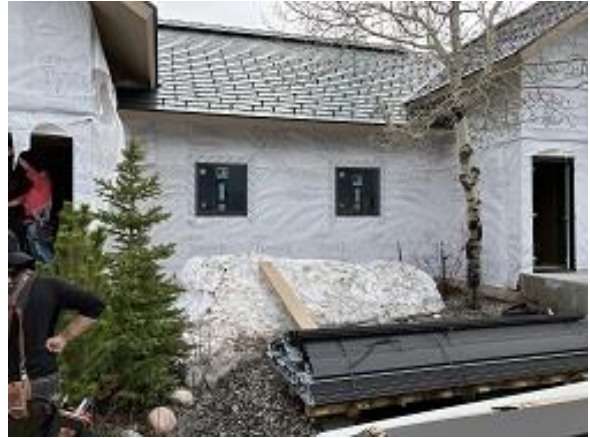
Building E6 Units 46 & 47 Front Doors & Windows Installed

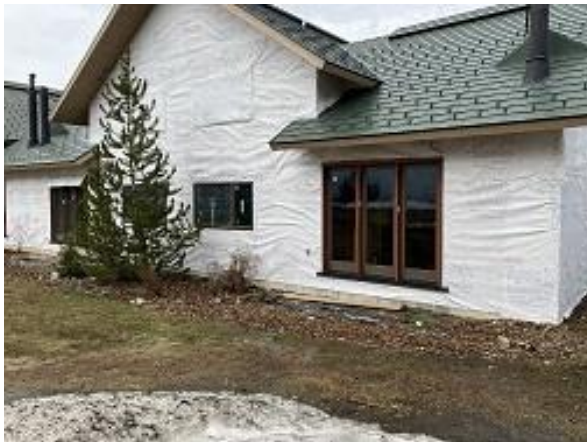
Building E6 Units 45 & 46 Deck Doors & Lower Back Windows Installed

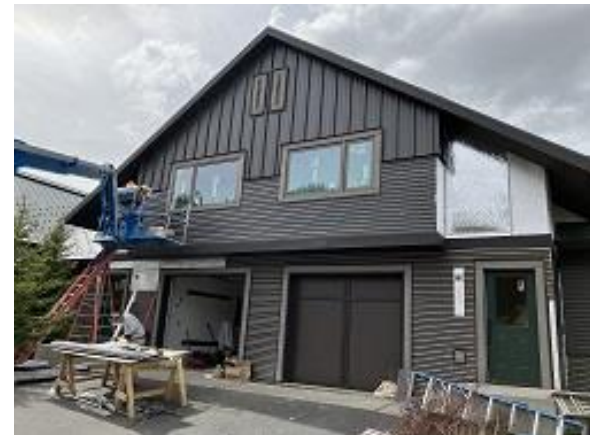
Building E8 Units 55 & 56 Front Lap Siding Installed

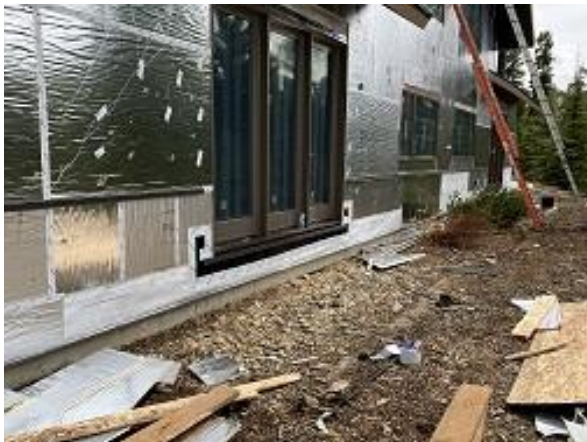
Building E8 Unit 57 Deck Ledger Flashing Installed

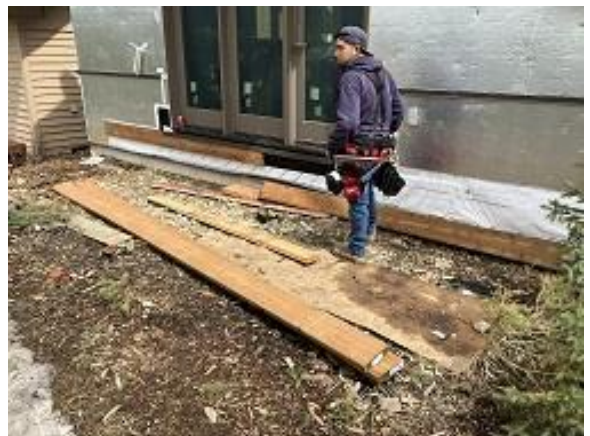
Building E8 Unit 55 Deck Ledger Board Installed

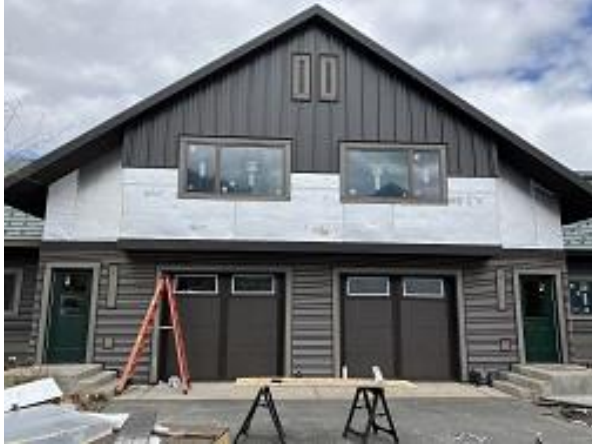
Building E8 Units 57 & 58 Front Corrugated Installed

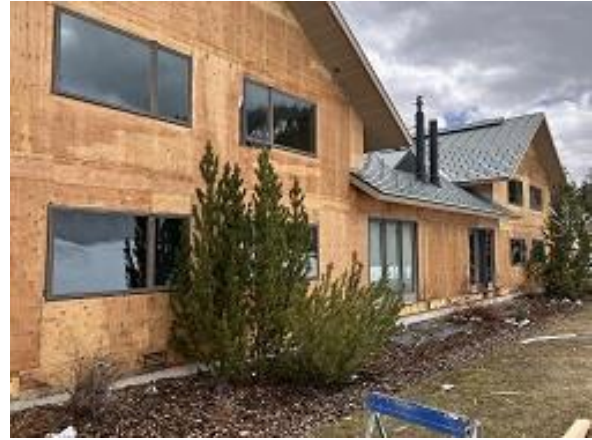
Building E6 Unit 47 & 48 Back Sheathing Exposed

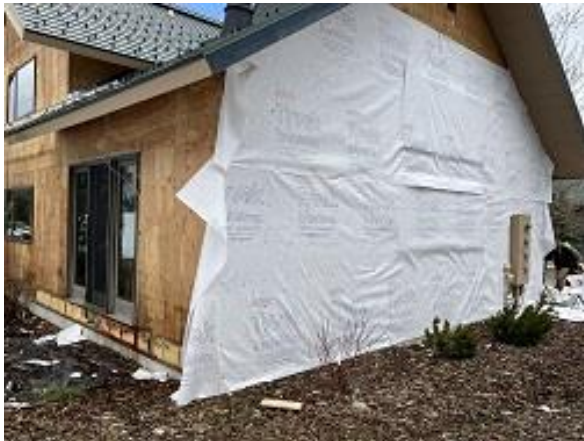
Building E6 Unit 45 Back Sheathing Exposed Side Tyvek Installed

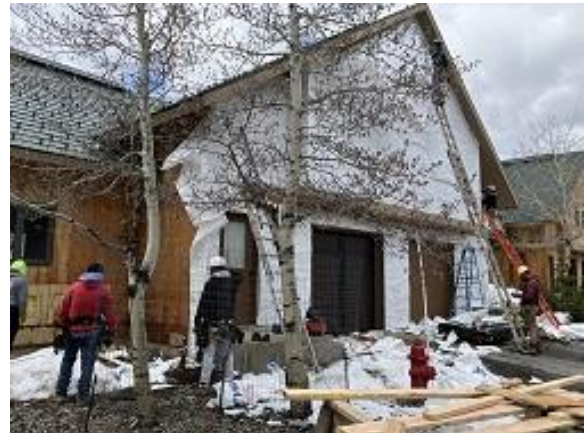
Building E6 Unit 45 & 46 Front Tyvek Installed

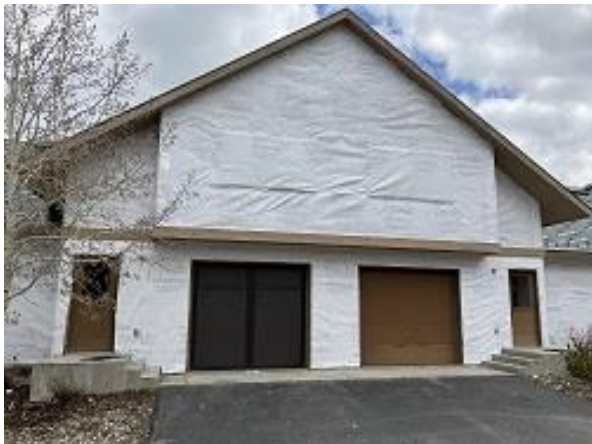
Building E9 Unit 61 & 62 Front Tyvek Installed

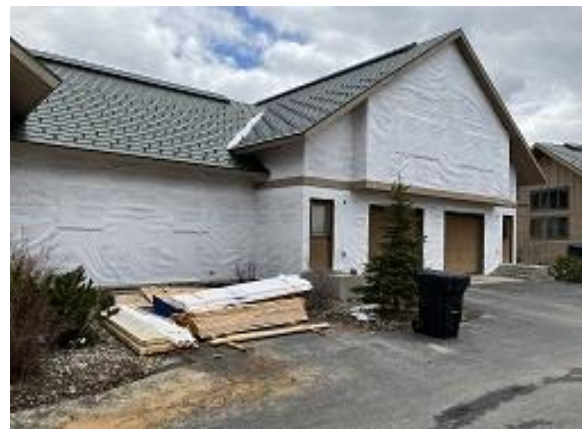
Building E9 Unit 63 & 64 Front Tyvek Installed
