Daily Observation Report

Date of Report: May 31, 2022
 Prepared By: Jim Goveia

PROJECT: BIG HORN CONDO SIDING REPLACEMENT & EXTERIOR UPGRADES PHASE 2

REPORT #: P2-188

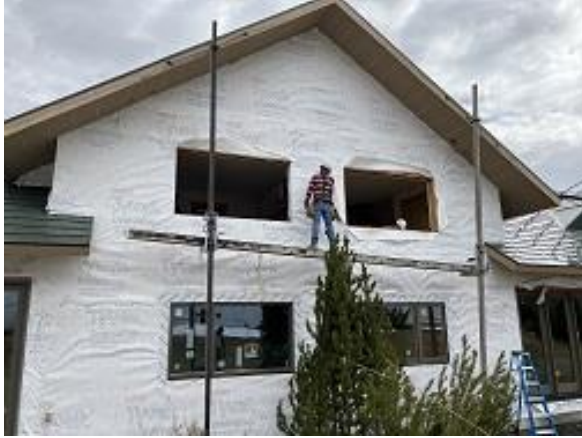
**Building E6 Units 47 & 48 Back Upper
Windows Removed**

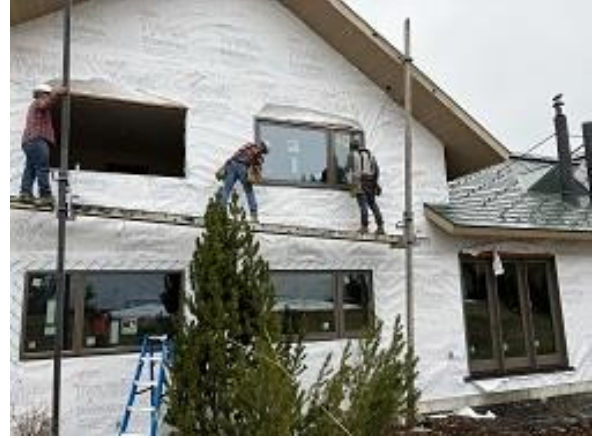
**Building E6 Units 47 & 48 Back Upper
Windows Installed**

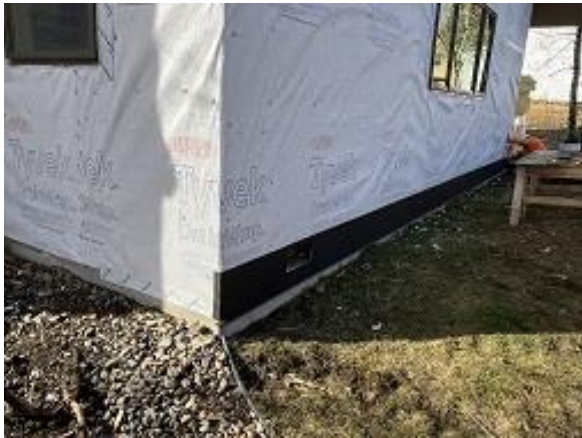
**Building E6 Unit 48 Side Base Flashing
Installed**

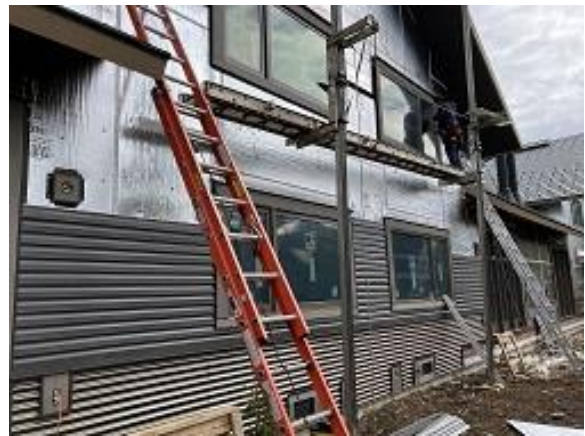
**Building E8 Units 55 & 56 Back Lap Siding
and Snap Batten Flashing Installed**

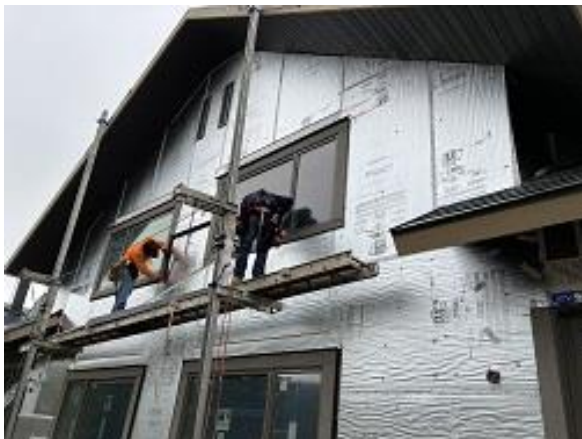
**Building E8 Units 55 & 56 Back Snap
Batten Flashing Installed**

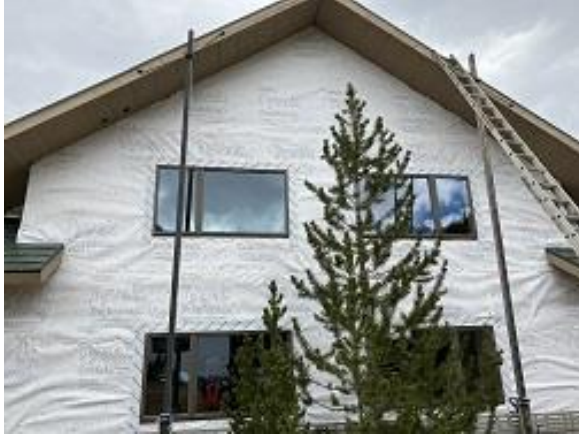
Building E6 Units 46 & 47 Back Upper Windows Installed

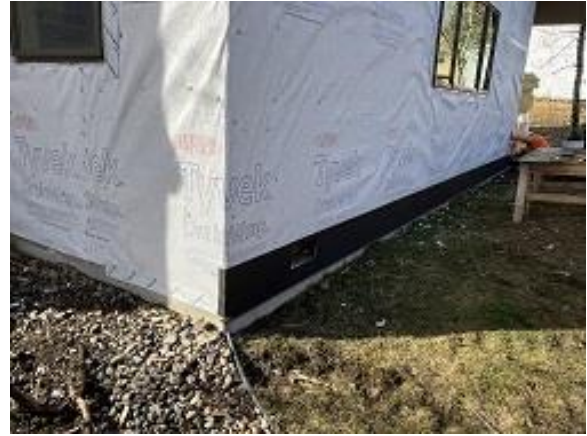
Building E6 Unit 48 Side Base Flashing Installed

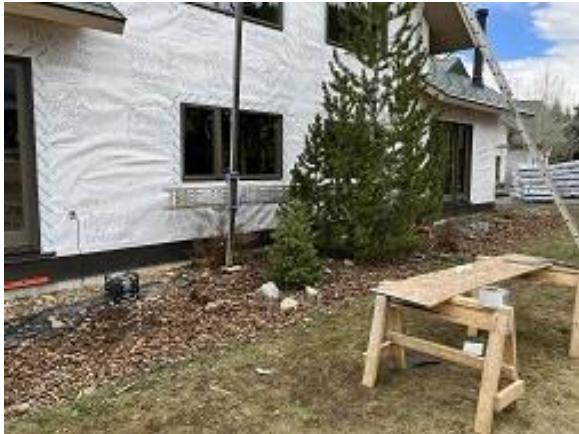
Building E6 Units 45 & 46 Back Base Flashing Installed

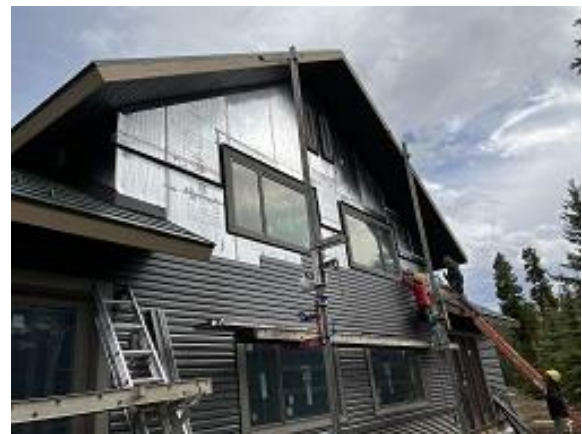
Building E8 Units 57 & 58 Back Lap Siding Installed

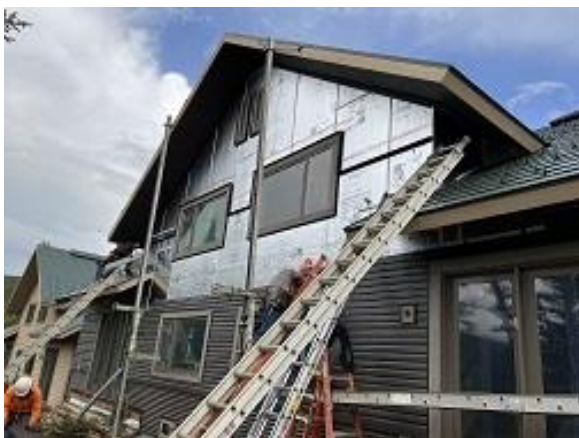
Building E8 Units 55 & 56 Back Lap Siding Installed

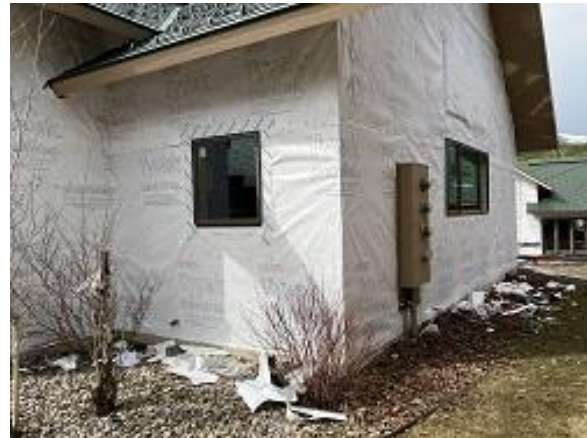
Building E9 Unit 64 Kitchen & Side Lower Window Installed

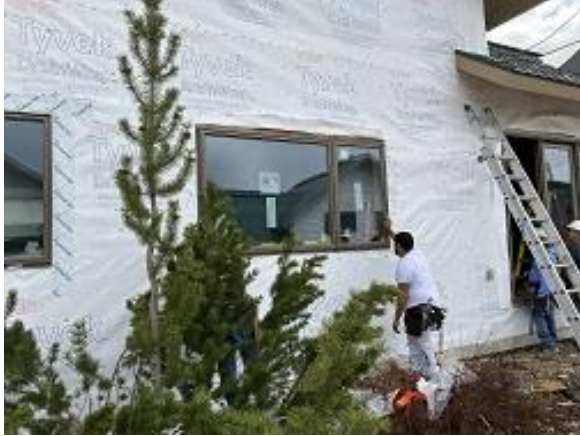
**Building E9 Unit 63 Back Lower
Window Installed**

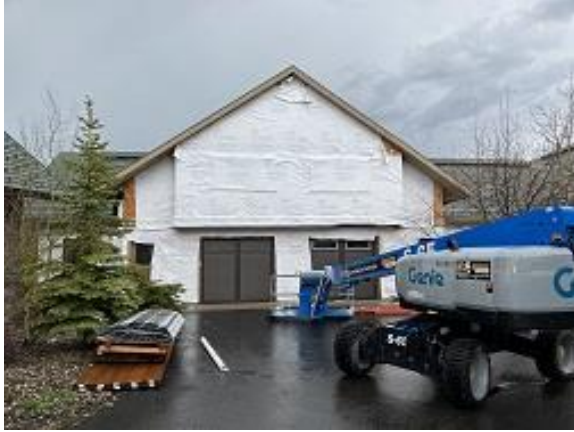
Building E5 Units 44 & 41 Front
Tyvek Installed

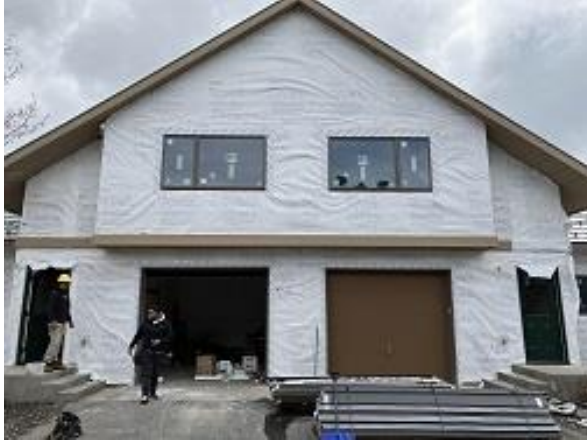
Building E6 Units 45 & 46 Front Upper Windows Installed

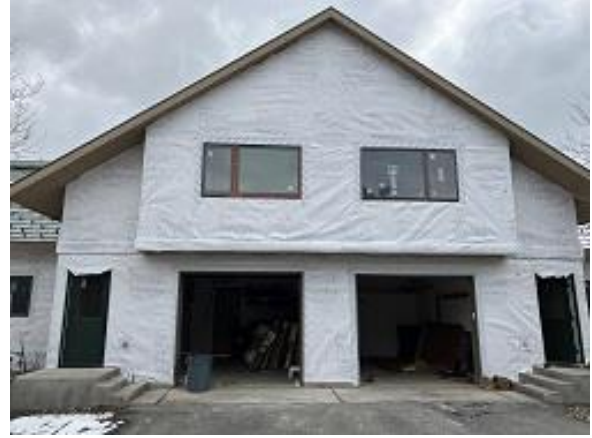
Building E6 Units 47 & 48 Front Upper Windows Installed

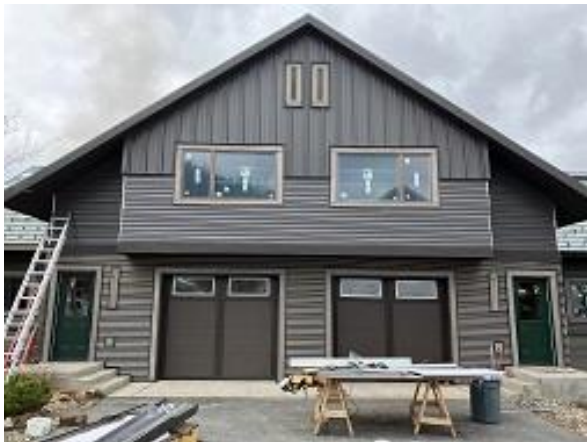
Building E8 Units 57 & 58 Front Lap Siding Installed

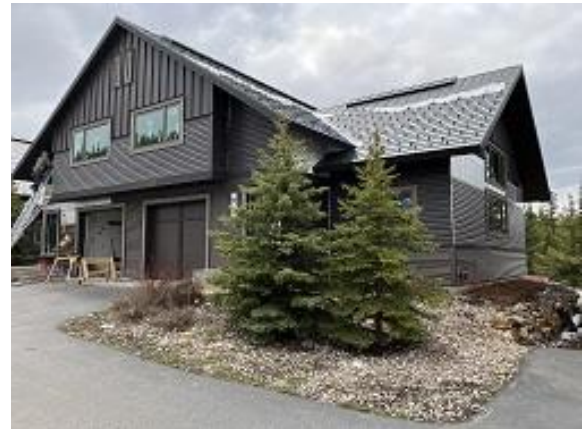
Building E8 Units 55 & 56 Front Lap Siding Installation Continued

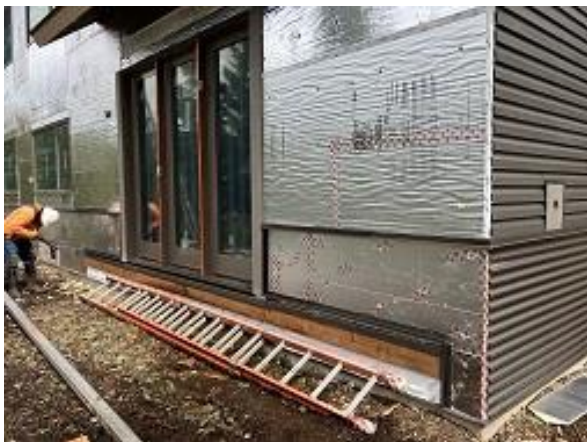
Building E8 Unit 58 Deck Ledger, Flashing and J Channel Installed

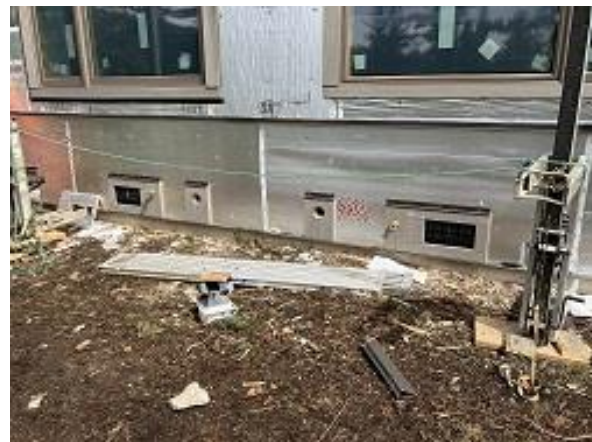
Building E8 Units 57 & 58 Back Block Outs Installed
