Daily Observation Report

Date of Report: June 6, 2022
 Prepared By: Jim Goveia

PROJECT: BIG HORN CONDO SIDING REPLACEMENT & EXTERIOR UPGRADES PHASE 2

REPORT #: P2-192

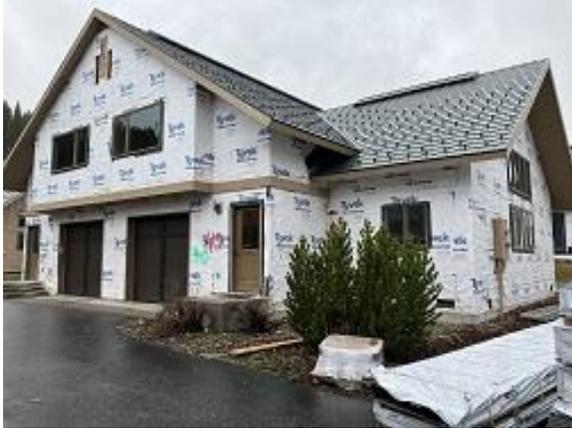
Building C5 Units 39 & 40 Siding & Deck Demolition Complete

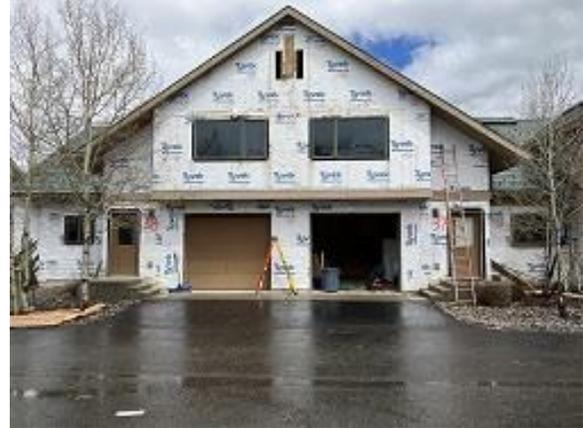
Building D Units 37 & 38 Front Siding Demolition Complete

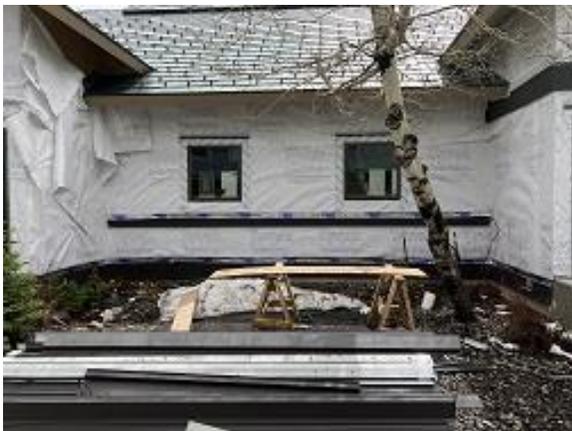
Building E6 Unit 46 & 47 Kitchen Window Head & Wainscot Flashing Installed

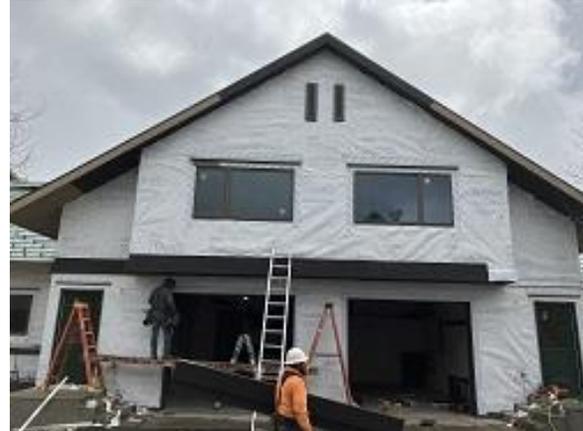
Building E6 Unit 47 & 48 Front Window Head Belly Band Flashing Installed

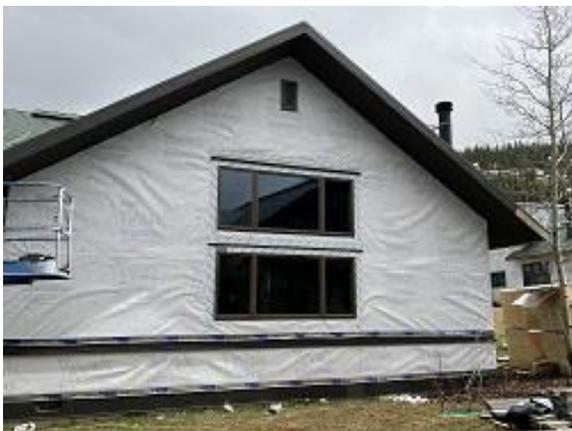
Building E6 Unit 48 Side Soffit, Window Head & Wainscot Flashing Installed

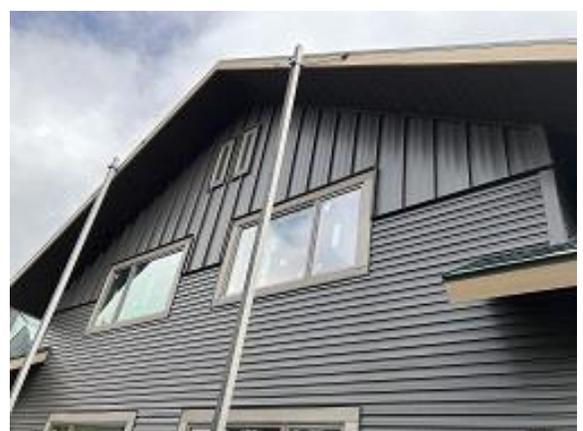
Building E8 Units 57 & 58 Back Snap Batten Siding Installed

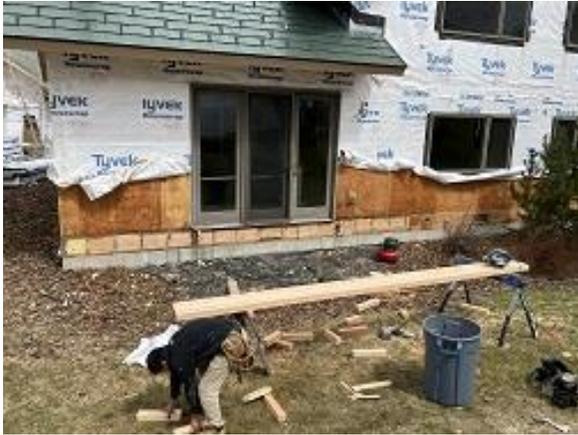
Building C5 Unit 40 Deck Blocking Installed

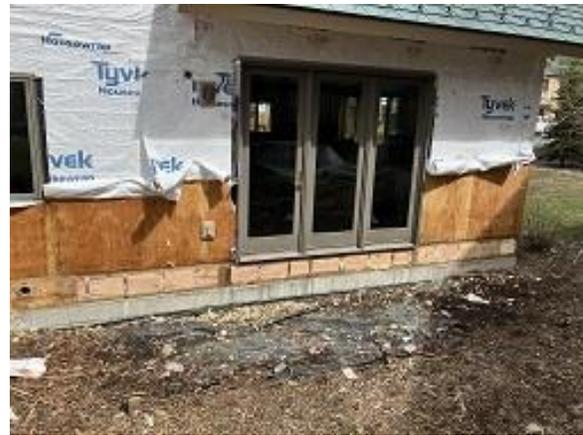
Building C5 Unit 39 Deck Blocking Installed

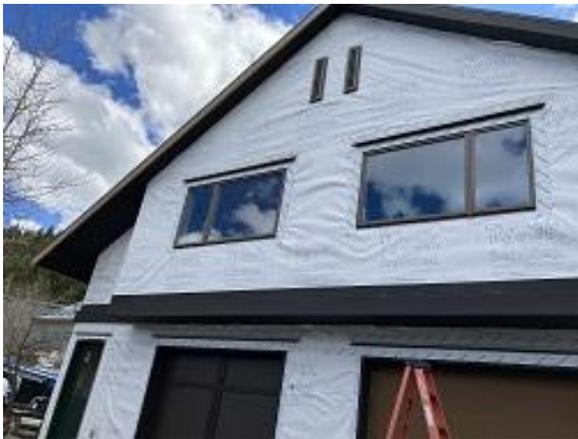
Building E6 Units 47 & 48 Front Belly Band, Soffit & Fascia Installed

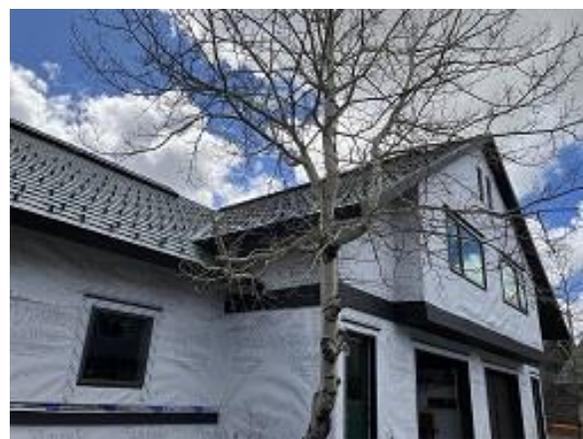
Building E6 Units 47 & 48 Front Belly Band, Soffit & Fascia Installed

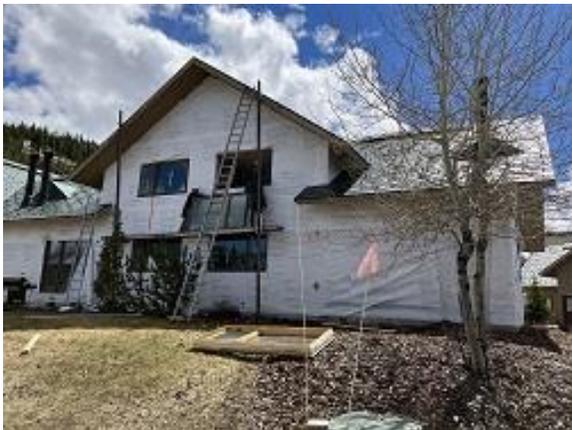
Building E9 Unit 61 Back Upper Window Install

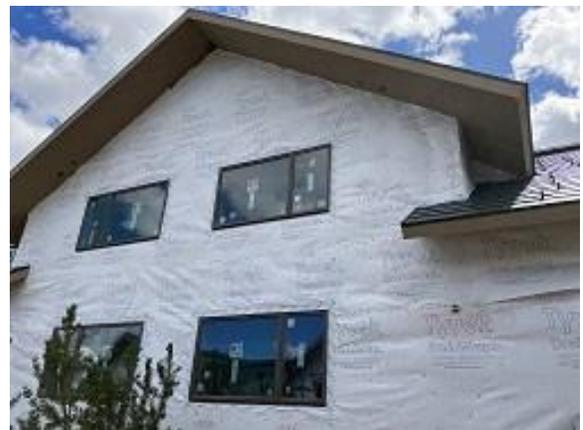
Building E9 Units 63 & 64 Back Upper Windows Installed

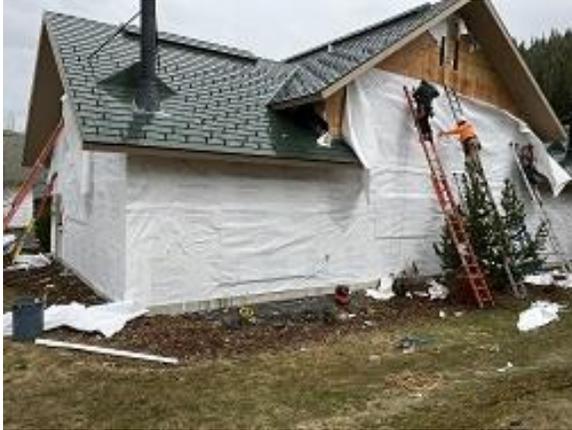
Building C5 Units 39 & 40 Back Tyvek Installed

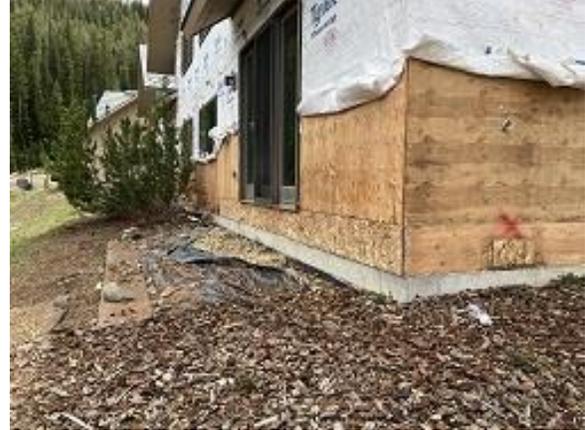
Building D Units 38 Deck Sheathing Installed

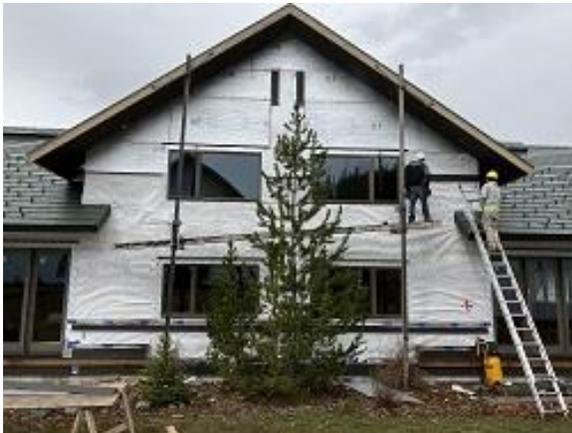
Building E6 Units 45 & 46 Back Insulation Installed

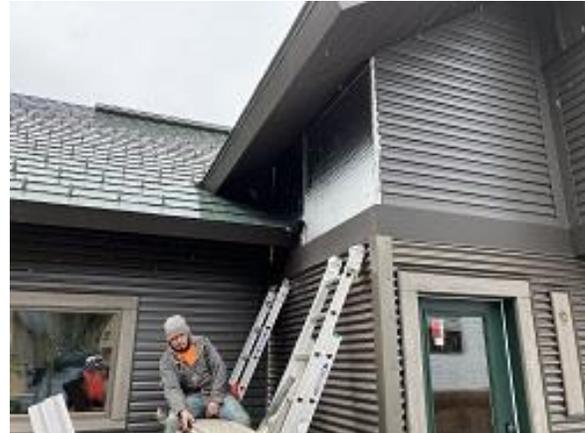
Building E8 Units 58 Front Roof Flashing, Insulation & J Channel Installed

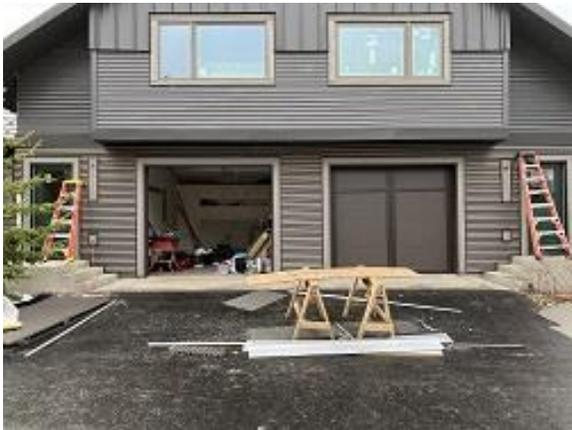
Building E8 Units 55 & 56 Front Corrugated Siding Installed

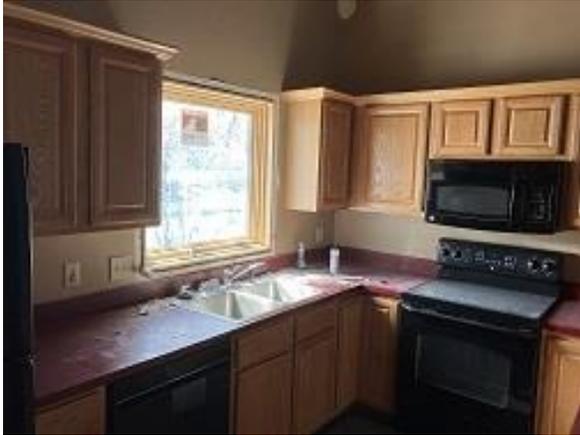
Building E5 Unit 42 Kitchen Window Installed

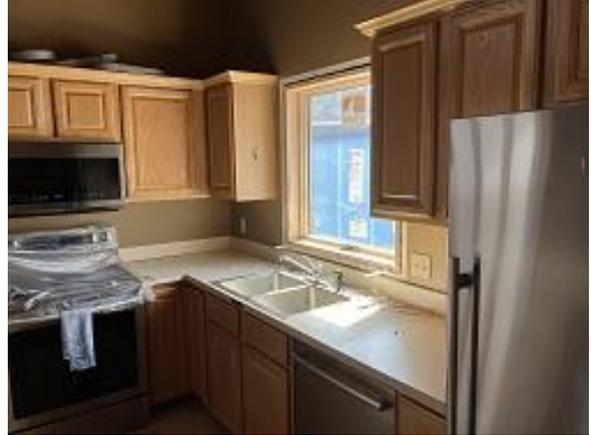
Building E5 Unit 41 Kitchen Window Installed

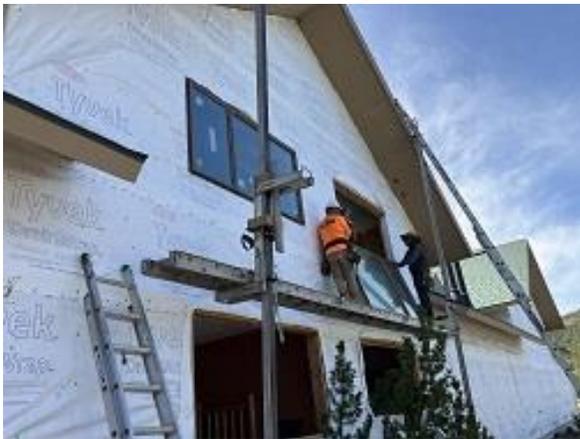
Building E5 Units 41 & 42 Back Upper Windows Installed

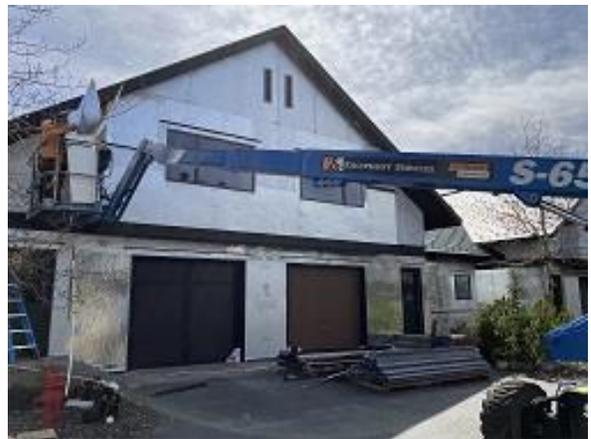
Building E6 Unit 45 Front Insulation Installation Continued

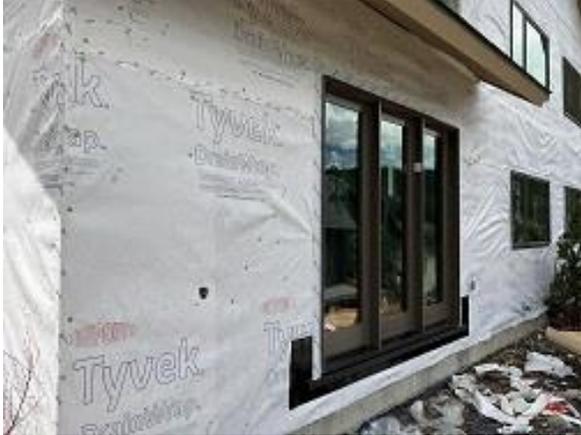
Building E5 Unit 41 Deck Door Installed

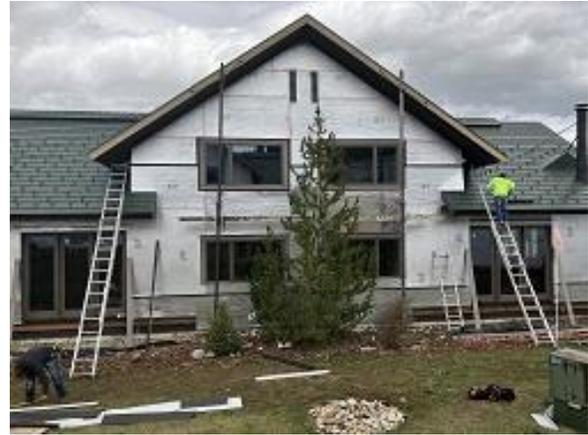
Building E6 Units 45 & 46 Back Window Trim & J Channel Installed

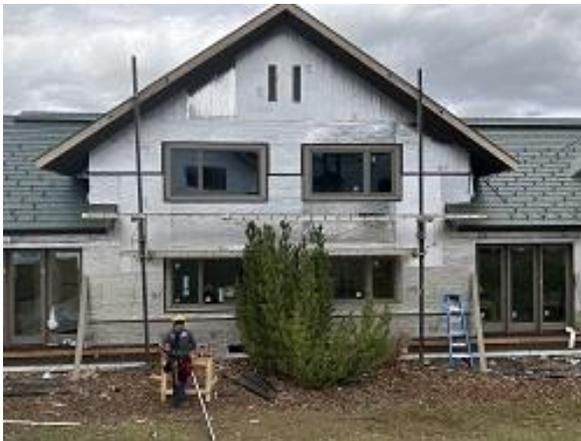
Building E6 Units 47 & 48 Back Window Trim & J Channel Installed

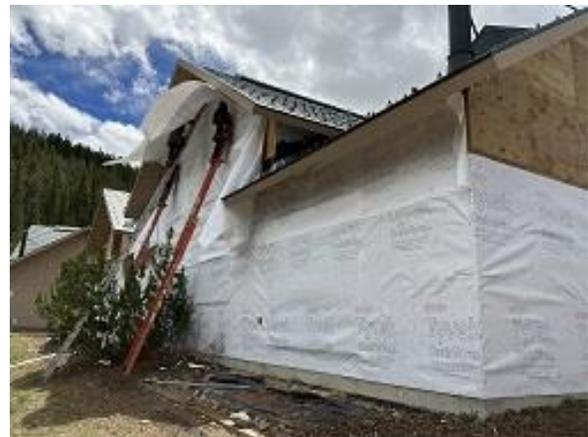
Building D Unit 37 & 38 Back Tyvek Installed
