Daily Observation Report

Date of Report: June 27, 2022
 Prepared By: Jim Goveia

PROJECT: BIG HORN CONDO SIDING REPLACEMENT & EXTERIOR UPGRADES PHASE 2

REPORT #: P2-206

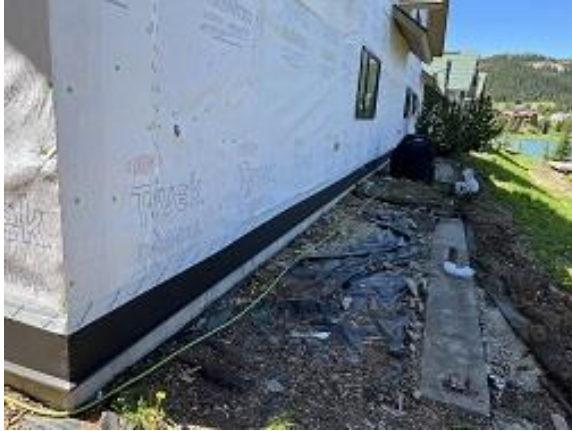
Building D Unit 36 Back Base Flashing Installed

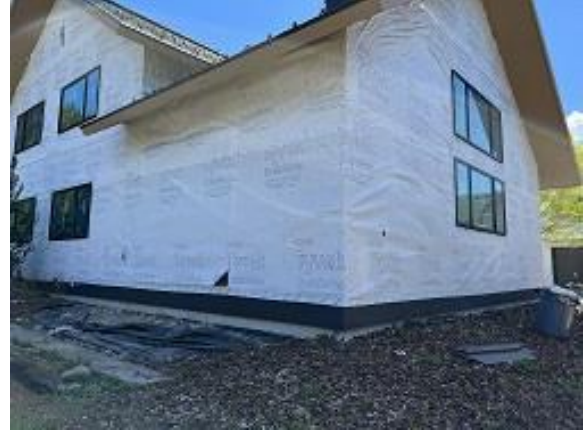
Building D Units 37 Back & 38 Back and Side Base Flashing Installed

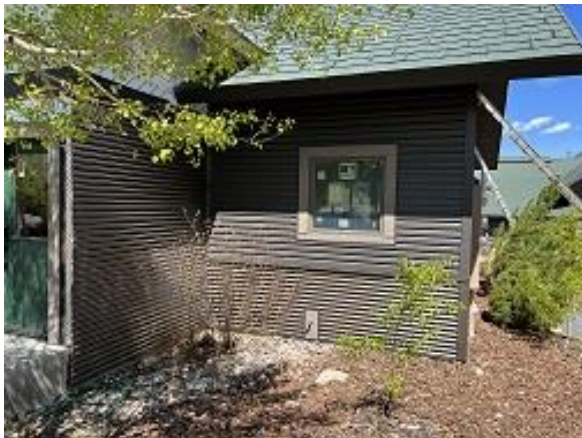
Building E5 Unit 41 Front Corrugated & Lap Siding Installed

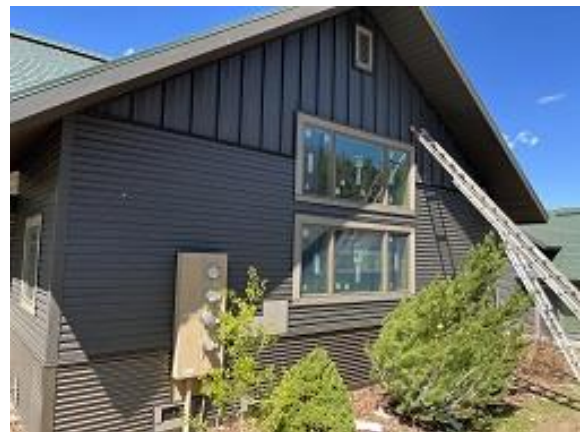
Building E5 Unit 41 Side Fascia Installed

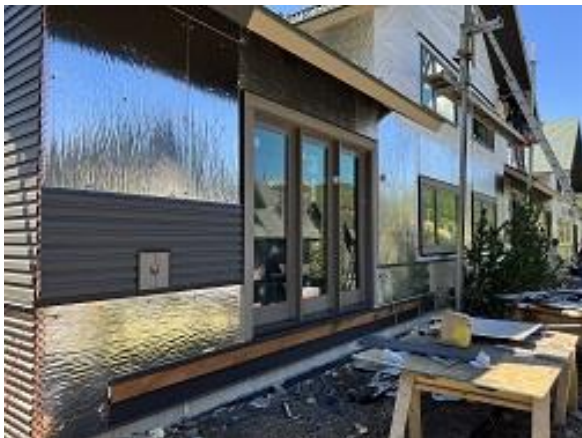
Building E5 Unit 41 Back Lap Siding Installed

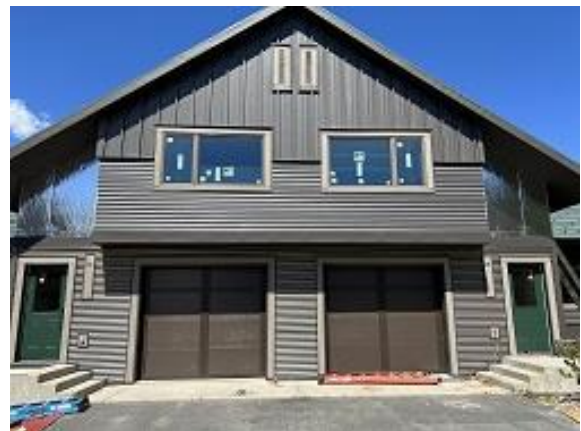
Building E9 Units 63 & 64 Front Lap & Snap Batten Siding Installed

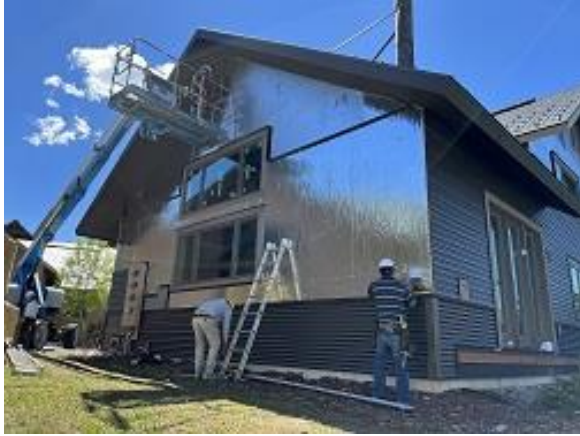
Building E9 Unit 64 Side Corrugated & Lap Siding Installed

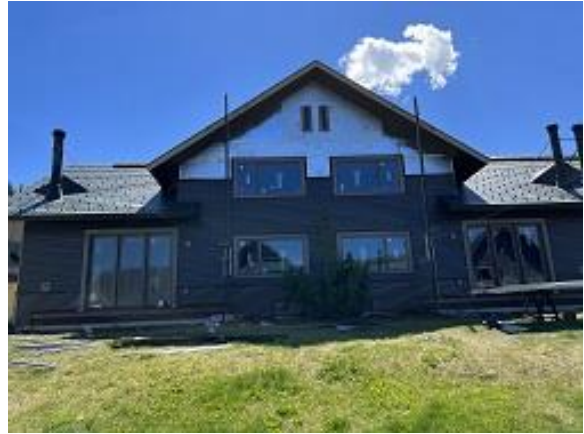
Building E9 Units 63 & 64 Back Lap Siding Installed

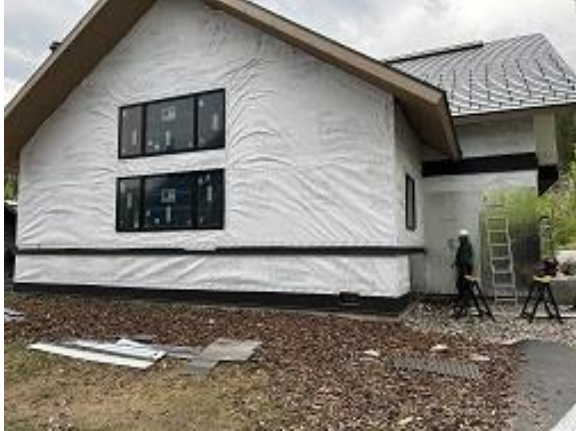
**Building D Unit 38 Side Wainscot
Flashing and Front Insulation Installed**

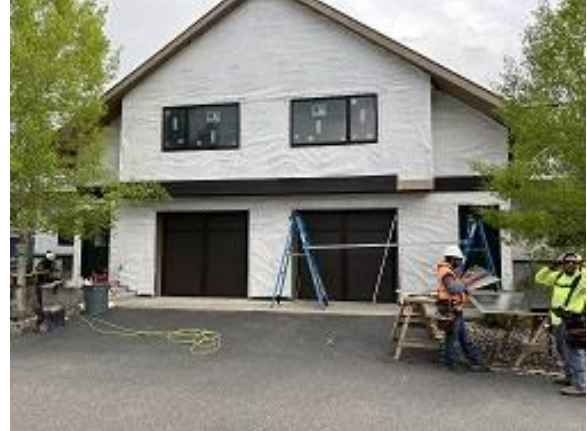
**Building D Units 37 & 38 Front Belly Band
Flashing Installed**

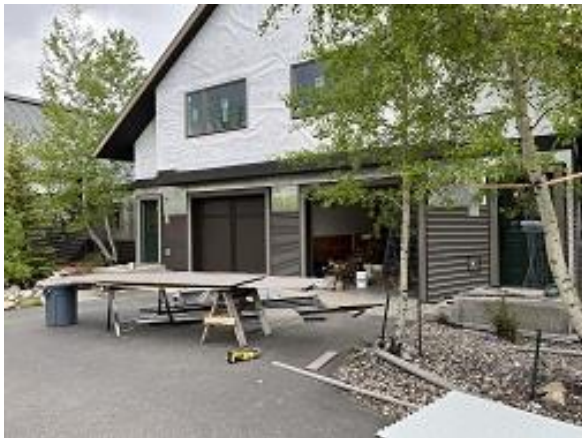
**Building E5 Units 43 & 44 Front
Corrugated Siding Installed**

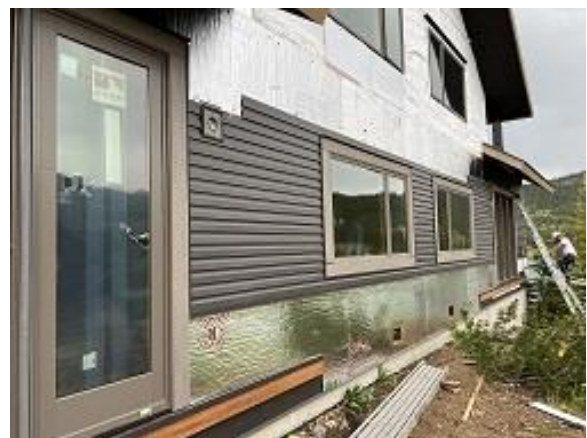
**Building E5 Units 43 & 44 Back Lap Siding
Installed**

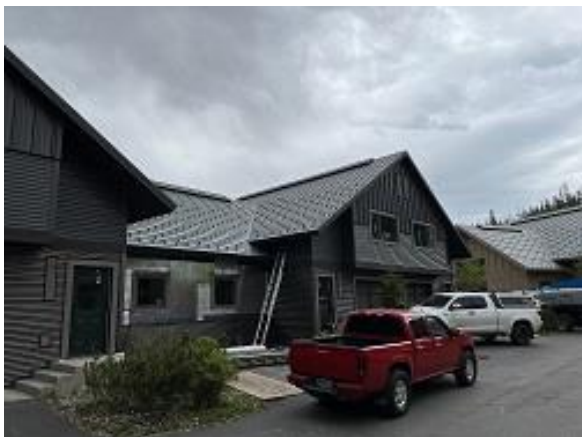
**Building E95 Units 62 & 63 Front Lap
Siding Installed**

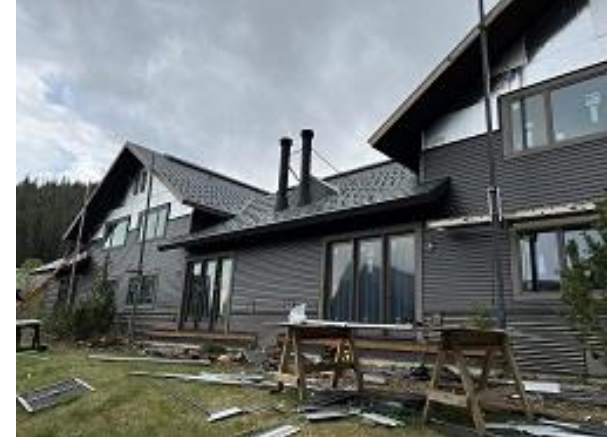
**Building E95 Units 62 & 63 Back Lap
Siding Installed**

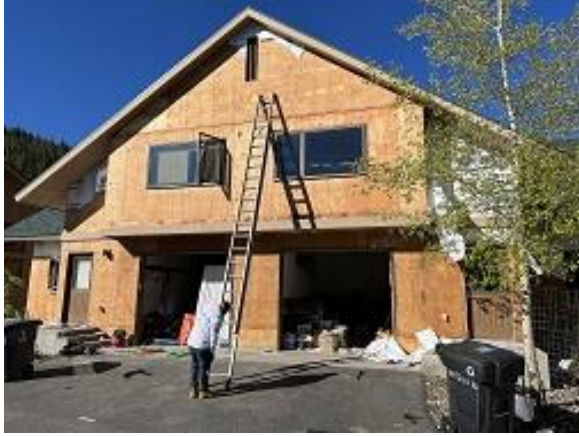
Building C8 Units 65 & 66 Front Demolition Complete

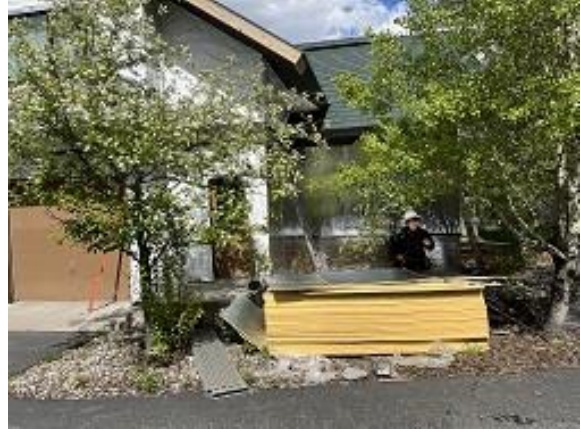
Building D Unit 36 Front Fascia, Soffit and Insulation Installed

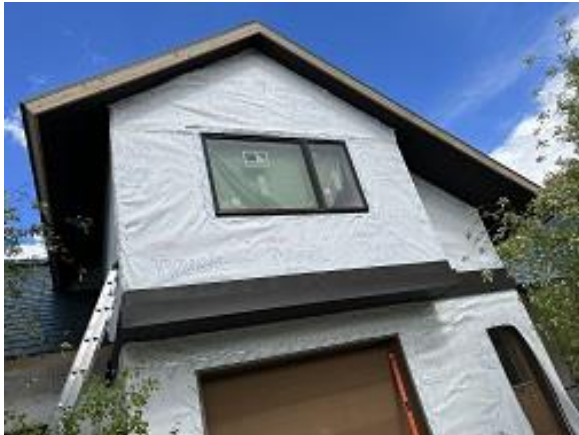
Building D Unit 36 Front Soffit Installed

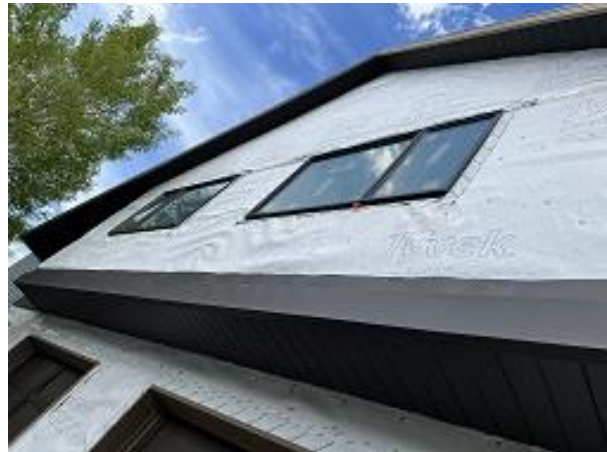
Building D Units 37 & 38 Front Soffit Installed

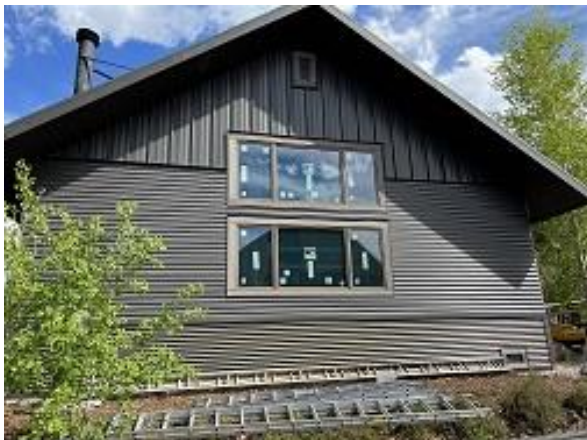
Building E9 Unit 61 Side Lap Siding Installed

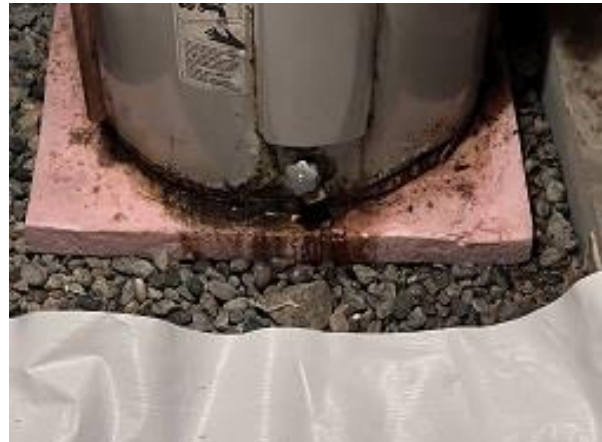
UNRESOLVED ISSUES/FACTORS CONTRIBUTING TO DELAY – While installing radon pipe and plastic in Unit 45 crawl space found water around water heater.

Building E6D Unit 45 Water Heater Leaking

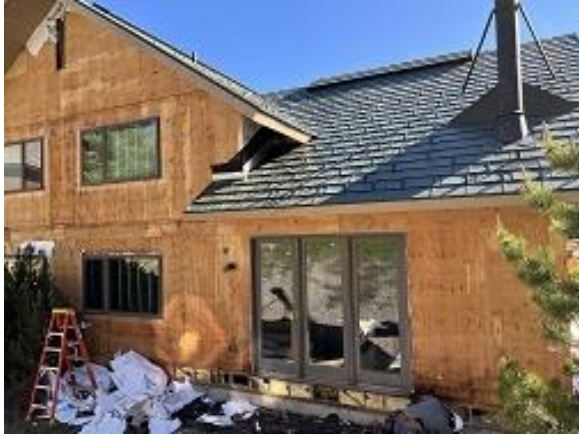
Building C8 Unit 66 Back Tyvek & Deck Sheathing Removed

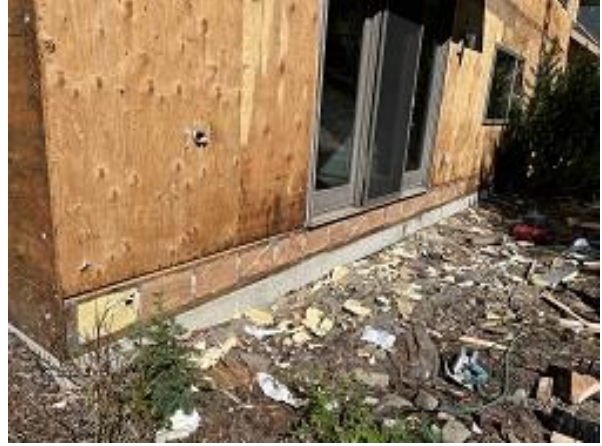
Building C8 Unit 65 Back Deck Blocking Installed

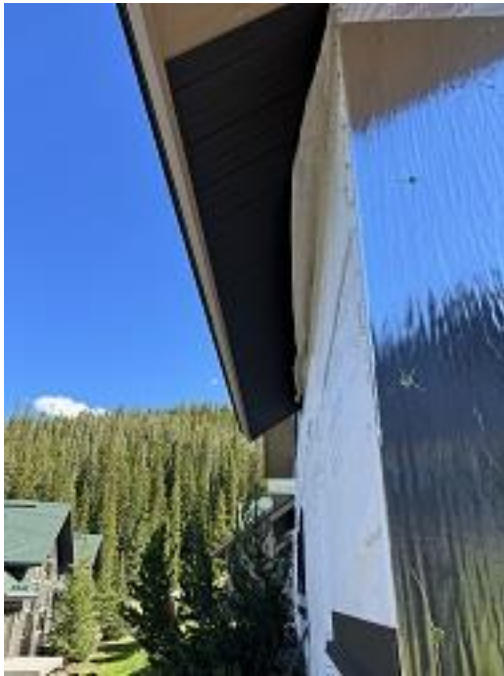
Building D Unit 38 Back Soffit Installed

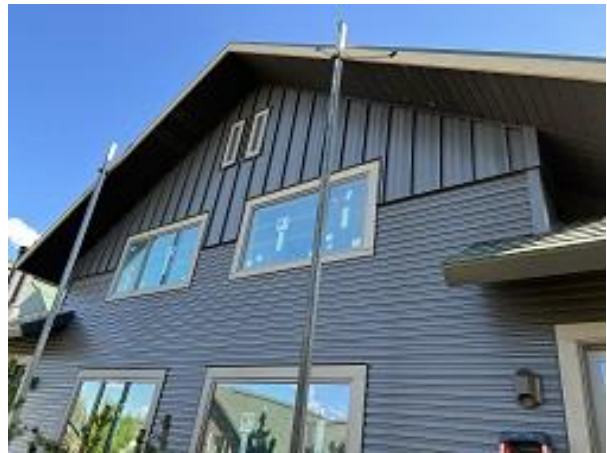
Building E9 Units 61 & 62 Back Snap Batten Siding Installed

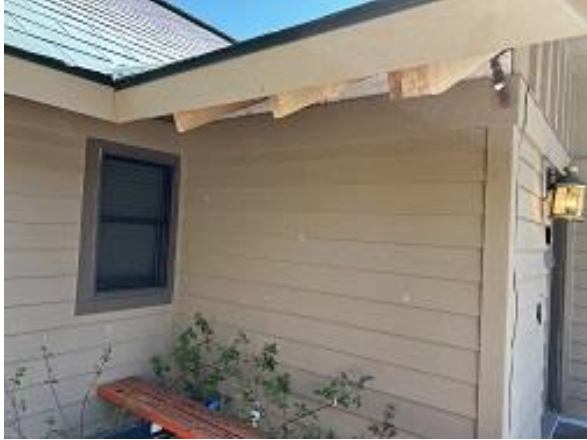
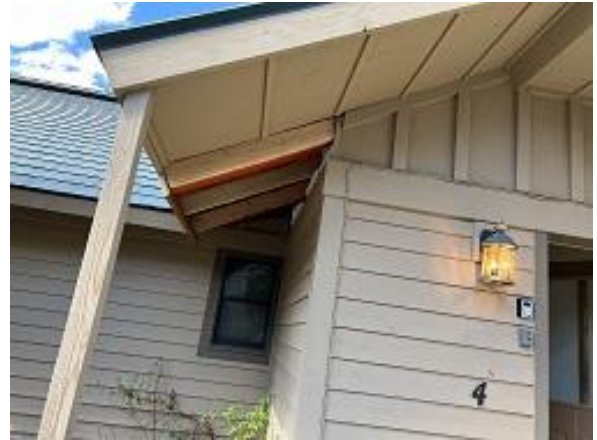
Observations – 1) A & B: units 1 - 7 Roof framing repair began with soffit removal. Triple LVLs were installed properly. Other work in the field does not match the drawings. We are seeking confirmation to clarify the difference. **2)** C8: units 65 & 66 Tyvek and windows installed. **3)** D: units 36 - 38 corrugated siding, garage flashing and insulation installation continued. **4)** E5 Unit 44 side lap siding installation continued. Units 41 & 42 window trim installed. **5)** E9: Units 63 & 64 back snap batten and units 62 & 63 front lap siding completed.

Building B Unit 4 Front Roof Framing Repairs Began

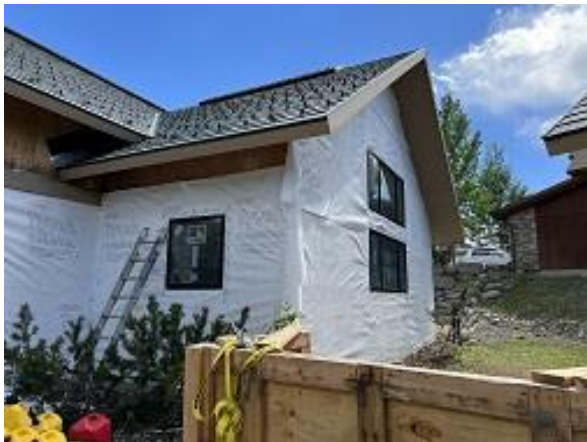
Building C8 Unit 65 Front Kitchen and Side Windows Installed

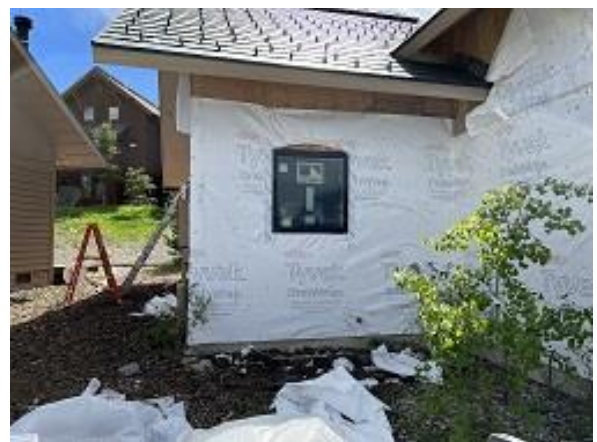
Building C8 Unit 66 Front Kitchen Window Installed

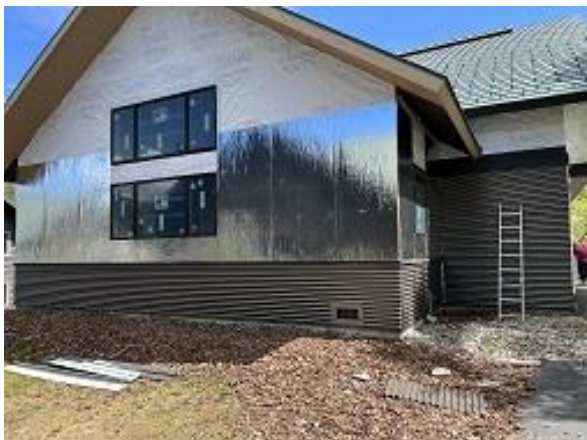
Building D Unit 38 Side & Front Corrugated Siding and Insulation Installed

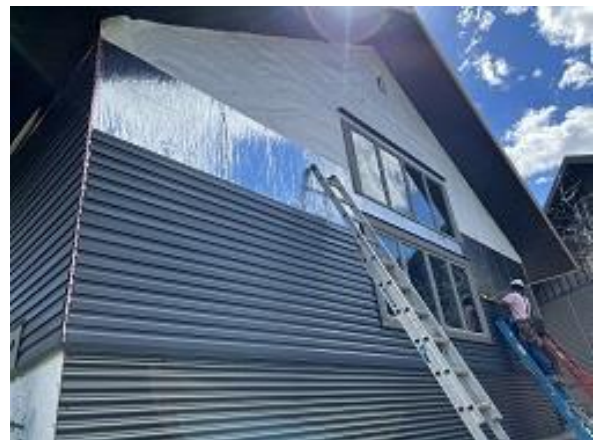
Building E5 Unit 44 Side Lap Siding Installed

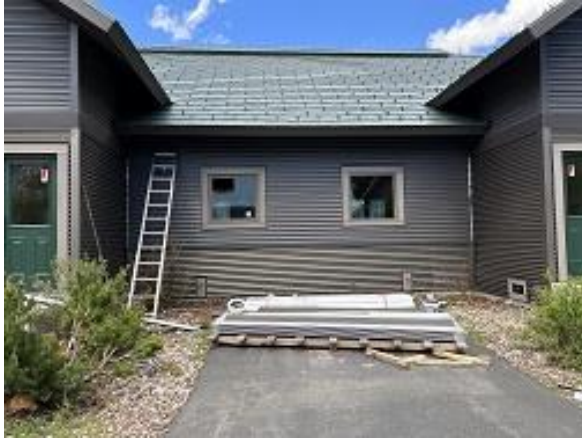
Building E9 Units 62 & 63 Front Lap Siding Installed

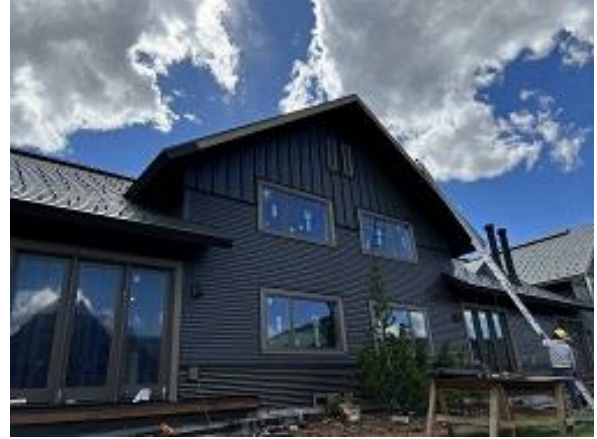
Building E9 Units 63 & 64 Back Snap Batten Siding Installed
