Daily Observation Report

Date of Report: July 5, 2022
 Prepared By: Jim Goveia

PROJECT: BIG HORN CONDO SIDING REPLACEMENT & EXTERIOR UPGRADES PHASE 2

REPORT #: P2-211

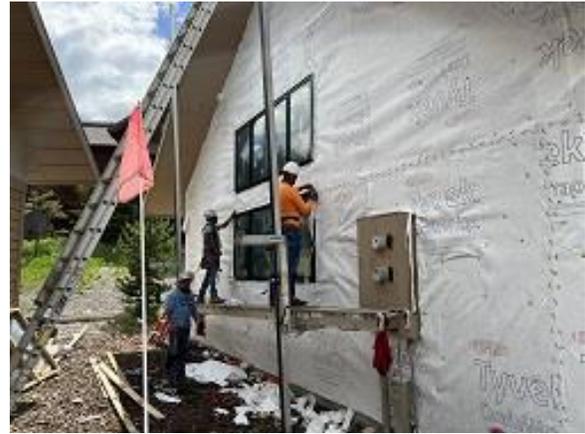
Unit 66

- Front upper-missing middle shims, l&s
- Back upper-window sticks, missing middle shims, l&s
- Back lower-missing middle shims, l&s
- Side upper-l&s
- Side lower-l&s
- Kitchen-missing middle side shims, l&s

**Building C8 Unit 66 Side Windows
Installed**

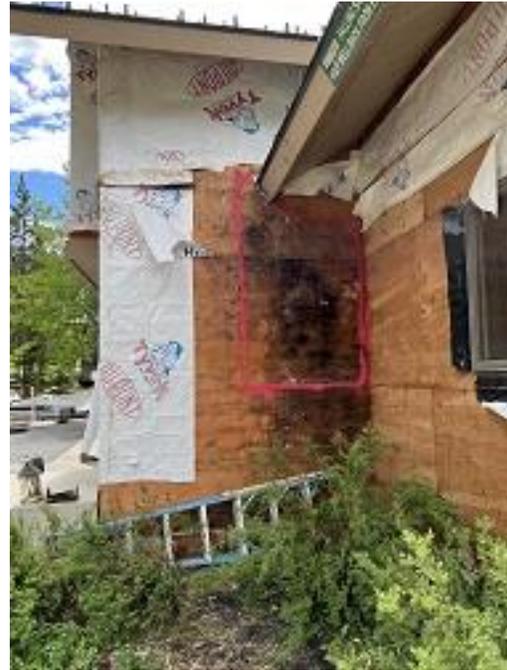
Observations – 1) C1: Units 12 & 13 deck ledger sheathing removed. Unit 12 front sheathing damage marked for repair. **2)** C8: Units 65 & 66 front doors installed. Doors are not centered in opening, missing long screws in top hinge, hardware needs adjusting. Unit 65 deck door installed. Long screws missing from one hinge, door needs adjusting. **3)** D: Units 36 - 38 deck footings demolition completed. Unit 36 Front lap siding installed and side snap batten flashing & J channel installed. Units 37 & 38 Front snap batten flashing & j channel installed. **4)** E5 Units 41 - 44 deck footings demolition completed. Unit 44 side lap siding continued.

Building C1 Unit 12 Front Tyvek Removed and Damaged Area Marked

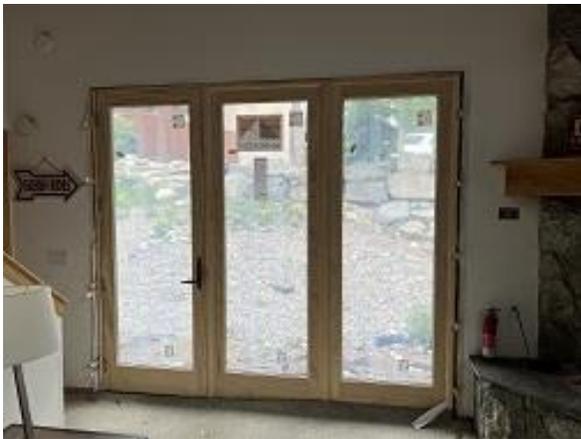
Building C8 Unit 65 Deck Door Installed

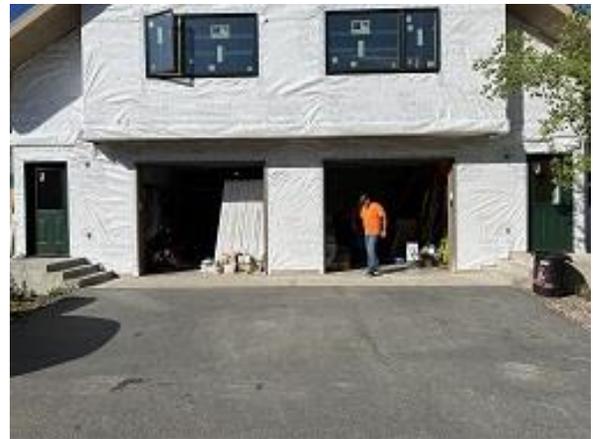
Building C8 Units 65 & 66 Front Doors Installed
