## Daily Observation Report

Date of Report: July 11, 2022  
 Prepared By: Jim Goveia

**PROJECT:** BIG HORN CONDO SIDING REPLACEMENT & EXTERIOR UPGRADES PHASE 2

**REPORT #:** P2-215

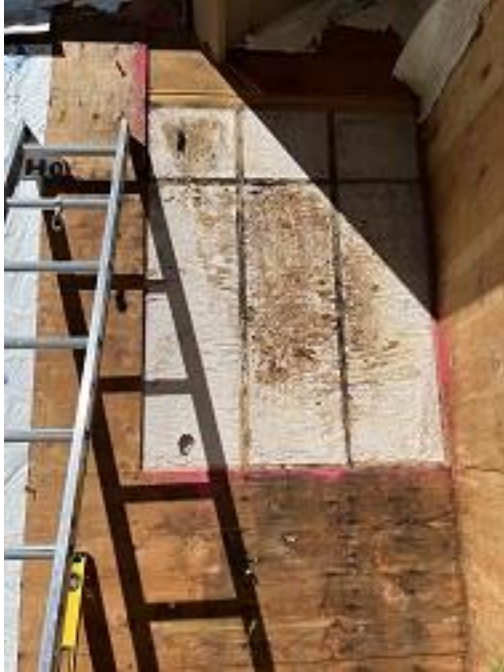
**Observations – 1)** C1: Unit 12 front removed damaged sheathing to reveal damaged substrate. Installed sister studs for added support and having it sprayed for mold. Observed damage to interior when sister stud blocking was installed. Units 12 & 13 deck sheathing replaced & rest of sheathing was exposed. No further damage was observed. **2)** C5: Units 39 & 40 front & side belly band flashing & corrugated siding installed. Insulation installation continued. **3)** D: Units 36 - 38 Front corners installed. **4)** E5 Units 41 - 44 front diverters & lap siding installed. **5)** E7: Units 49, 50 & 51 Deck posts stained. **6)** F2: Units 18 & 19 Deck posts stained.

**Building C1 Unit 12 Front Substrate Damage**

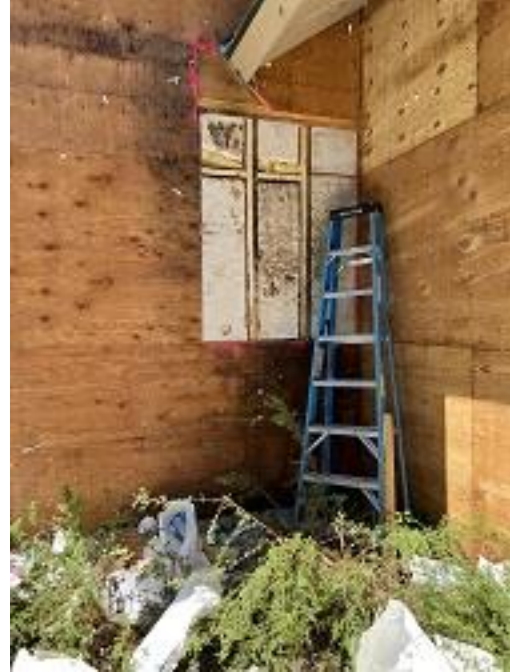
**Building C1 Unit 12 Front Sheathing Exposed Substrate Repaired**

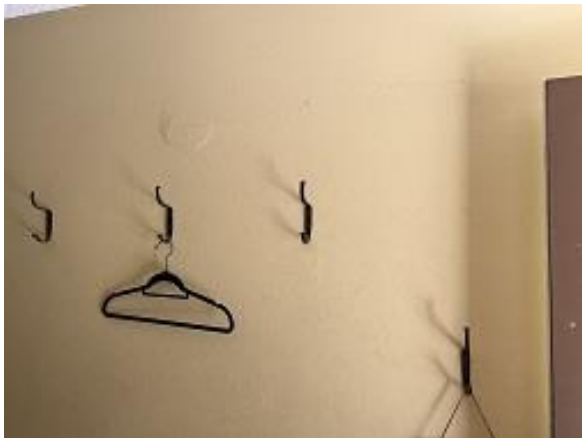
**Building C1 Unit 12 Front Substrate Repair Caused Interior Damage**

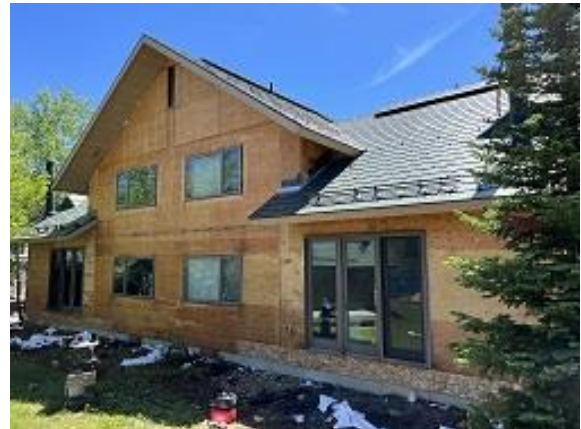
**Building C1 Units 12 & 13 Back Sheathing Exposed & Deck Sheathing Installed**

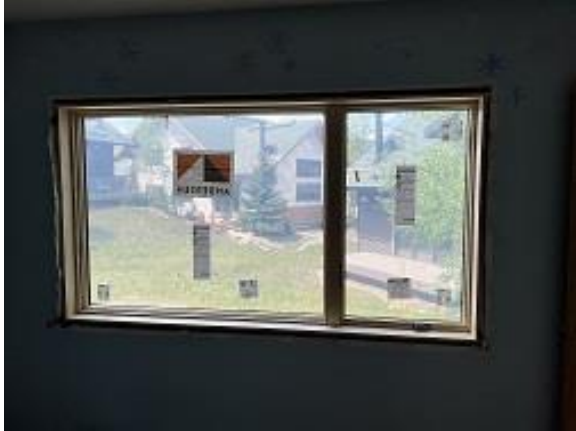
**Observations – 1)** C1: Unit 12 windows installed. Observed all installed square, plumb & level. Back lower window has silicone smear on upper extension jamb, back upper operable window does not latch and upper front operable window sticks. All windows missing middle vertical shims. **2)** C5: Units 39 & 40 Insulation, soffit, fascia & lap siding installation continued. **3)** E5 Units 41 - 43 front diverters & lap siding installation continued. **4)** Deck GLULAMs painted.

**Building C1 Unit 12 Back Lower Window Installed**

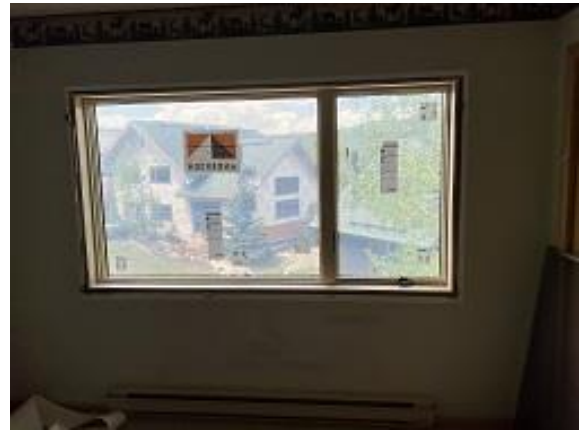
**Building C1 Unit 12 Back Upper Window Installed**

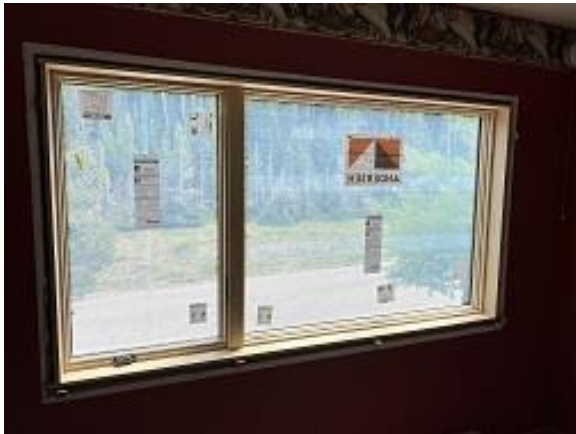
**Building C1 Unit 12 Front Upper Window Installed**

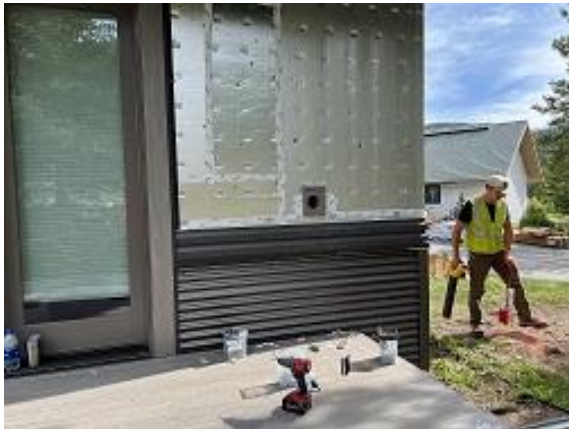
**Building E1 Unit 8 Back Lap Siding Removed to Locate Fireplace Vent**

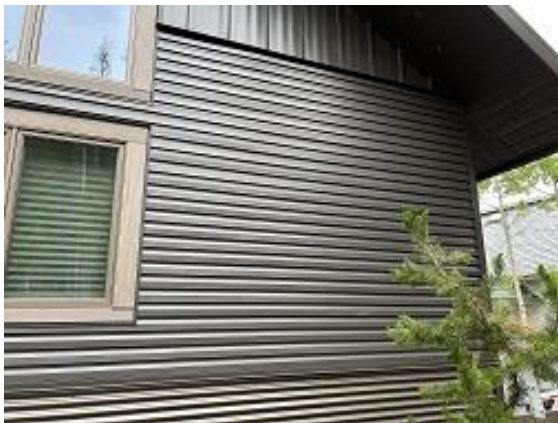
**Building E3 Units 27 Side Wire Penetration Repaired**
