Daily Observation Report

Date of Report: July 18, 2022
 Prepared By: Jim Goveia

PROJECT: BIG HORN CONDO SIDING REPLACEMENT & EXTERIOR UPGRADES PHASE 2

REPORT #: P2-220

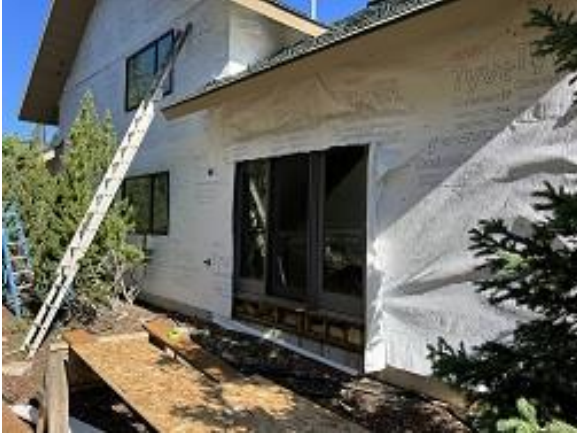
Building C2 Unit 14 Back Windows Installation Began

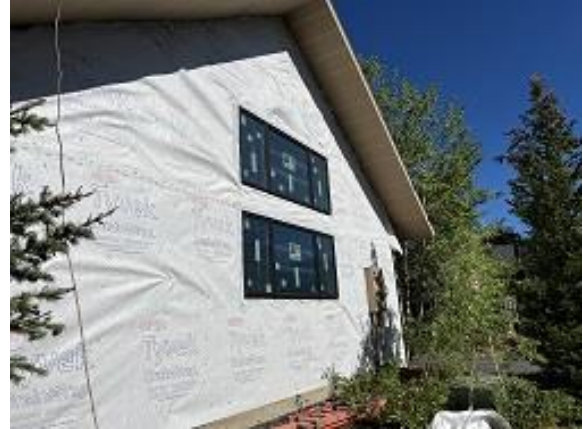
Building C2 Unit 14 Side Windows Installation Began

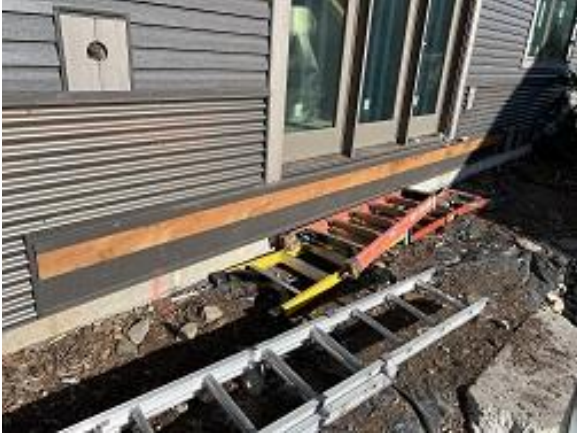
**Building E5 Units 41 - 44 Deck Ledger
Board 2x8 Wrong Size Should Be 2x10**

Observations – 1) C2: Units 14 & 15 window installation began. **2)** C5: Units 39 & 40 back snap batten flashing installation continued. **3)** C8: Units 65 & 66 insulation, corrugated siding and snap batten flashing installation continued. **4)** D: Units 36 - 38 deck door installation began. **5)** E5: Units 41 - 44 deck ledger installed was 2x8 should have been 2x10 and 1/4" x 6" RSS screws should be 5/8" x 6" lags. 2x8 to be replaced by 2x10 ledger boards. Contacting engineer to approve 3 RSS screws to replace one 5/8" lag.

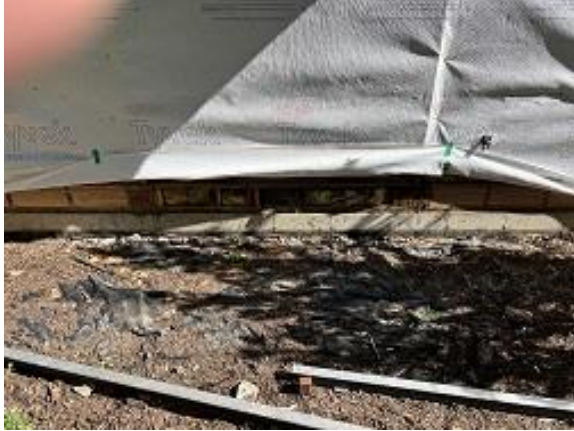
**Building C2 Unit 15 Deck Ledger
Mold Treatment**

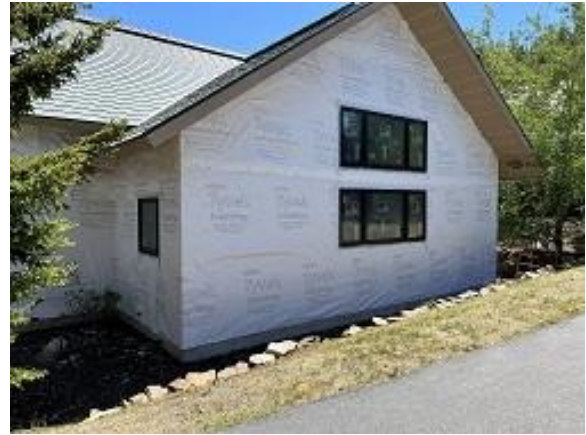
Observations – 1) C1: Units 12 & 13 front doors installed. **2)** C2: Units 14 & 15 deck ledger blocking completed. Unit 14 front door installed. Unit 15 windows installed. Observed all side shims were wedged in place and some only wedged the jamb extensions. Side lower window not square. All others were square & level. Exterior: side and bedroom windows are missing screws in flange. Flashing tape not adhering properly to Tyvek. Kitchen flashing tape is not full 4". **3)** C3: Unit 32: entry door installed. Unit 33: windows installed. Observed kitchen window could not be centered on cabinets due to rough opening restrictions. Front upper window is square and level. **4)** C8: Units 66 - 65 side & front snap batten siding installed. **5)** E1: Units 8 - 11 touch-up paint continued. **6)** E3: Unit 24 Wire penetration repairs continued.

**Building C2 Unit 15 Front & Side Windows
Installed**

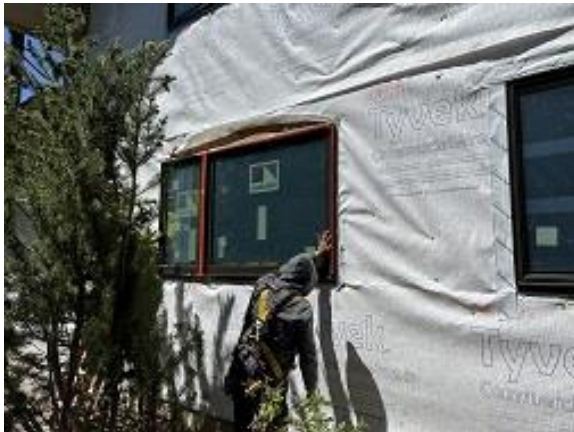
**Building C2 Unit 15 Back Lower
Window Installed**

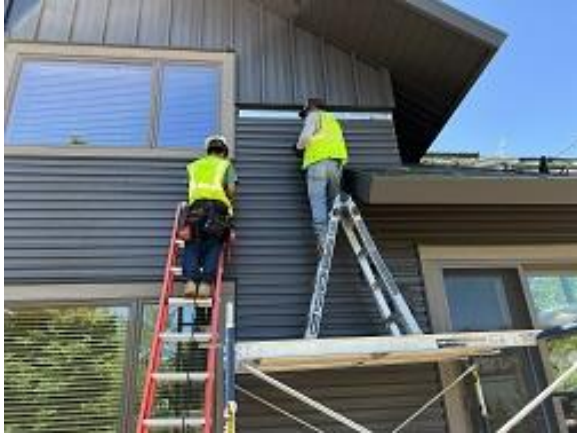
**Building E3 Unit 24 Lap Siding
Wire Penetration Repair**
