Daily Observation Report

Date of Report: July 25, 2022
 Prepared By: Jim Goveia

PROJECT: BIG HORN CONDO SIDING REPLACEMENT & EXTERIOR UPGRADES PHASE 2

REPORT #: P2-225

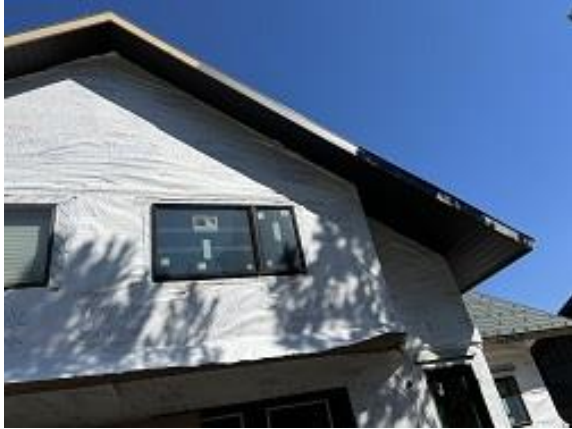
Building C1 Unit 12 Front Soffit & Fascia Installed

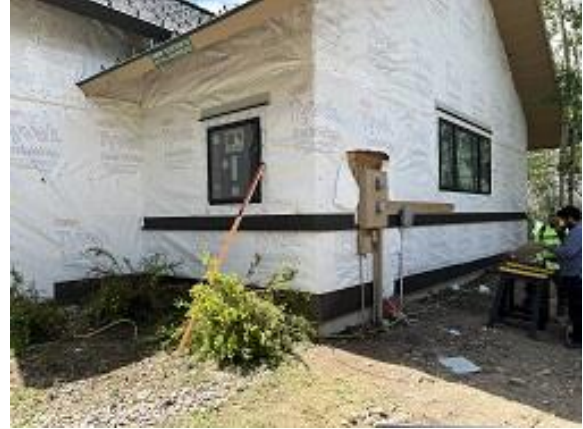
Building C1 Unit 12 Front & Side Base, Wainscot & Head Flashing Installed

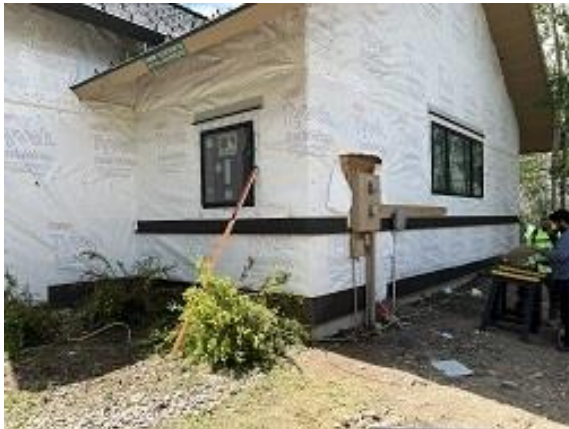
Building C1 Unit 12 Front & Side Base, Wainscot & Head Flashing Installed

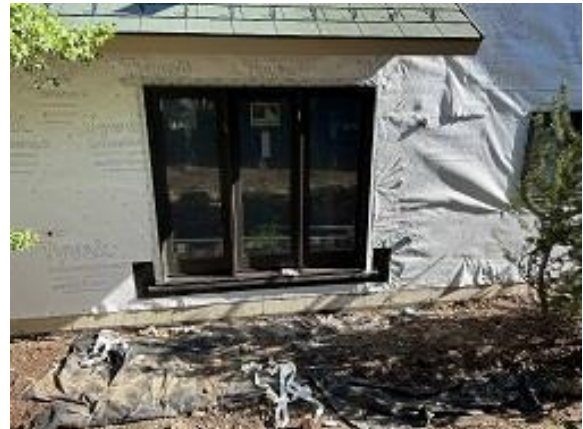
Building C2 Unit 15 Deck Door Installed

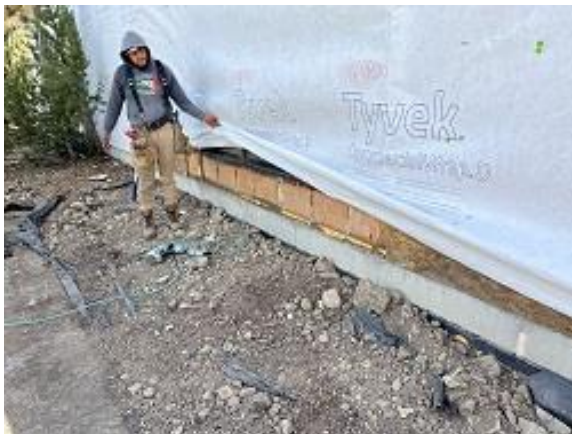
Building C3 Unit 33 Deck Ledger Blocking Installed

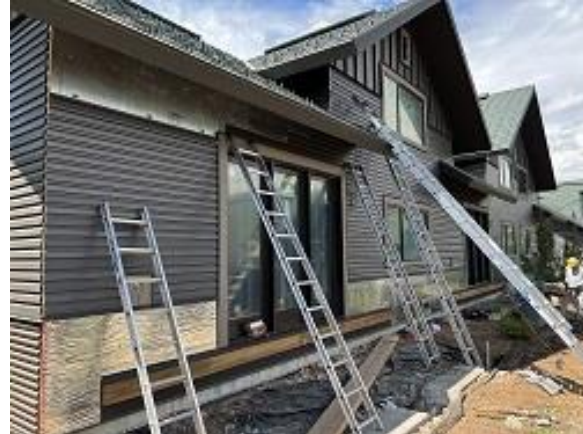
Building D Units 36 & 37 Lap Siding Installed

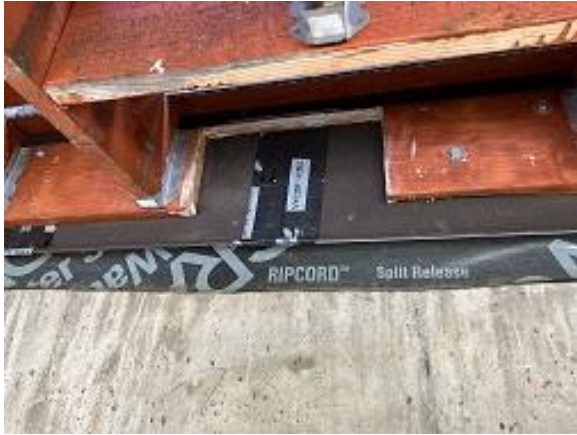
**Building E7 Unit 52 Deck Ledger
Flashing & Additional Flashing Tape Installed**

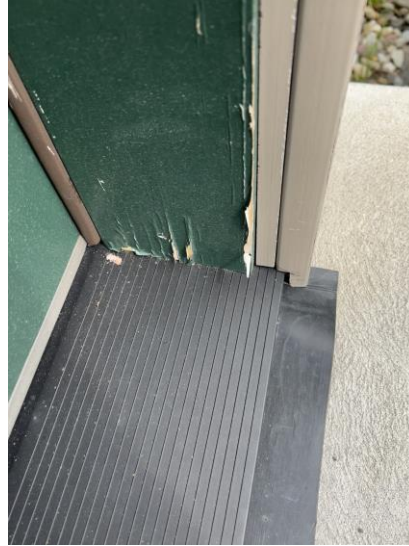
**Building E7 Unit 49 Front Door Paint
Peeling Moment**

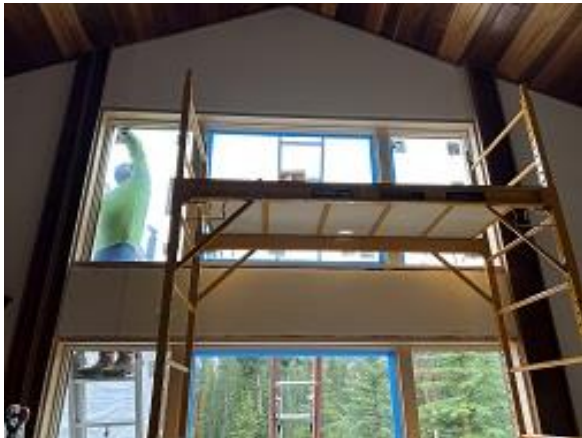
**Building E8 Unit 58 Side Window Moved to
Correct Location in Rough Opening**

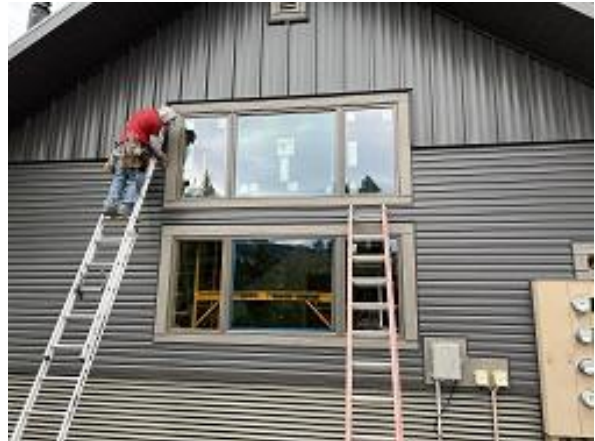
**Building E8 Unit 58 Side Window Moved to
Correct Location in Rough Opening**

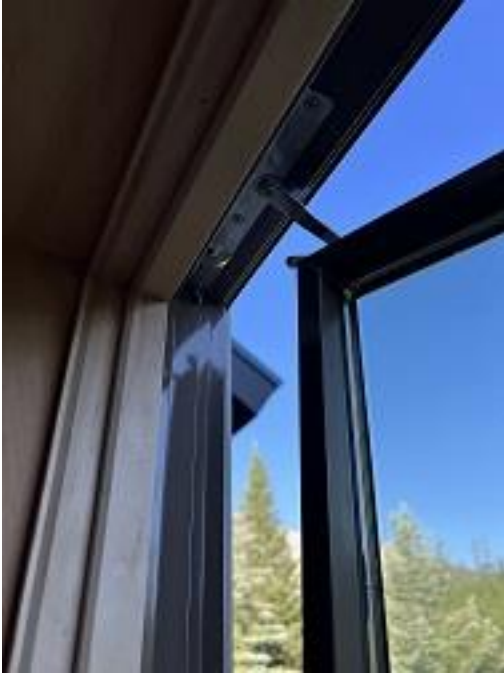
**Building E8 Unit 56 Back Lower
Window Rivet Broken**

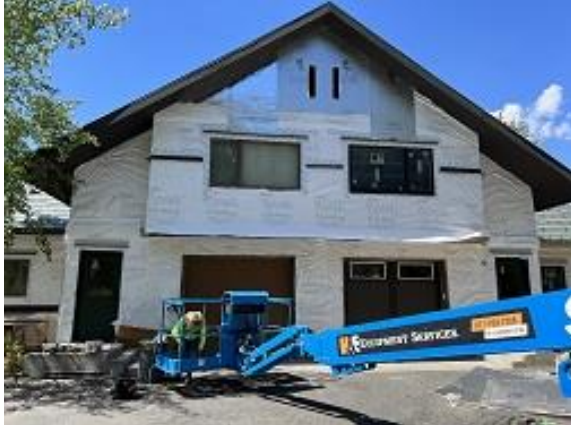
Building C1 Units 12 & 13 Front Snap Batten & Head Flashing and Insulation Installed

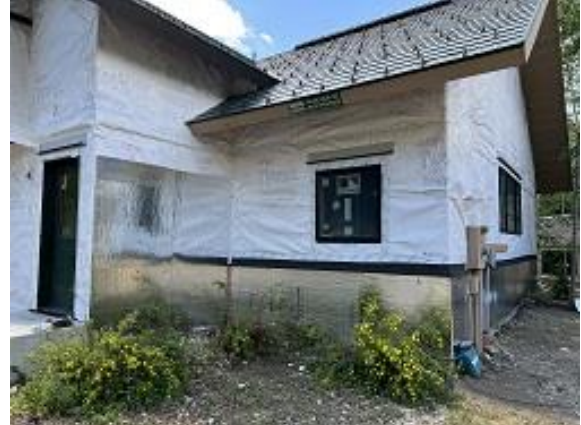
Building C1 Unit 12 Front & Side Insulation Installed

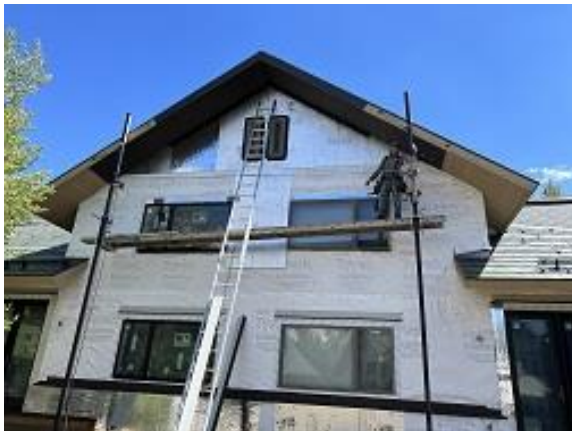
Building C1 Units 12 & 13 Back Soffit, Fascia and Insulation Installed

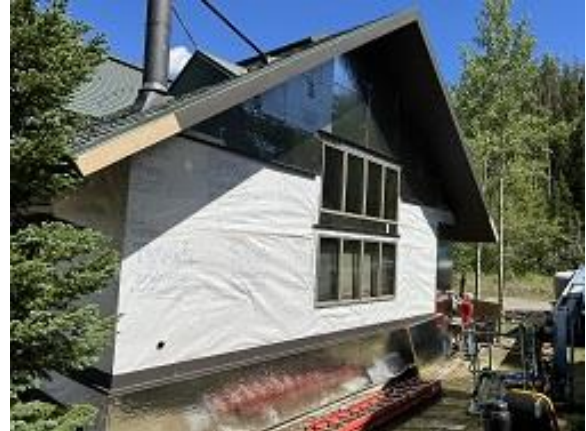
Building C1 Unit 13 Side Snap Batten Flashing and Insulation Installed

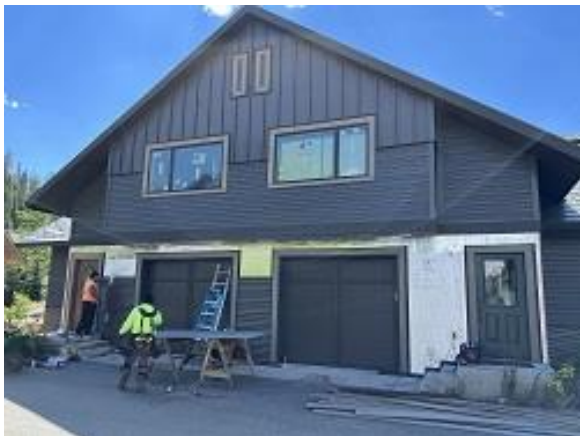
Building C5 Units 39 & 40 Front Corrugated Siding Installation Continued

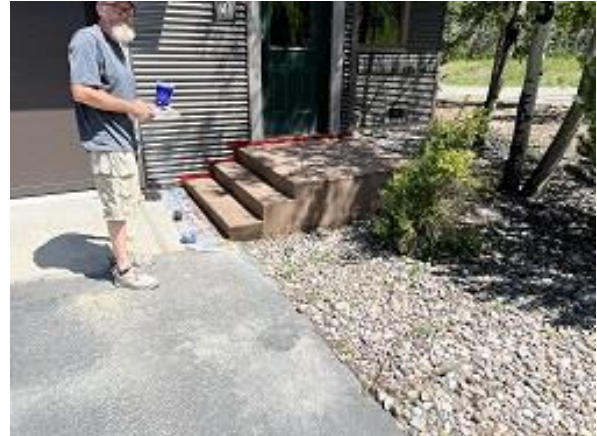
Building E3 Unit 27 Stoop Refinishing Began See Lower Left Sept Side for Color

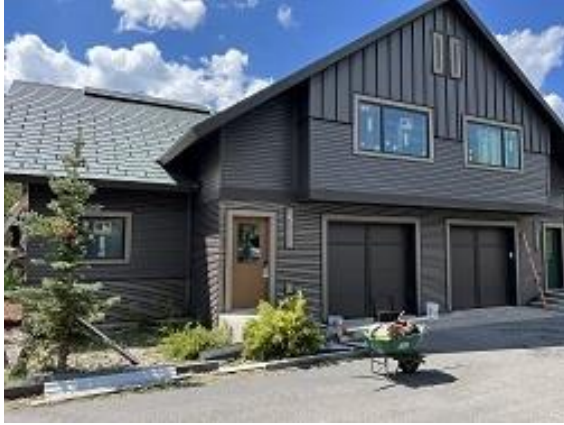
Building C5 Units 39 & 40 Front Corrugated Siding & Corners Installed

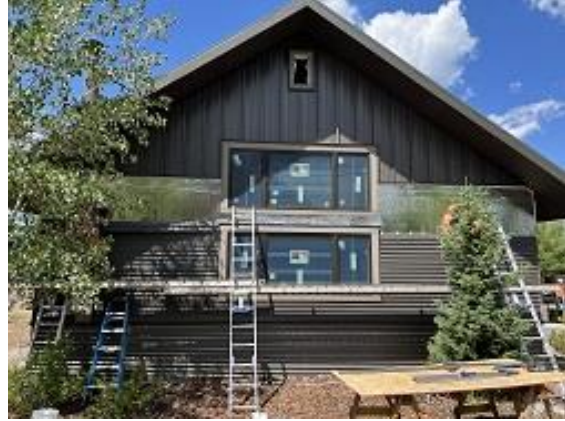
Building C5 Unit 39 Side Lap Siding Installed

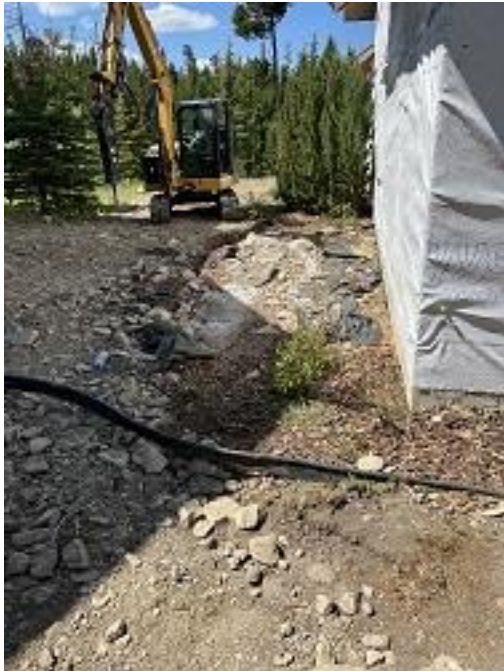
Building C7 Units 59 & 60 Deck Footing Demolition

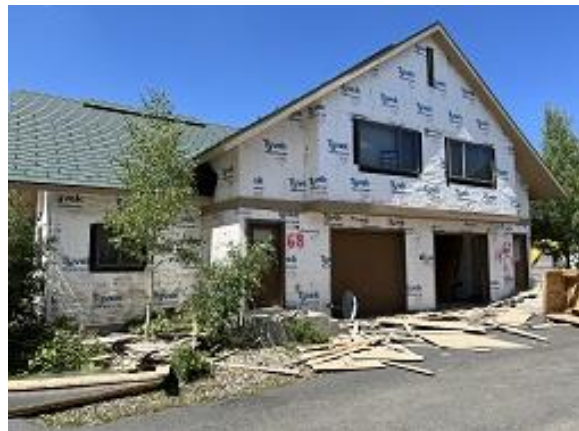
Building C9 Units 67 & 68 Front Siding Demolition

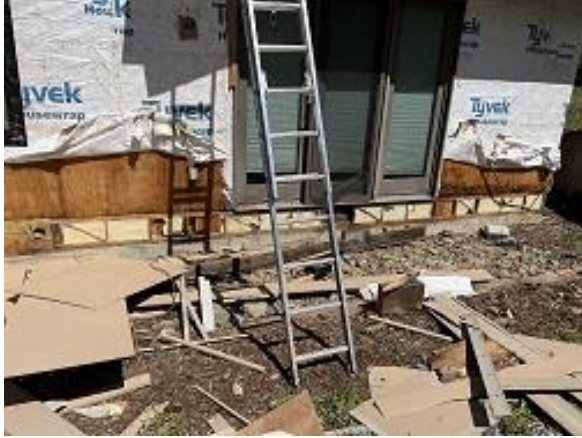
**Building C9 Unit 68 Deck Ledger
Sheathing Removed & Blocking Installed**

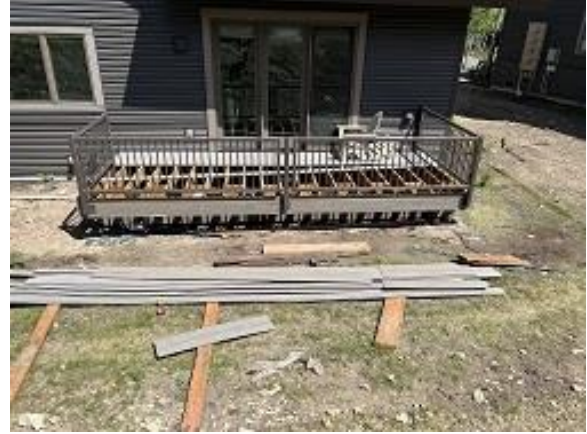
Building E2 Unit 23 Deck Railing Installed

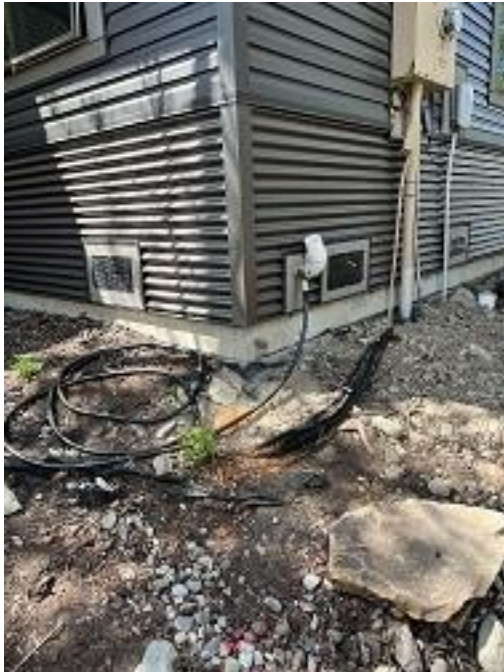
**Building F2 Unit 16 Side
Radon System Exhaust**

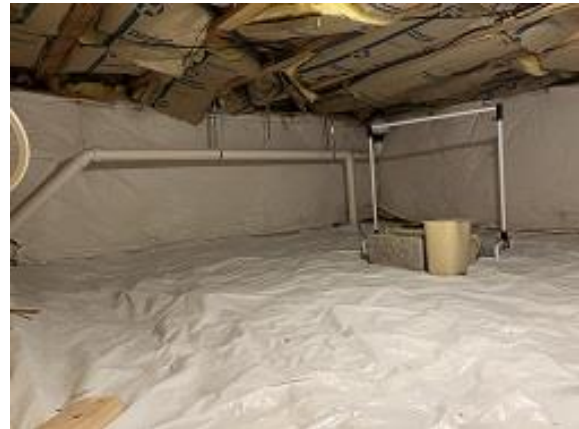
**Building F2 Unit 16 Radon System
Installed**

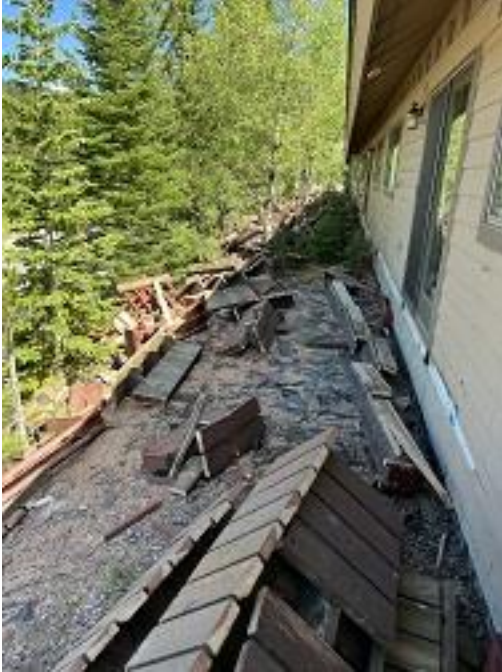
Building B Units 3 - 7 Deck Demolition

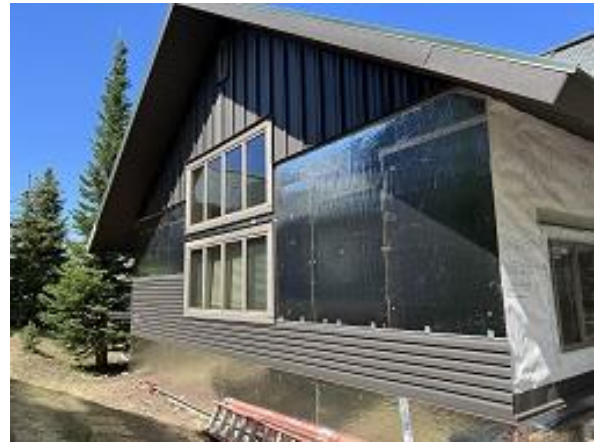
Building C1 Unit 13 Side Lap Siding Installed

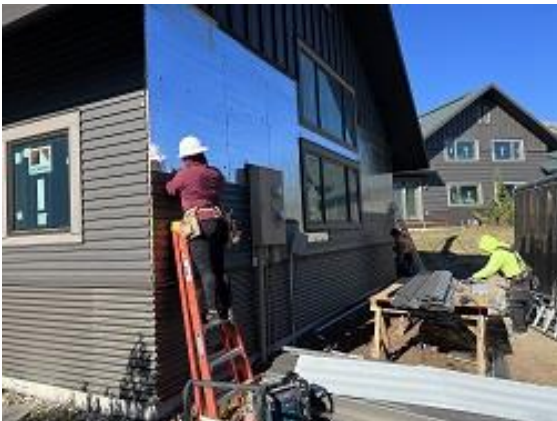
Building C5 Unit 40 Side Lap Siding Installed

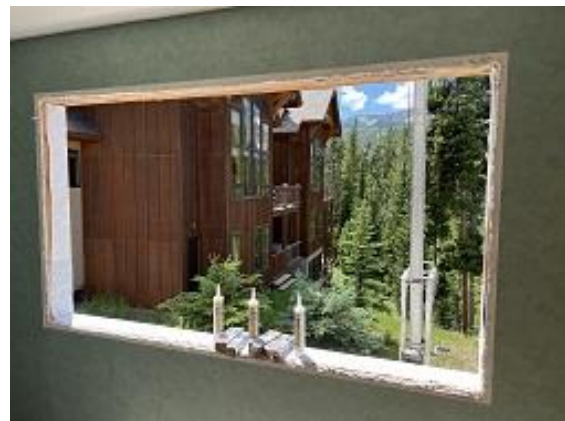
Building C7 Unit 59 Back Upper Window Removed

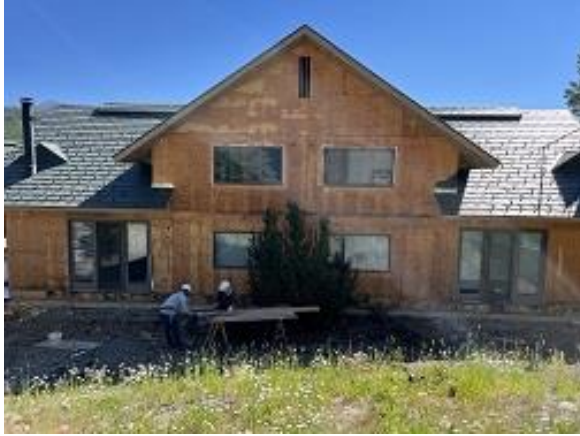
**Building C9 Units 67 & 68 Back
Sheathing Exposed**

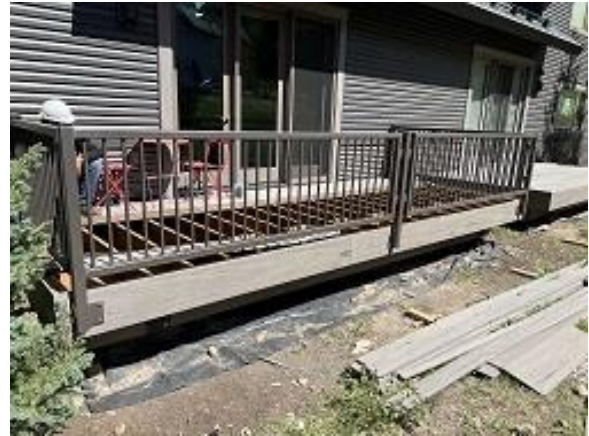
Building E4 Units 29 Deck Railing Installed

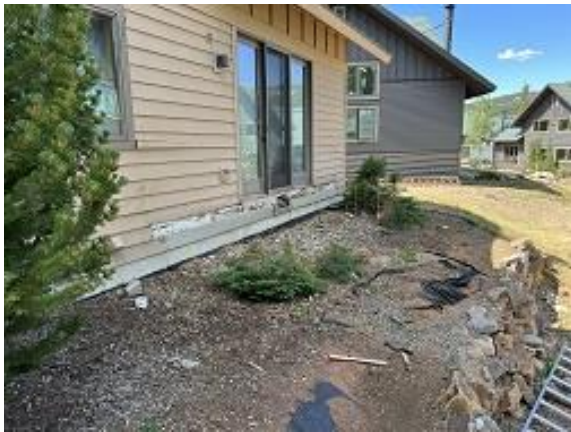
Building C10 Unit 69 Deck Demolition

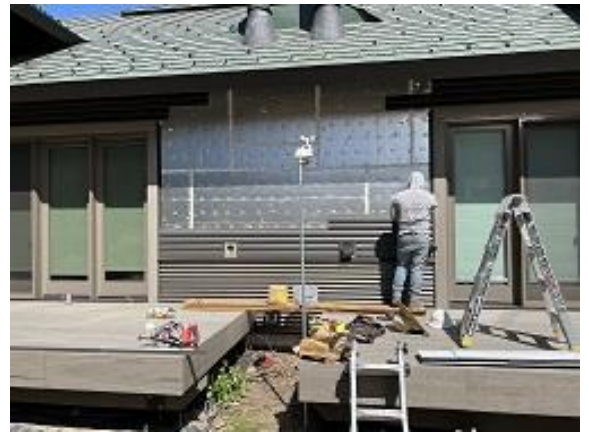
**Building E2 Units 21 & 22 Back Fireplace
Vent Located and Lap Siding Replaced**

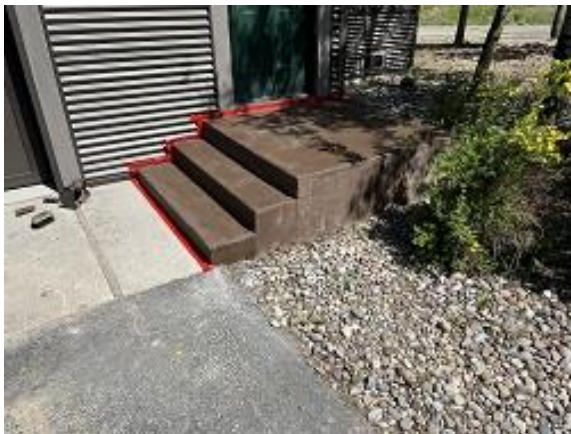
Building E3 Unit 27 Stoop Refinished

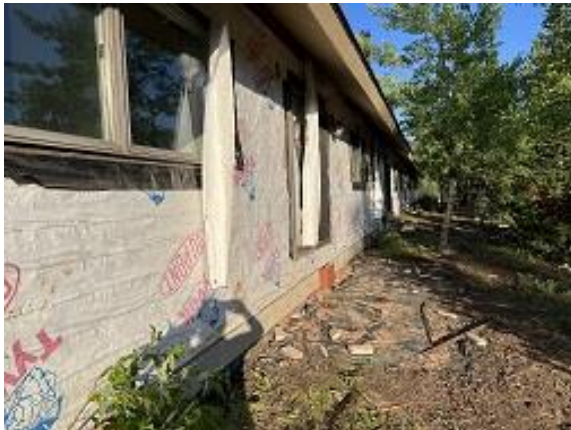
Building B Units 3-7 Back Siding Demolition

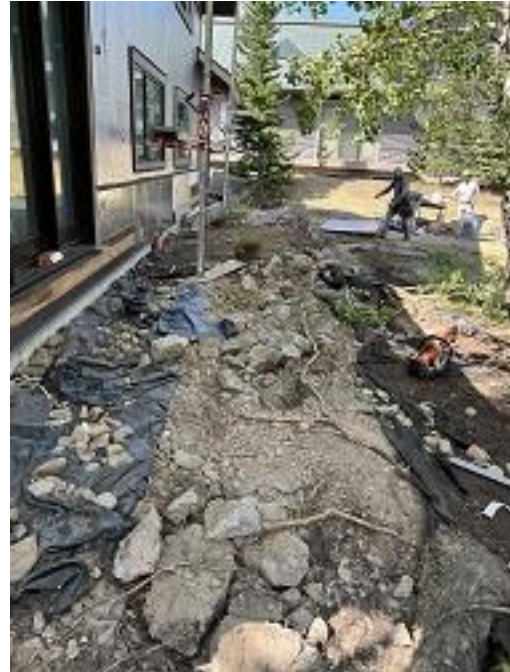
Building C1 Units 12 & 13 Deck Footing Demolition

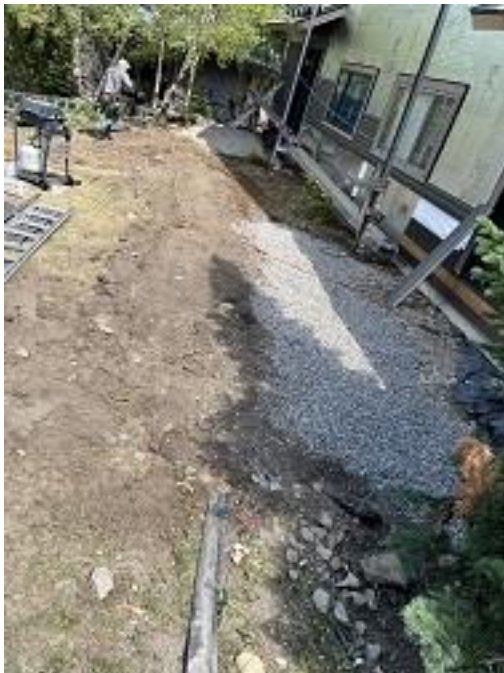
Building C1 Units 12 & 13 Deck Footings Infilled

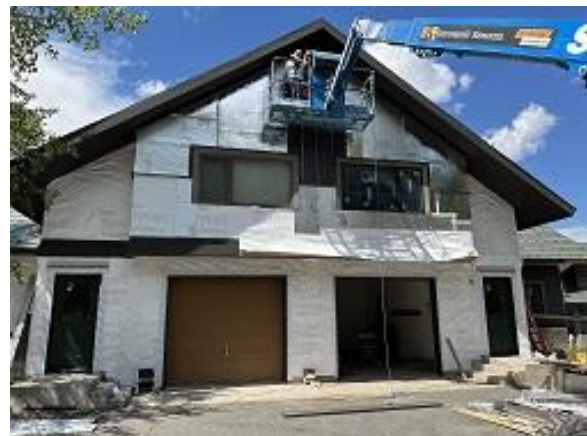
Building C1 Units 12 & 13 Front Snap Batten Siding Installed

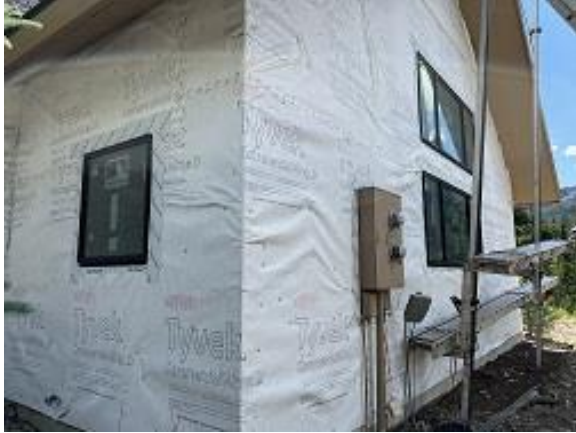
Building C7 Unit 59 Kitchen & Side Windows Installed

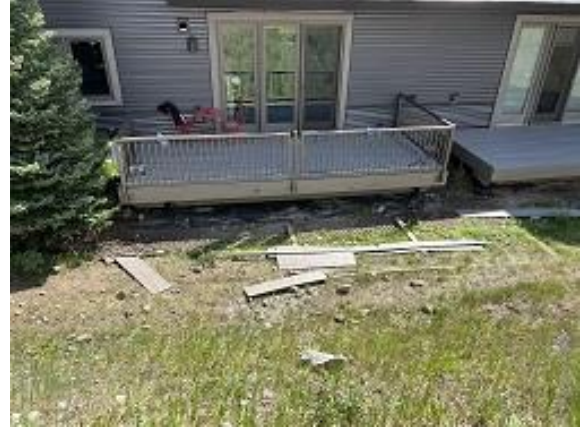
Building E4 Unit 29 Decking Reinstalled

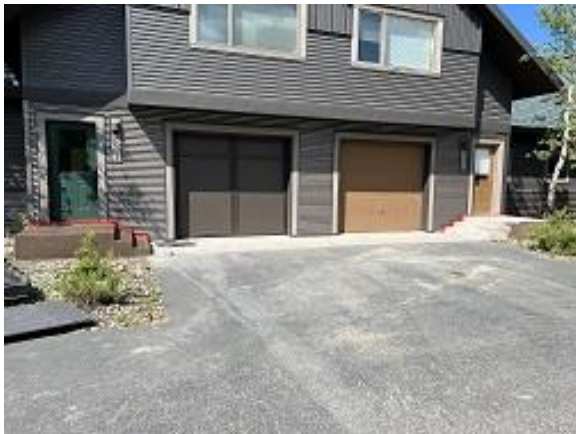
Building E4 Units 31 & 32 Stoop Refinishing

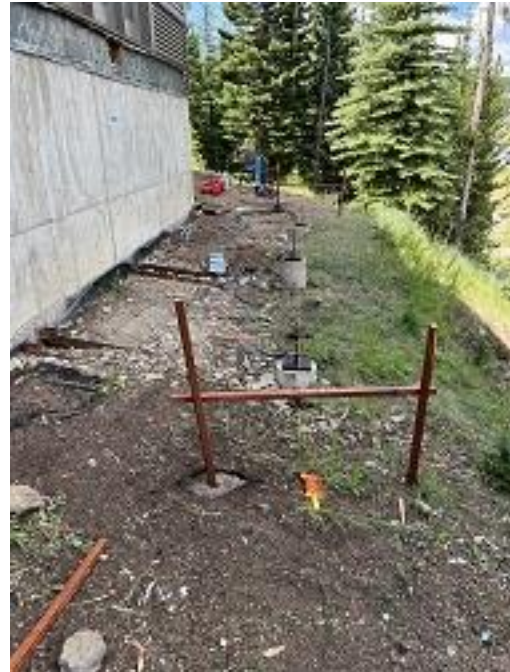
Building E7 Unit 52 Deck Post Knife Plates Installed
