Daily Observation Report

Date of Report: Aug 2, 2022
 Prepared By: Jim Goveia

PROJECT: BIG HORN CONDO SIDING REPLACEMENT & EXTERIOR UPGRADES PHASE 2

REPORT #: P2-230

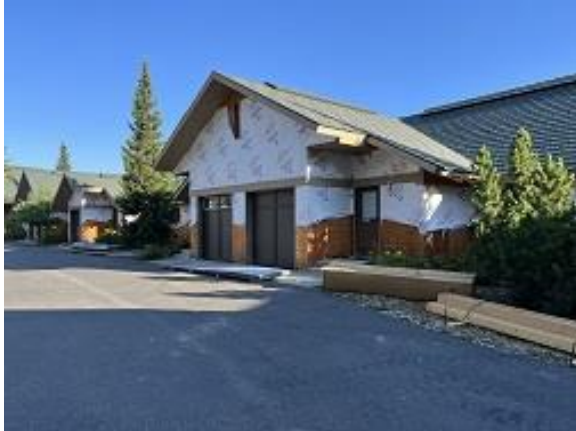
Building B Units 3 - 7 Siding Demolished

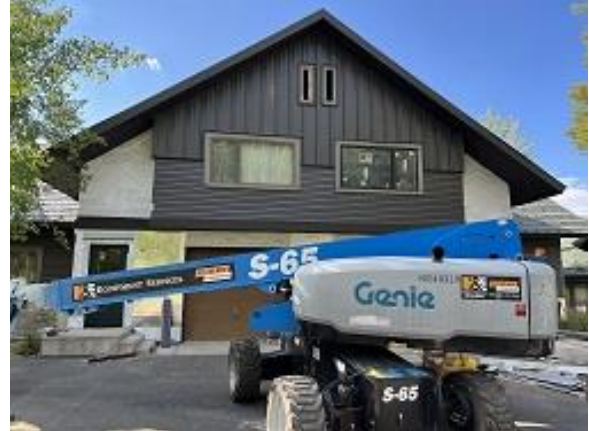
Building C1 Units 12 & 13 Front Lap Siding Installed

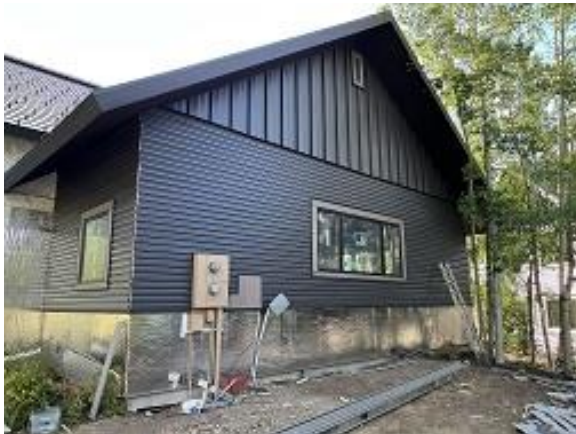
Building C1 Unit 12 Front & Side Lap Siding Installed

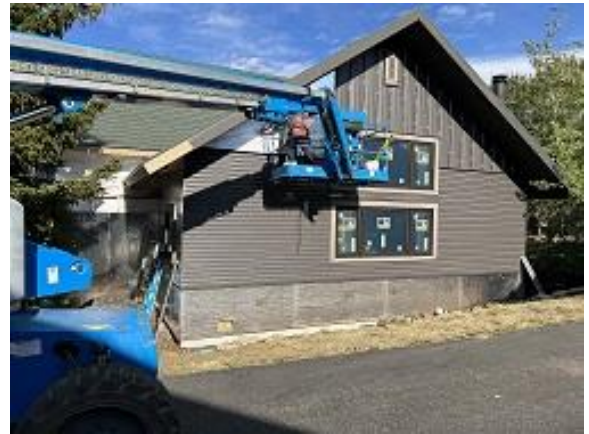
Building C2 Unit 15 Side Snap Batten Siding Installed

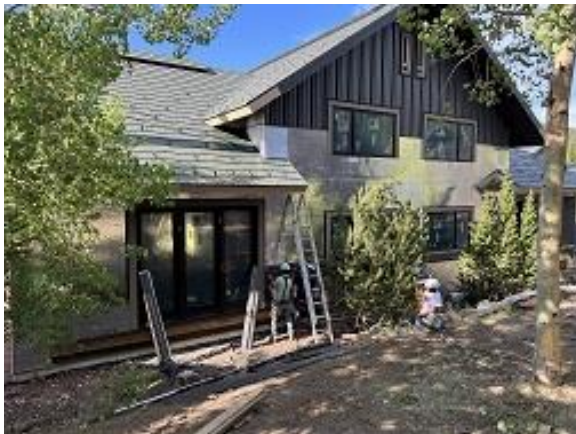
Building C2 Units 14 & 15 Back Lap Siding Installed

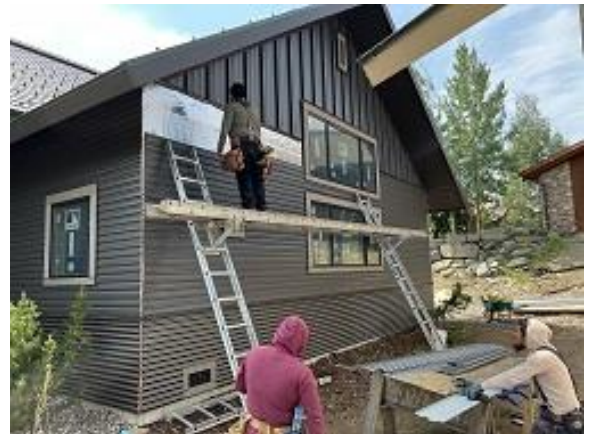
Building C8 Unit 65 Side Lap Siding Installed

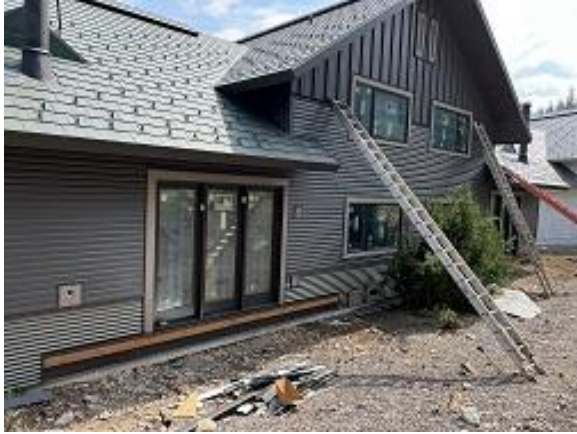
Building C8 Unit 65 Back Lap Siding Installed

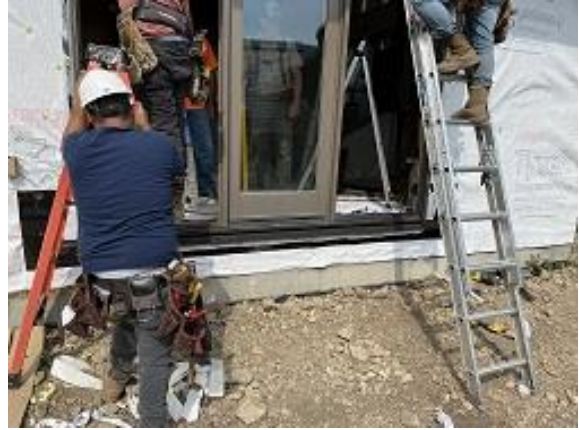
Building C3 Unit 33 Deck Door Removed & Reinstalled

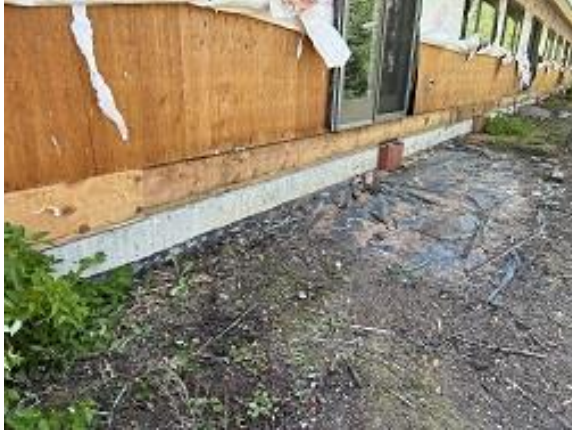
**Building B Unit 3 Deck Ledger
Sheathing Removed**

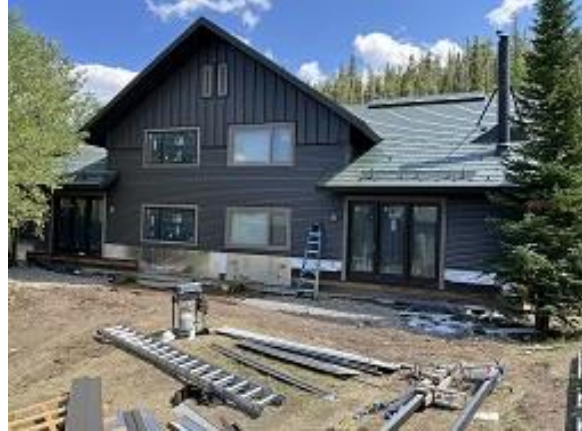
**Building C1 Units 12 & 13 Back Lap Siding
Installed**

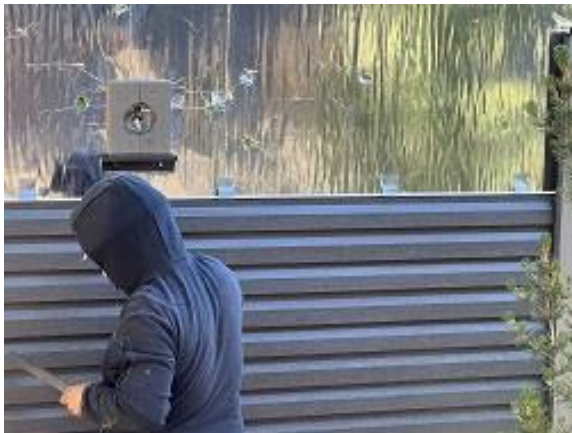
Observations – 1) B: Units 3 - 7 Deck ledger sheathing removed and sheathing exposed. No damage observed. **2)** C1: Units 12 & 13 front & back lap siding installed. **3)** C2: Units 14 & 15 back lap siding installation continued. Observed lap siding being installed with clips spaced too far apart and without the proper number of fasteners causing removal and proper installation of lap siding. Front insulation installed. Unit 14 observed side lap siding removed at fireplace vent. **4)** E1: Units 8 - 11 radon systems installed in crawl space and exhaust penetrations made.

**Building C2 Unit 15 Back Lap Siding
Installed Clips One Screw Only**

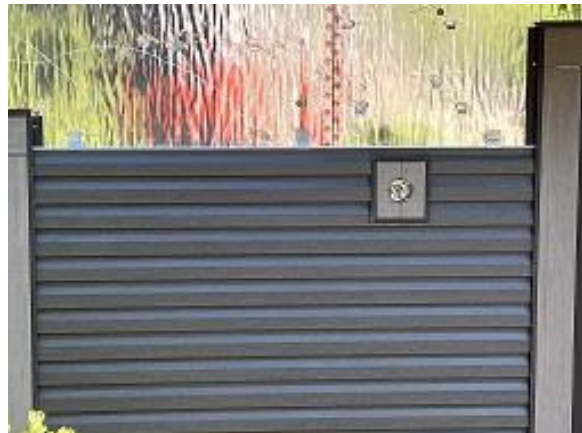
**Building C2 Unit 14 Back Lap Siding
Installed Clips More Than 24 Inches Apart**

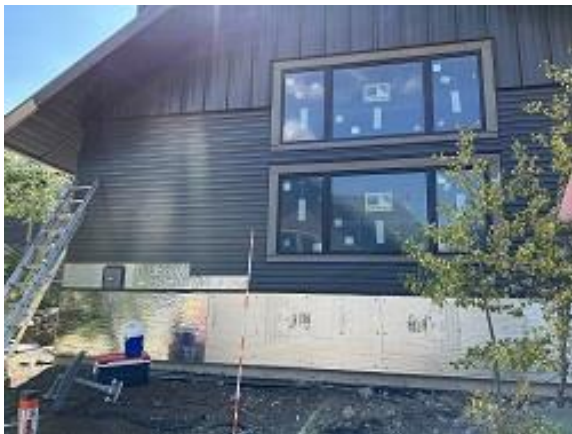
**Building C2 Unit 14 Side Lap Siding
Removed at Fireplace Vent**

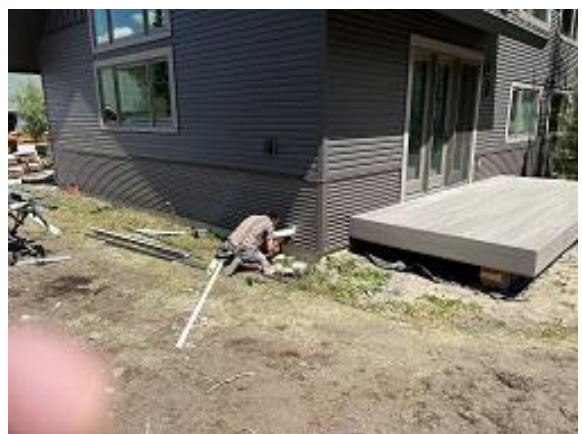
**Building E1 Unit 11 Side Radon Exhaust
Siding Penetration**

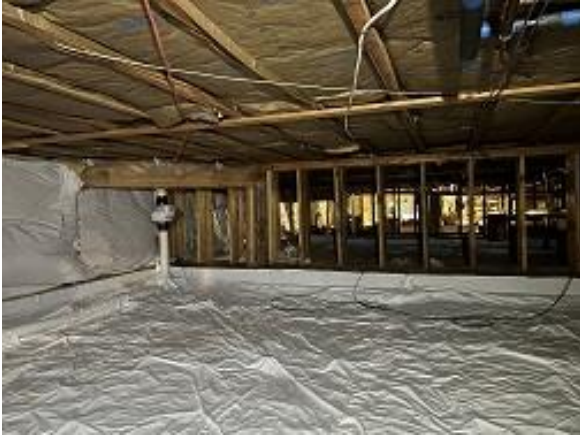
Building E1 Unit 9 Radon System Installed

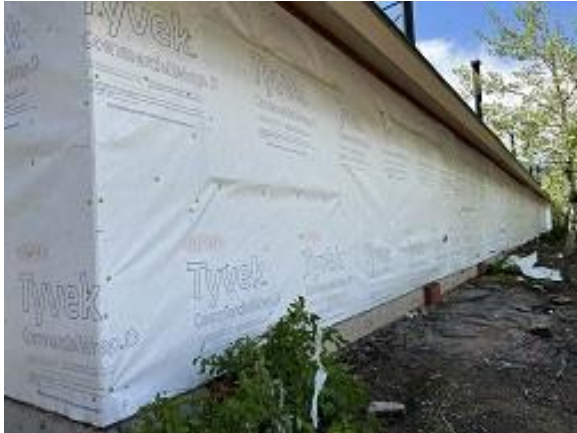
Building B Units 3 -7 Back Tyvek Installed

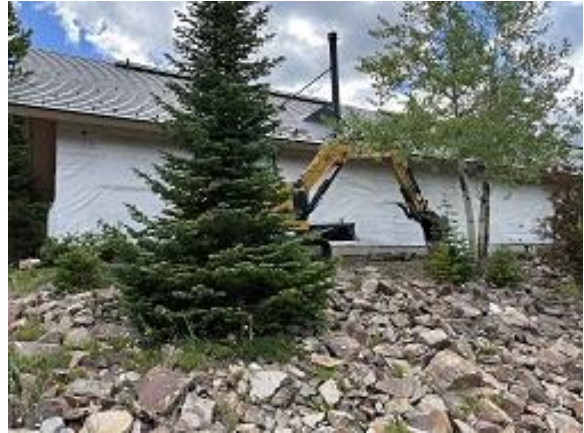
Building B Unit 3 Deck Footing Removal

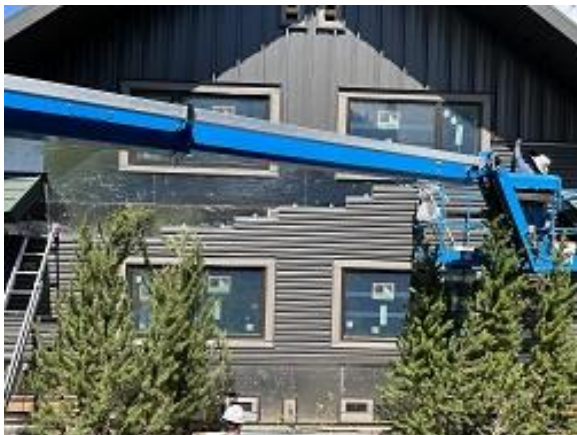
Building C2 Units 14 & 15 Back Lap Siding Installed

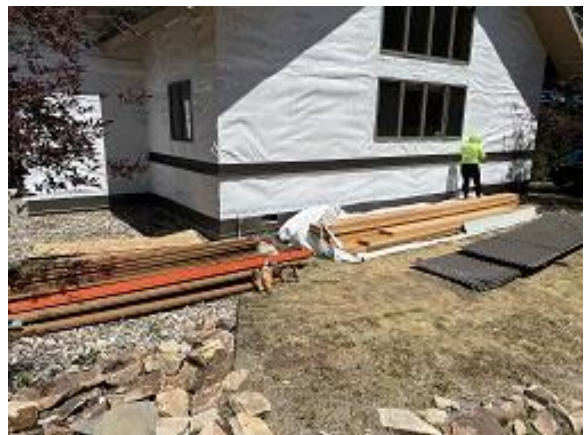
Building C3 Unit 32 Front & Side Wainscot & Base Flashing Installed

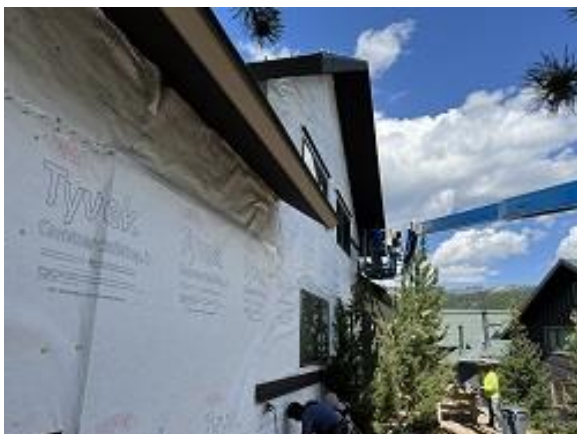
Building C3 Units 32 & 33 Back Soffit, Fascia, Wainscot & Head Flashing Installed

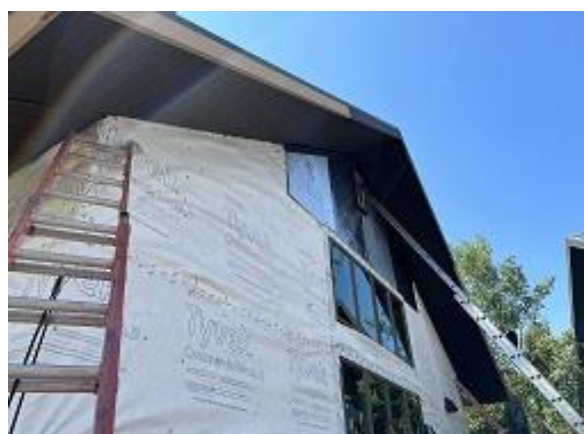
Building C3 Unit 33 Side Soffit & Fascia Installed

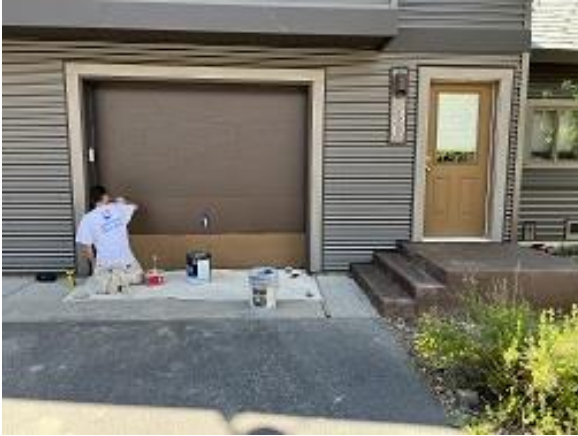
Building E4 Unit 30 Garage Door Painted

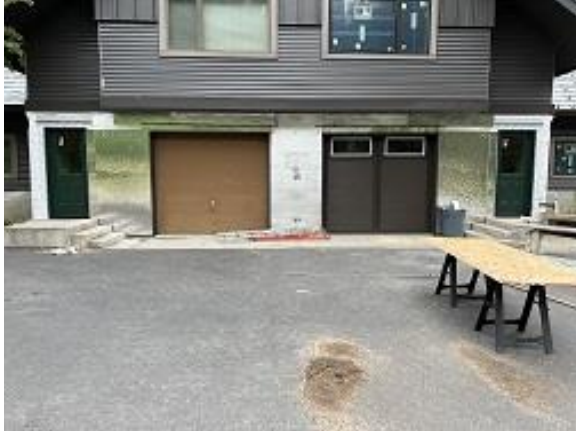
**Building C1 Units 12 & 13 Front Base
Flashing & Insulation Board Installed**

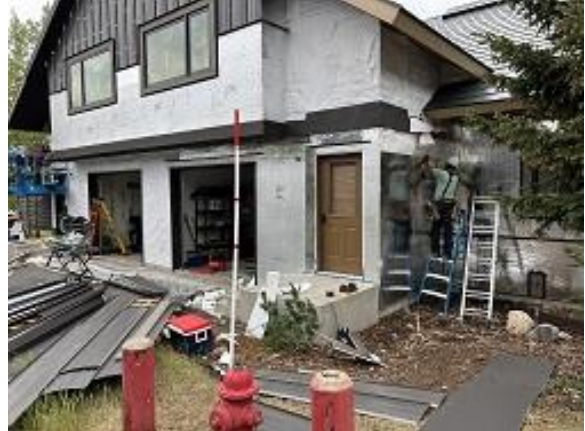
**Building C2 Units 14 & 15 Front Insulation
Board Installed**

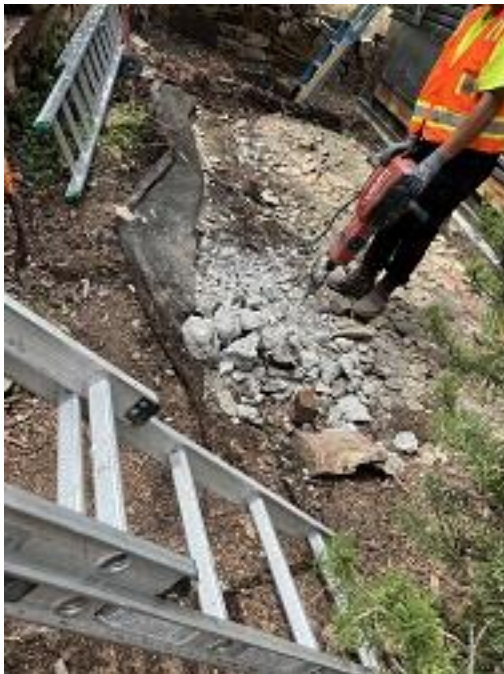
**Building C2 Unit 15 Back Deck
Footing Removed**

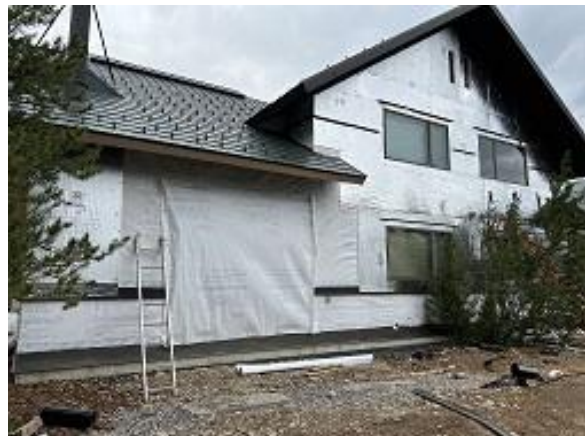
**Building C3 Units 32 & 33 Back Head &
Snap Batten Flashing and Insulation Board
Installed**

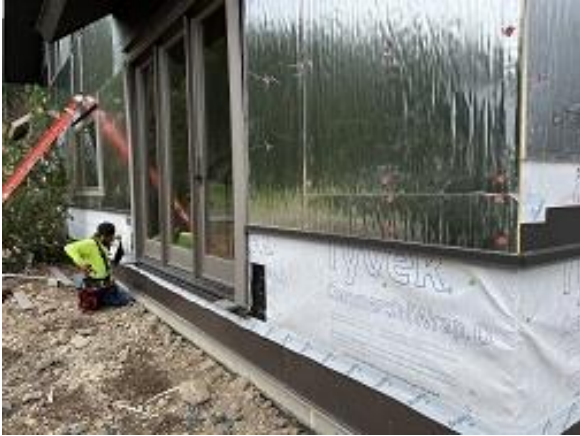
Building C3 Unit 33 Deck Door Trim Installed

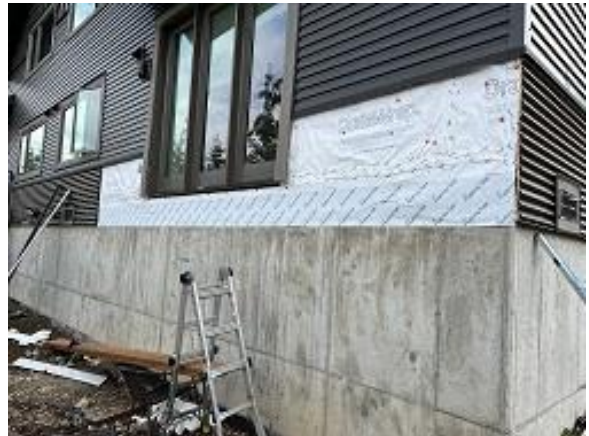
Building E7 Unit 52 Deck Ledger Tyvek and Flashing Tape Installed
