Daily Observation Report

Date of Report: Aug 8, 2022
 Prepared By: Jim Goveia

PROJECT: BIG HORN CONDO SIDING REPLACEMENT & EXTERIOR UPGRADES PHASE 2

REPORT #: P2-234

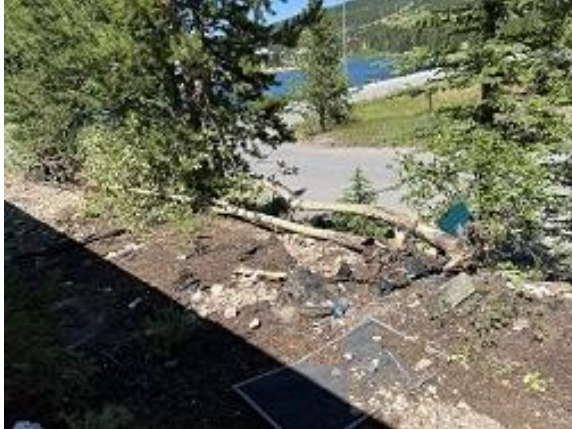
Building B Units 6 & 7 Deck Footing & Tree Removed

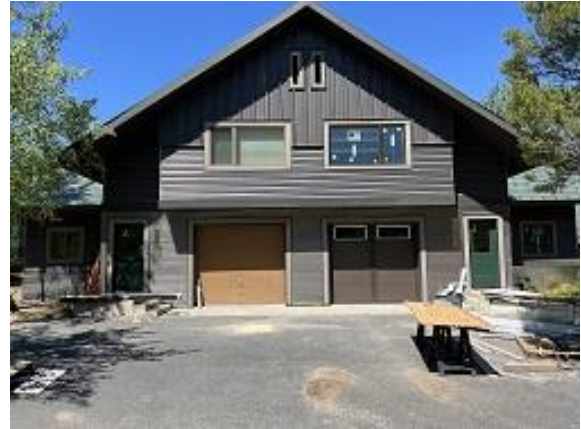
Building C1 Units 12 & 13 Front Corrugated Siding Installed

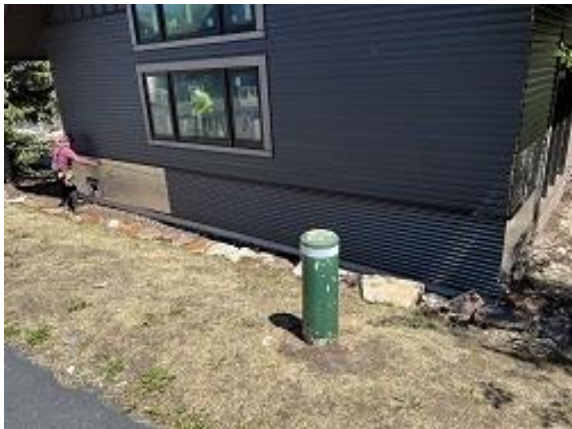
Building C2 Unit 15 Side Corrugated Siding Installed

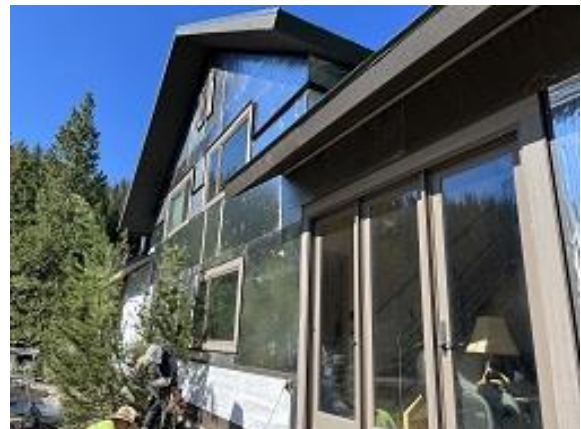
Back Window & Door Trim, Snap Batten Flashing, J Channel and Foam Board Installed

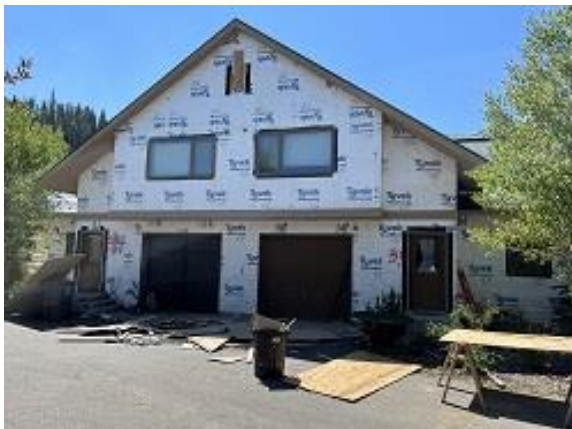
Building C4 Units 34 & 35 Front Siding Demolition Completed

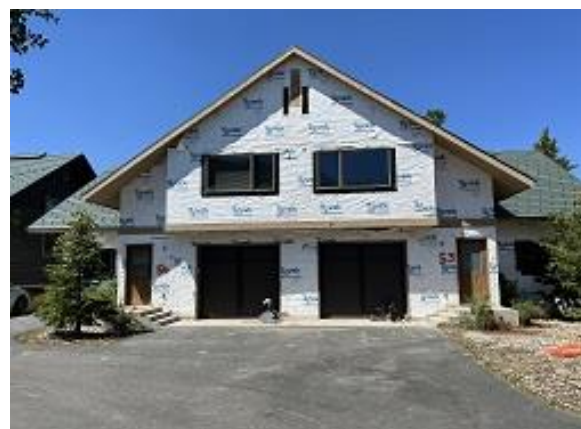
Building C6 Units 53 & 54 Front Siding Demolition Completed

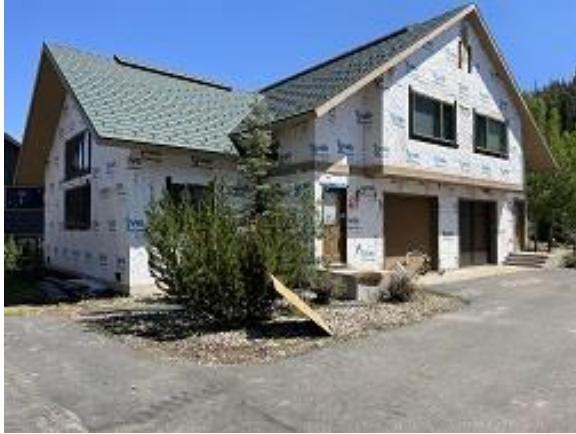
Building C10 Units 69 & 70 Front Siding Demolition Completed

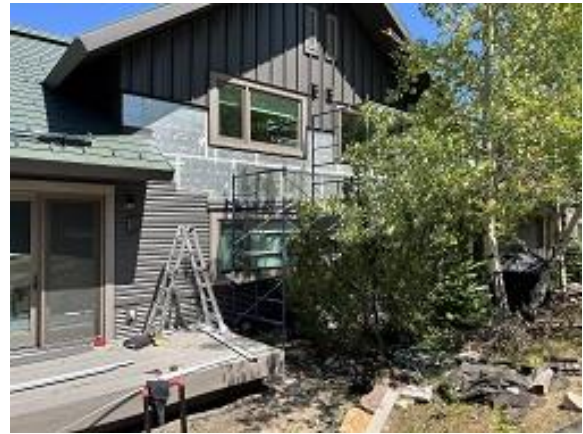
Building E1 Units 10 & 11 Back Lap Siding Repair

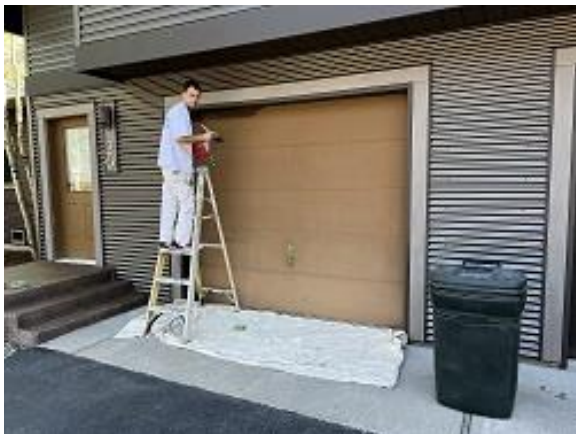
Building E3 Unit 26 Garage Door Painted

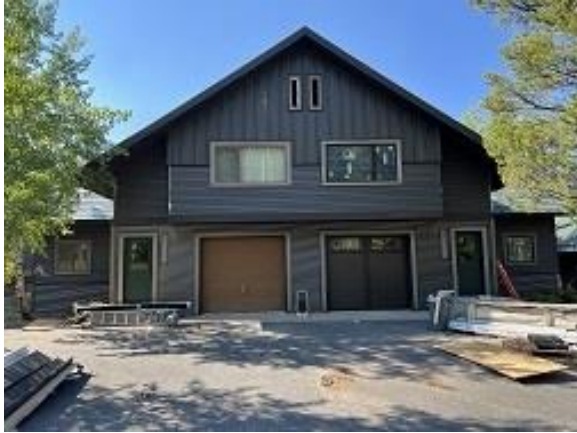
**Building C1 Units 12 & 13 Front
Corrugated Siding Installed**

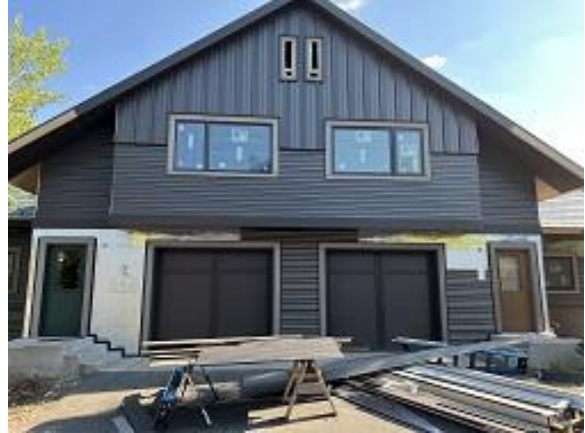
**Building C2 Units 14 & 15 Front
Corrugated Siding Installed**

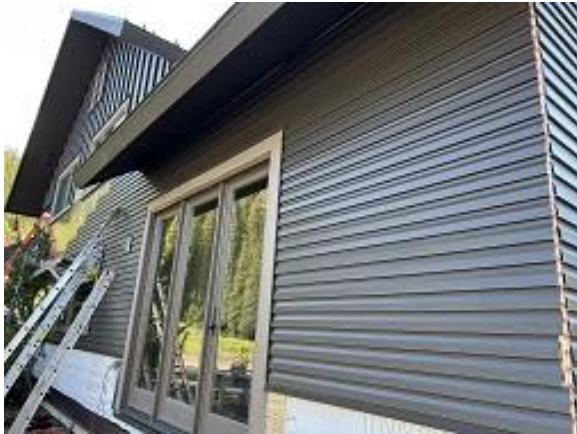
**Building C3 Unit 33 Back Lap Siding
Installed**

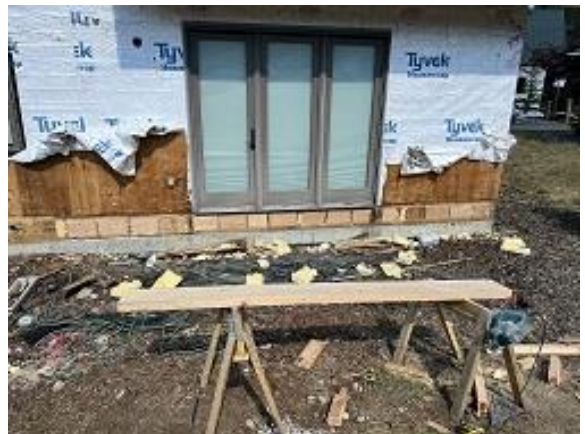
**Building C4 Unit 34 Deck Ledger Blocking
Installed**

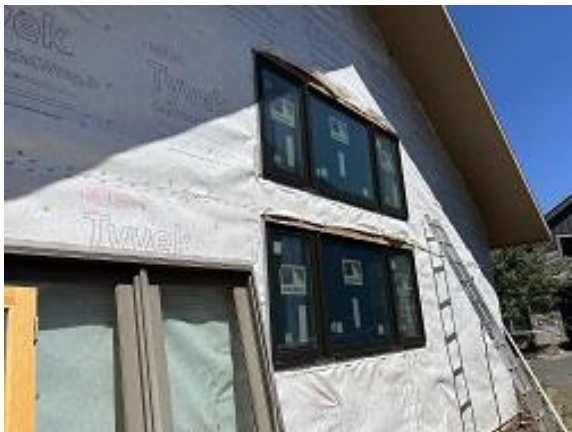
Building C7 Unit 60 Side Windows Installed

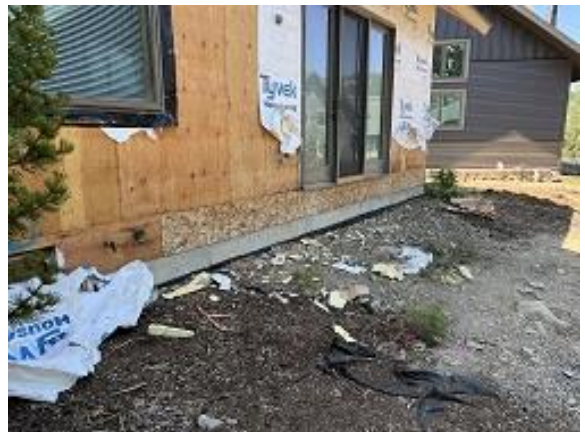
**Building C10 Unit 69 Deck Ledger
Sheathing Installed**

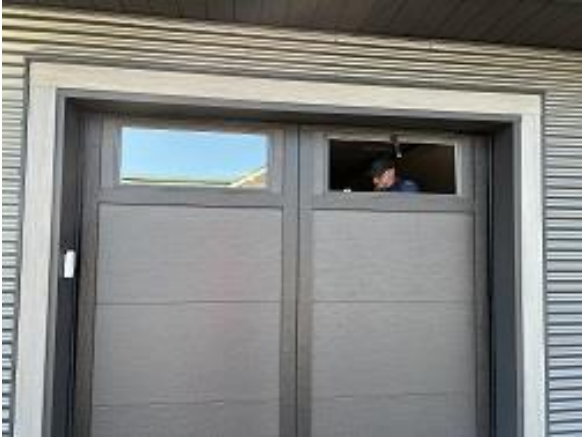
**Building E1 Unit 8 Garage Door Window
Sash Replacement**

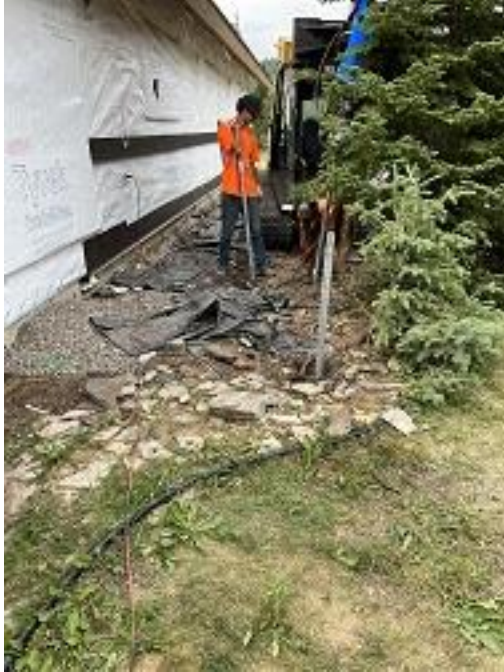
Building A Unit 1 Deck Helical Piers Installed

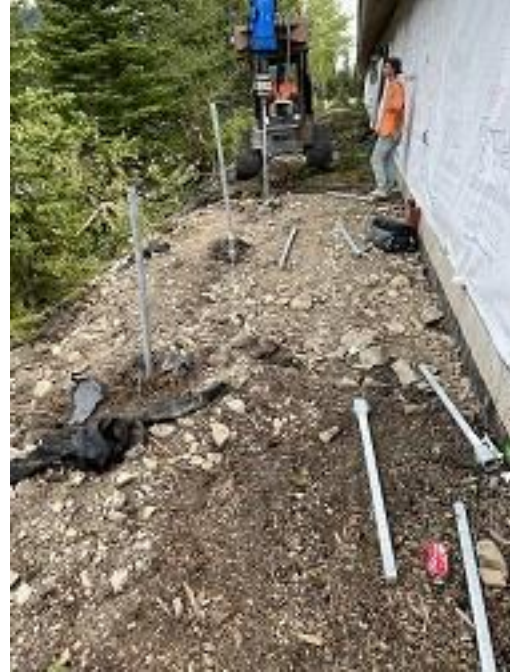
Building B Unit 7 Deck Helical Piers Installed

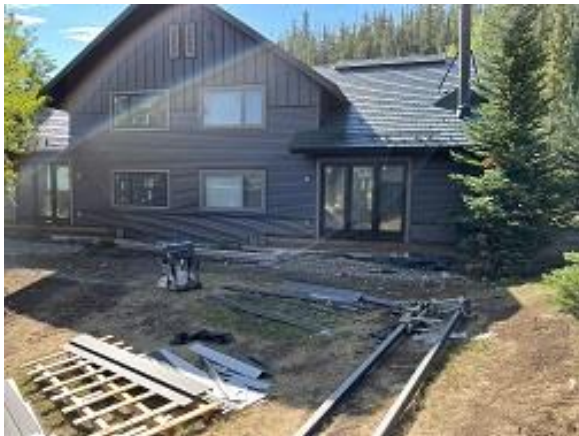
Building C1 Units 12 & 13 Back Corrugated Siding Installed

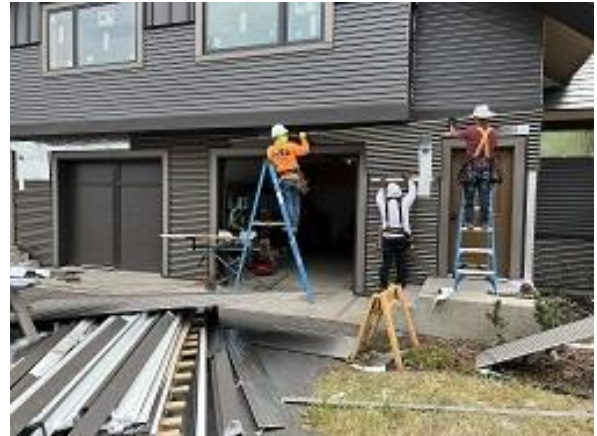
Building C2 Units 14 & 15 Front Corrugated Siding Installed

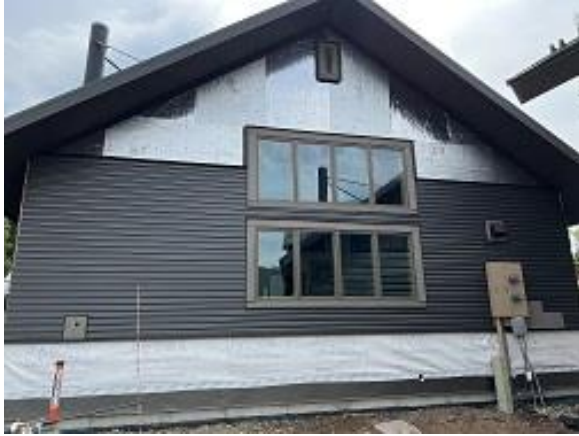
Building C3 Unit 33 Side Lap Siding Installed

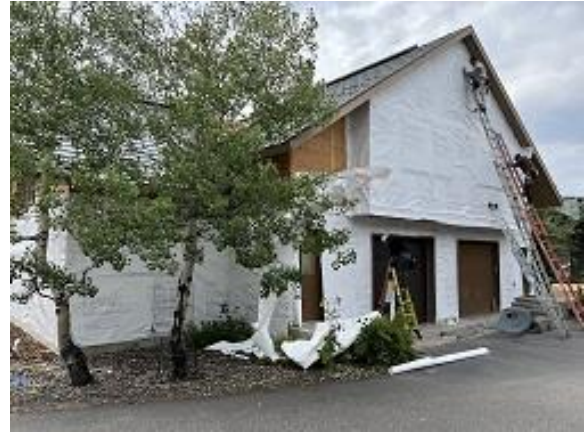
Building C4 Units 34 & 35 Front & Side Tyvek Installed

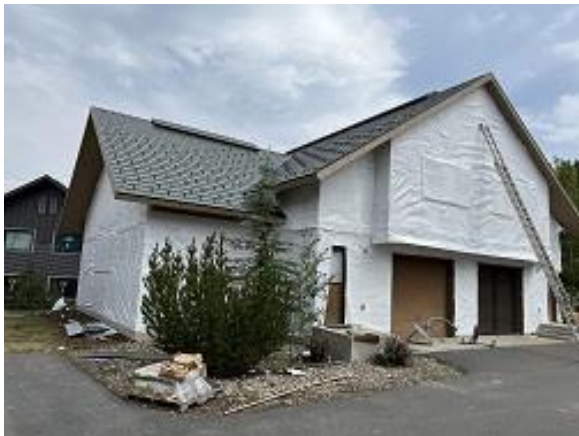
Building C10 Units 69 & 70 Front & Side Tyvek Installed

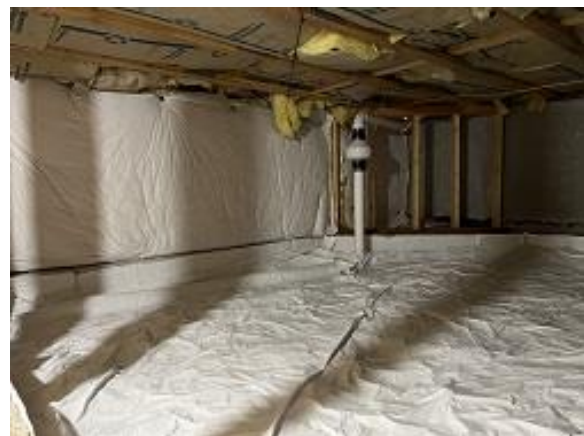
Building E4 Unit 30 Radon System Installed

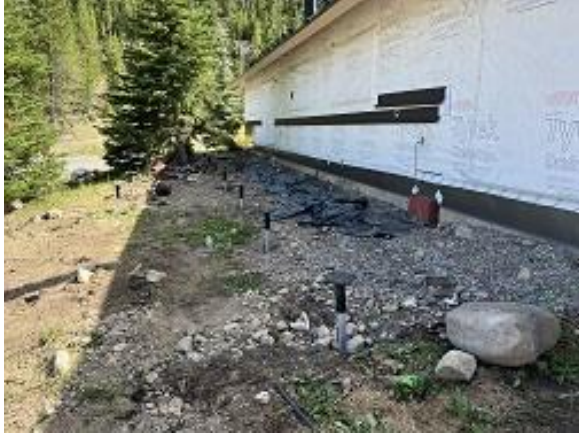
**Building A Units 1 & 2 Deck Pier Beam
Mounts Installed**

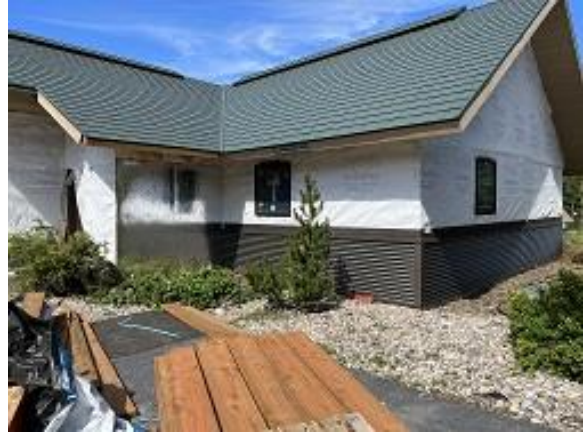
**Building A Unit 1 Front & Side Corrugated
Siding Installed**

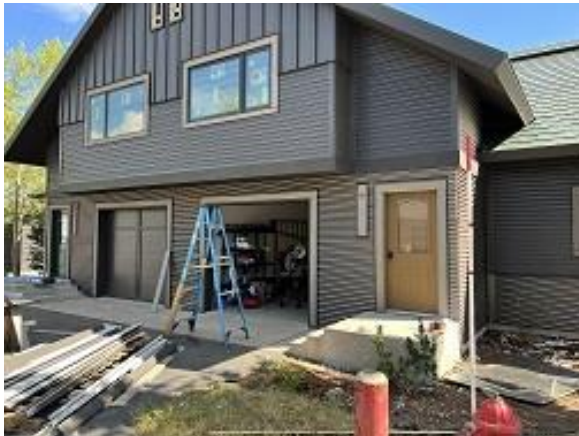
**Building C2 Units 14 & 15 Front
Corrugated Siding Installed**

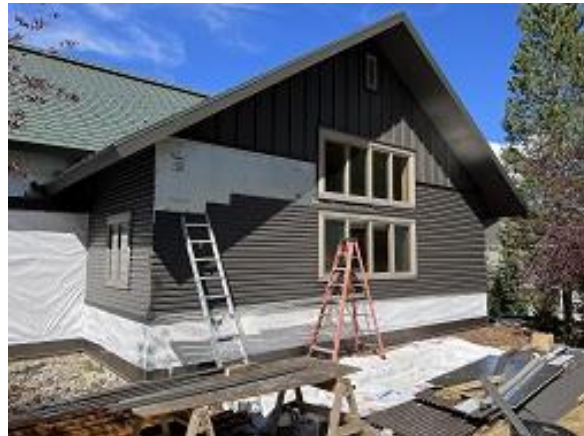
**Building C3 Units 32 Side Lap Siding
Installed**

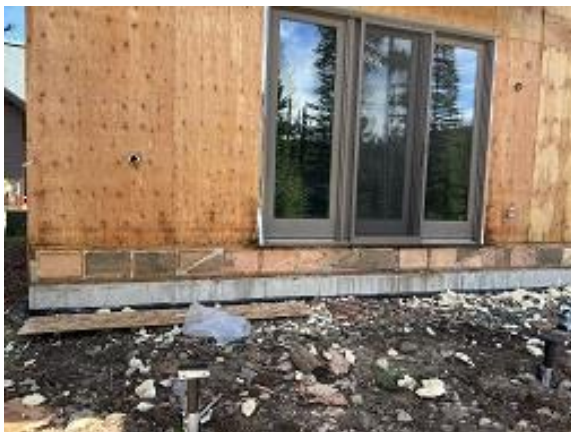
**Building C6 Unit 53 Deck Ledger
Sheathing Removed & Blocking Installed**

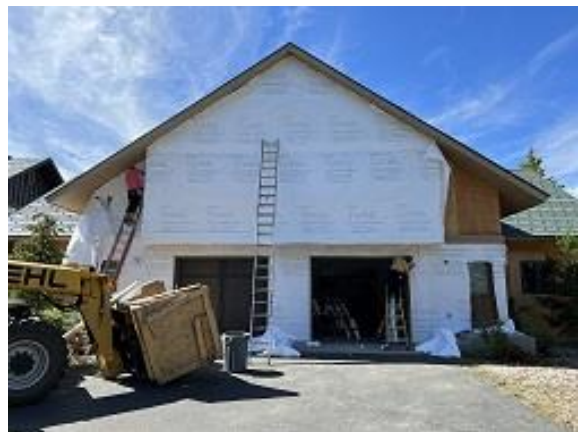
**Building C6 Units 53 & 54 Front Tyvek
Installed**

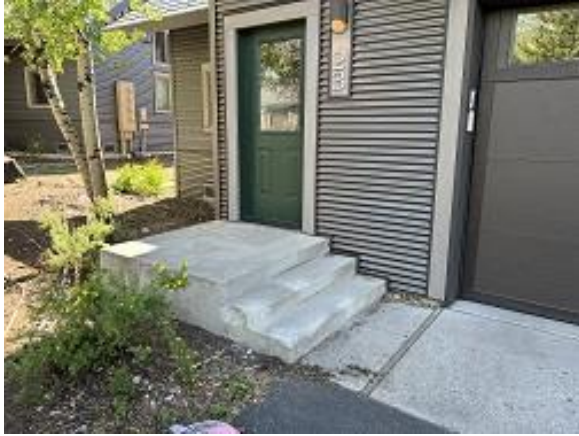
Building E2 Unit 23 Stoop Patched

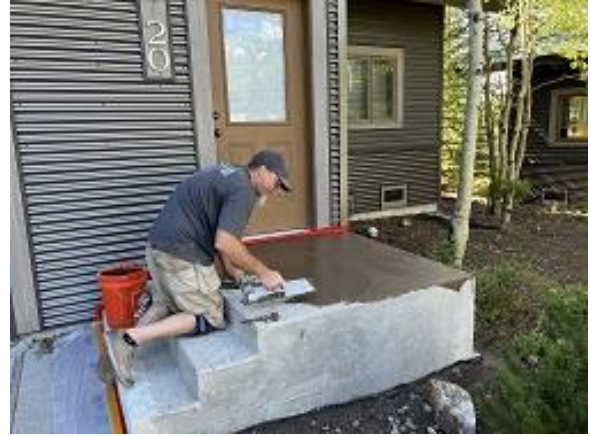
Building E2 Unit 20 Stoop Color Coat

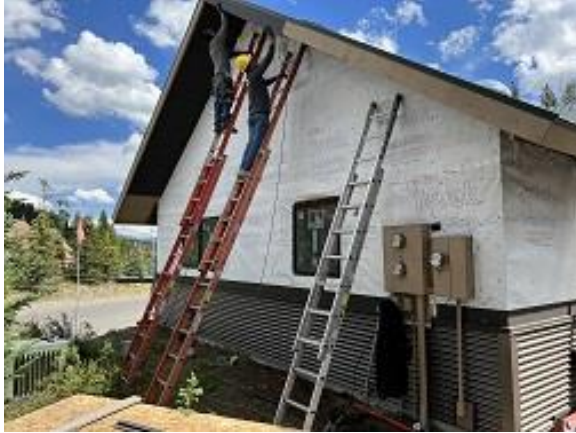
Building A Unit 2 Side Soffit & Fascia Installed

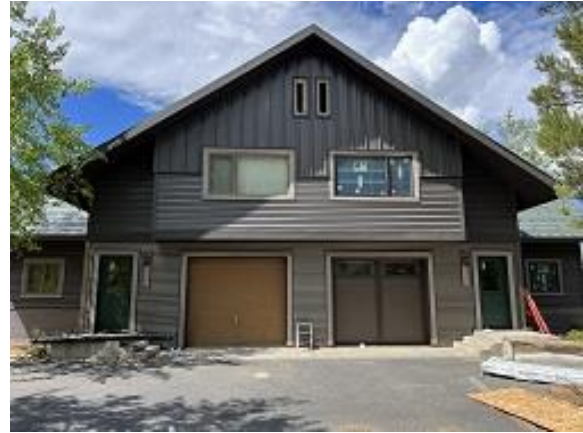
Building C1 Units 12 & 13 Front Corners Installed

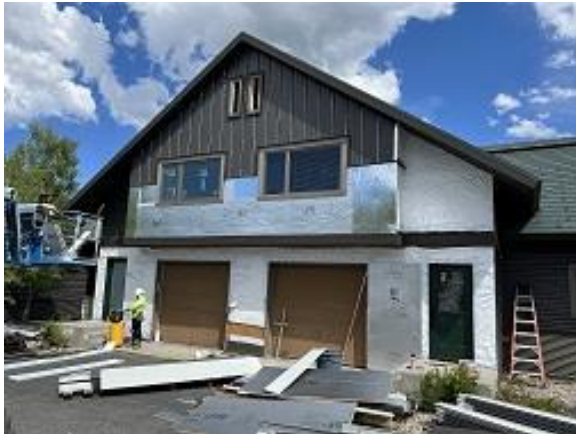
Building C3 Units 32 & 33 Front Snap Batten Siding Installed

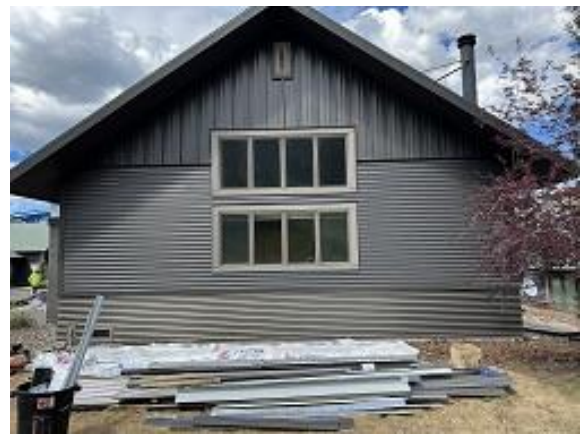
Building C3 Unit 32 Side Corrugated Siding Installed

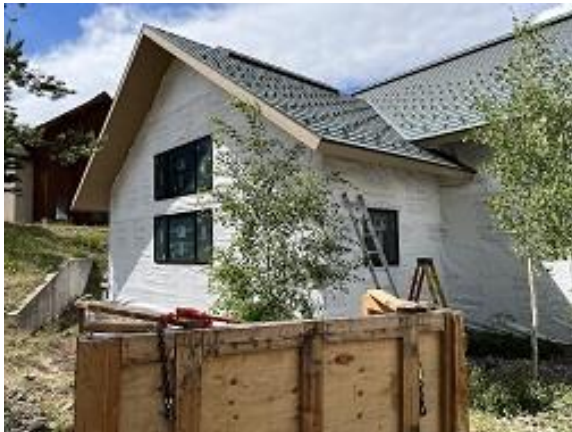
Building C9 Unit 68 Side & Kitchen Windows Installed

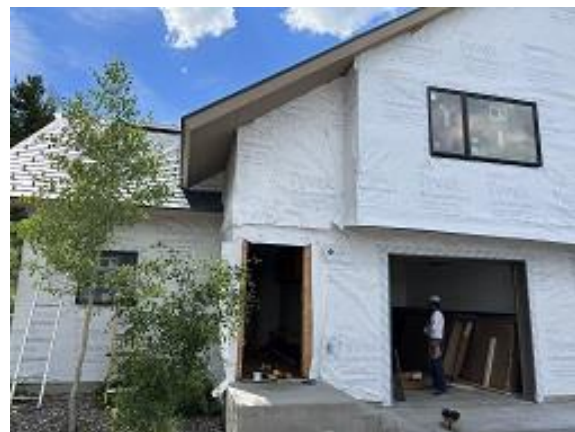
Building C9 Unit 68 Front Upper & Kitchen Windows Installed

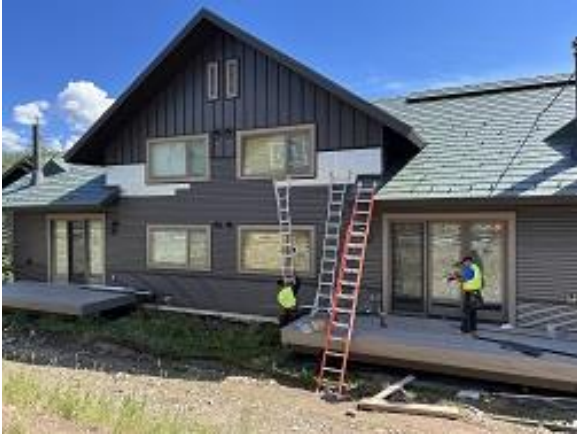
**Building E2 Units 21 & 23 Back Lap
Siding Repair**

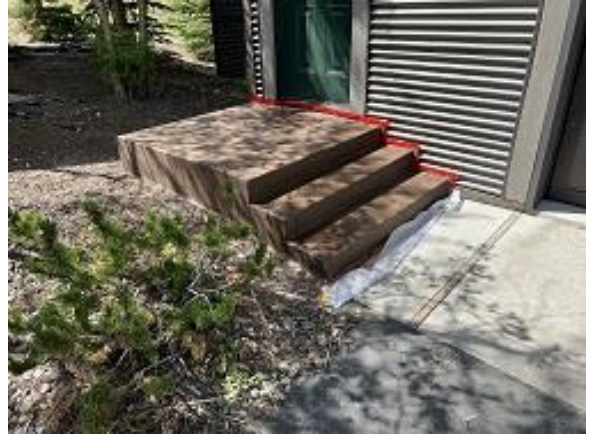
**Building F2 Unit 19 Stoop Refinishing
Began**
