Daily Observation Report

Date of Report: Aug 15, 2022
 Prepared By: Jim Goveia

PROJECT: BIG HORN CONDO SIDING REPLACEMENT & EXTERIOR UPGRADES PHASE 2

REPORT #: P2-239

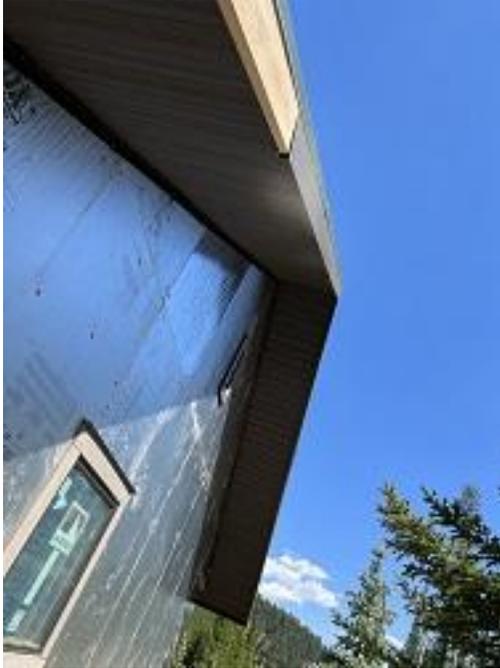
Building A Unit 1 Side Soffit, Fascia and Insulation Installed

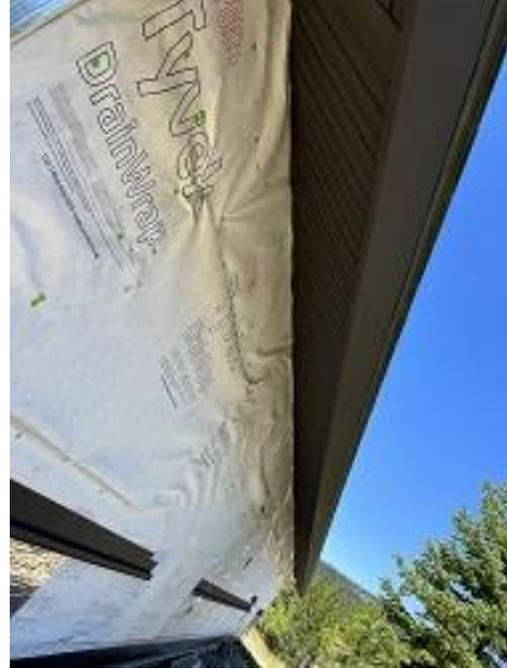
Building A Units 1 & 2 Back Soffit and Fascia Installed

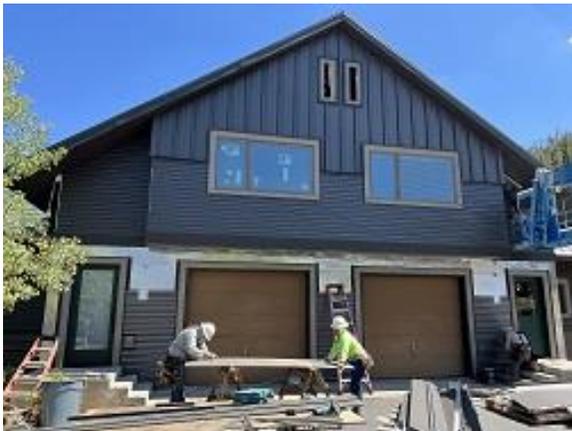
Building C3 Units 32 & 33 Front Lap & Corrugated Siding Installed

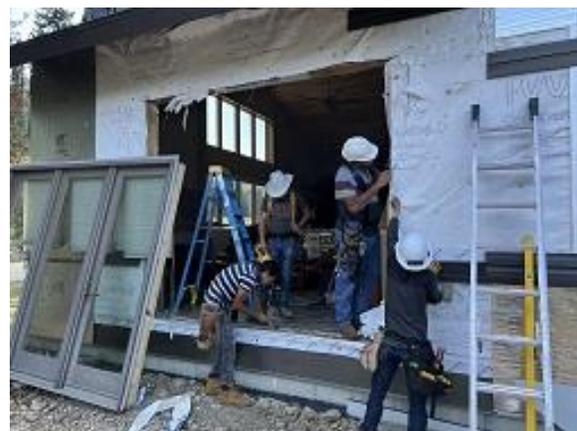
Building C3 Unit 32 Deck Door Remove, Flashed and Replaced

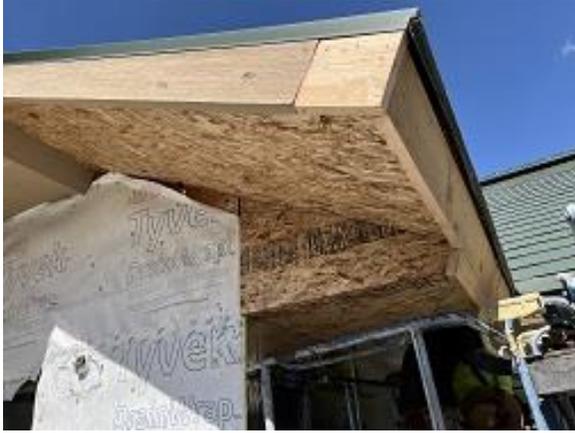
**Building A Unit 1 Front Rafter Repair
Fascia Installed**

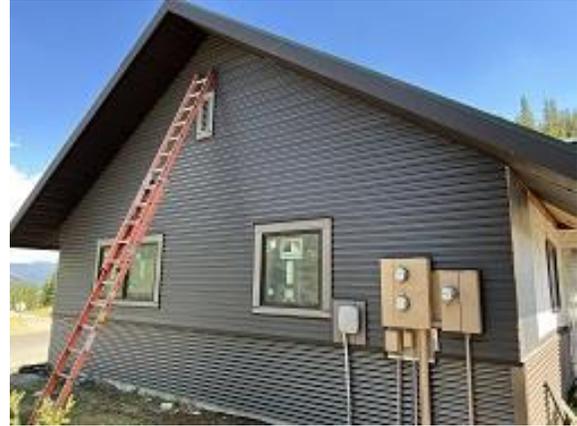
Building A Unit 2 Side Lap Siding Installed

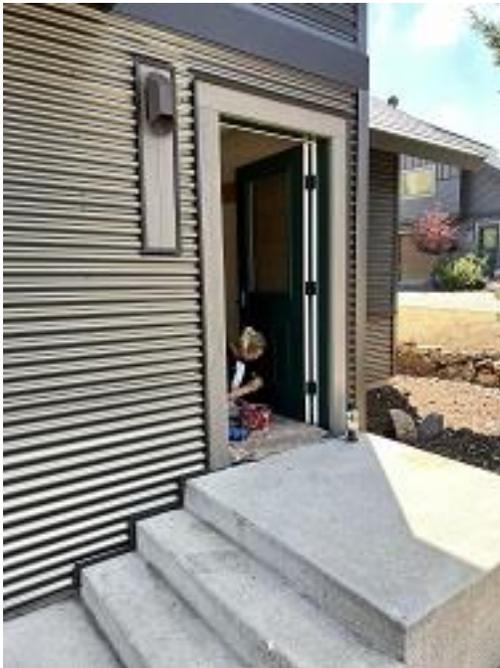
Building C2 Unit 15 Front Door Painted

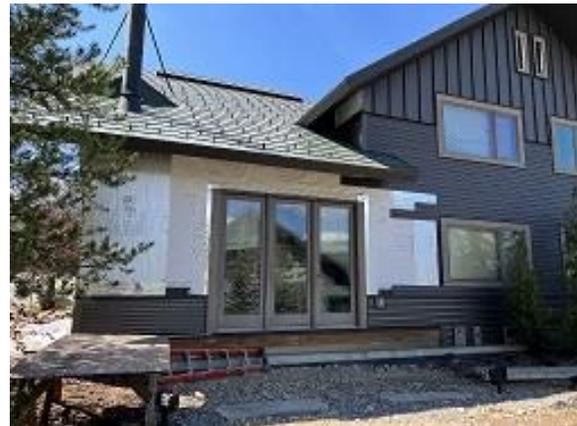
**Building C3 Unit 32 Back Lap Siding
Installation Continued**

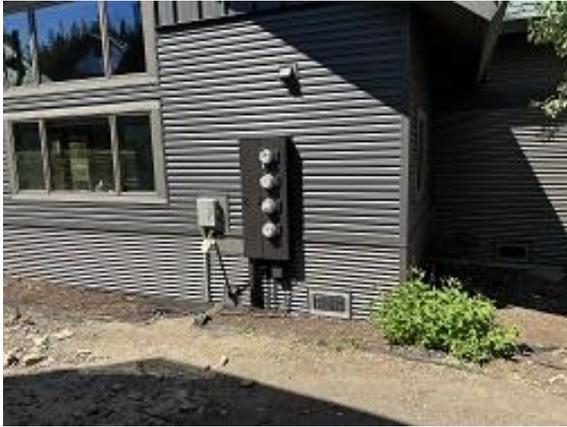
**Building E2 Unit 23 Side
Electrical Box Painted**

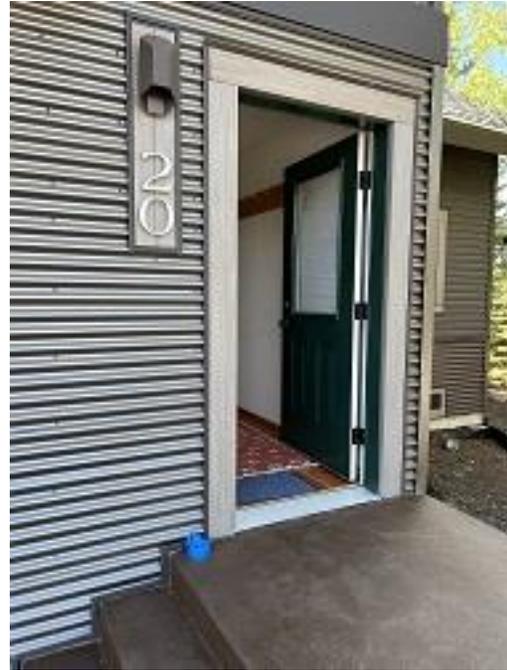
Building E2 Unit 20 Front Door Painted

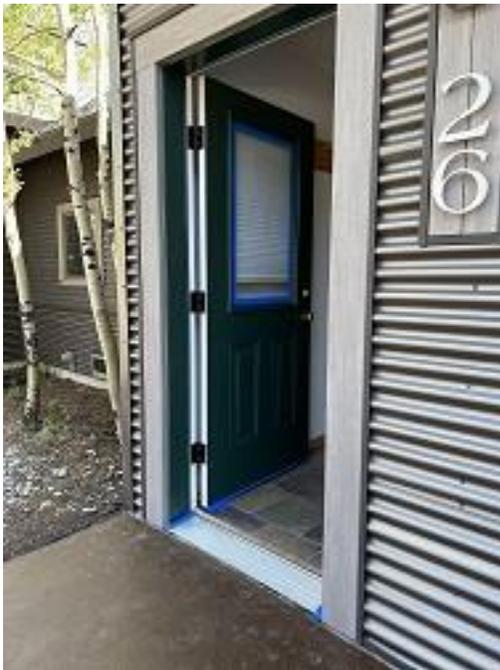
Building E3 Unit 26 Front Door Painted

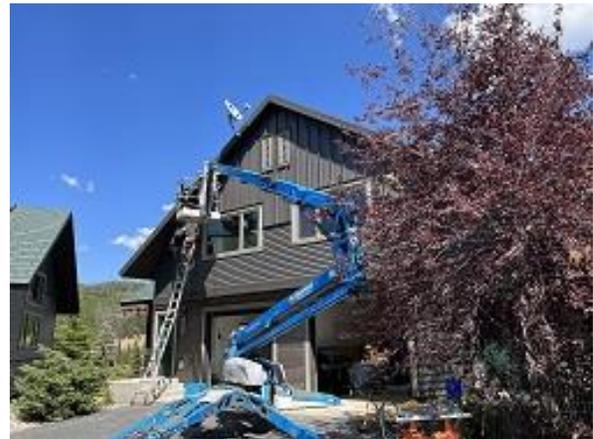
Building E5 Unit 44 Satellite Dish Installed

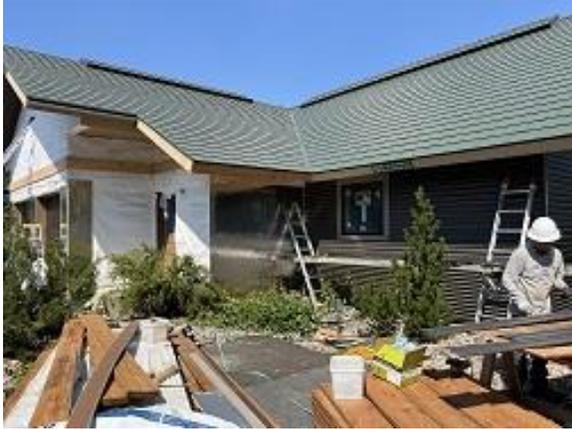
Building A Unit 1 Front Lap Siding Installed

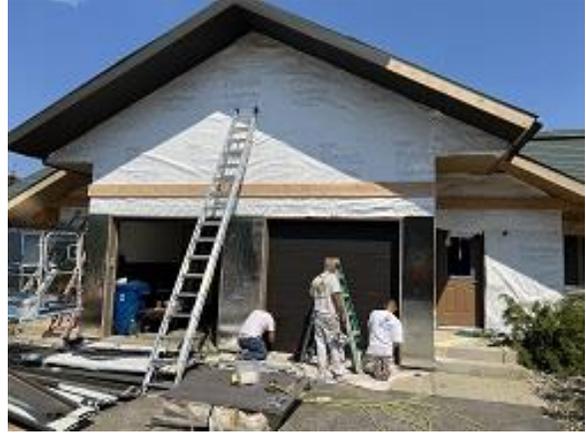
Building A Unit 1 Belly Band Installed & Garage Door Painted

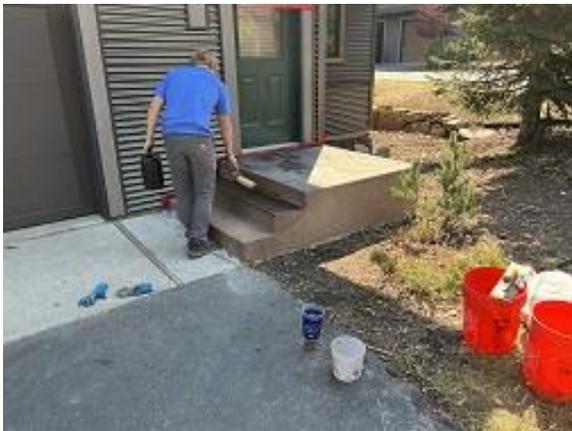
Building C2 Unit 15 Stoop Refinishing

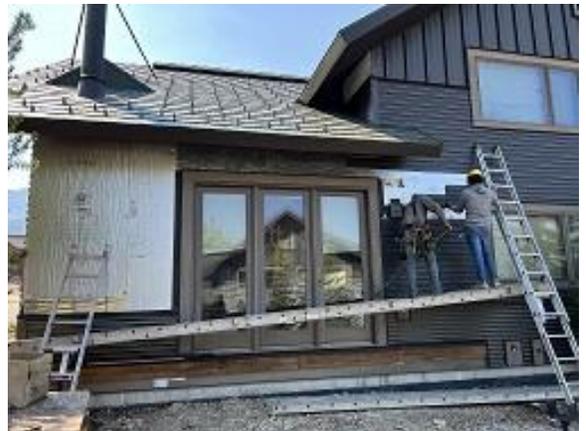
Building C3 Unit 32 Back Lap Siding Installed

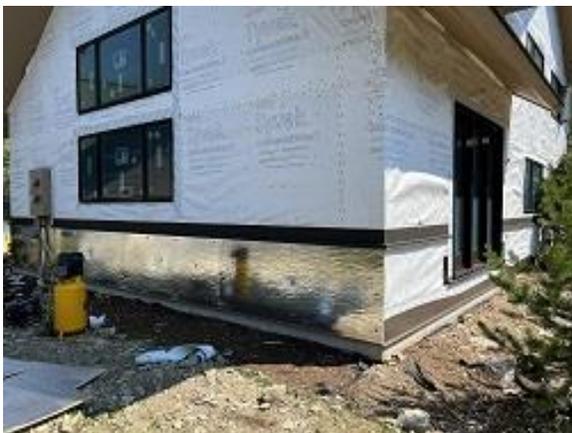
Building C7 Unit 59 Back & Side Base & Wainscot Flashing Installed

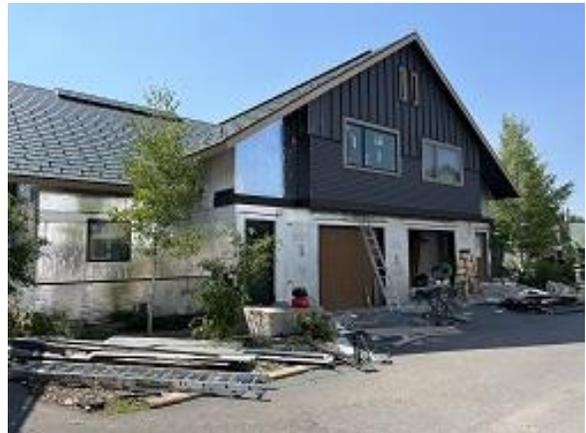
Building C9 Units 67 & 68 Front Lap Siding Installed

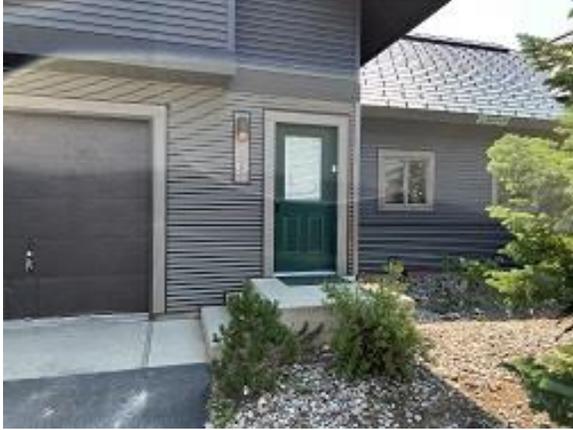
Building E1 Unit 9 Front Door Painted

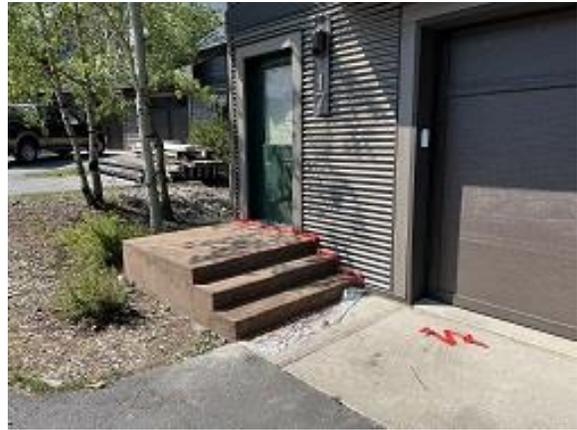
Building F1 Unit 17 Stoop Refinishing

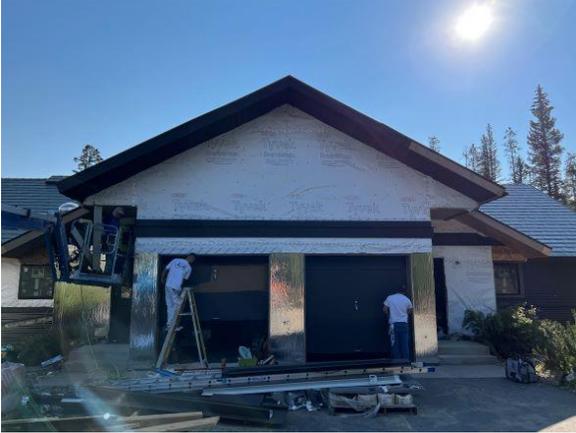
Building A Unit 1 & 2 Garage Doors Painted and Belly Band Flashing Installed

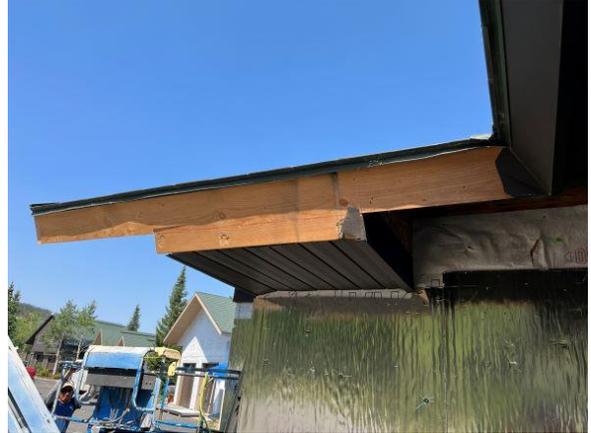
Building A Unit 1 Front Fascia & Soffit Installed

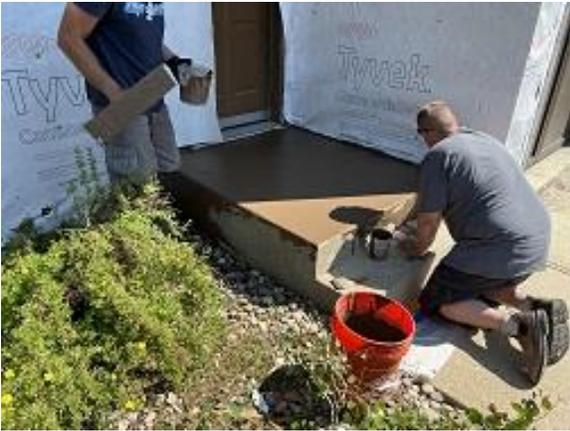
Building B Unit 4 Stoop Refinishing

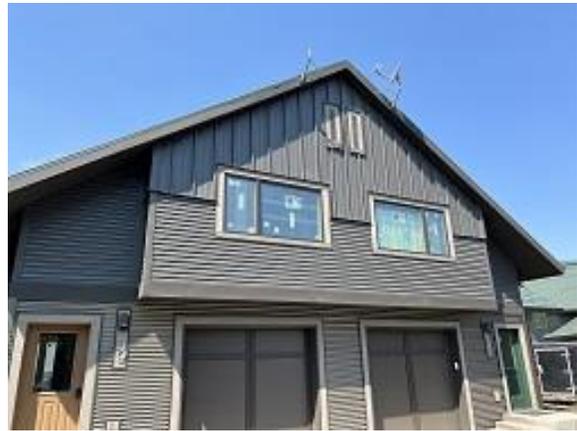
Building C5 Units 39 & 40 Satellite Dish Installed

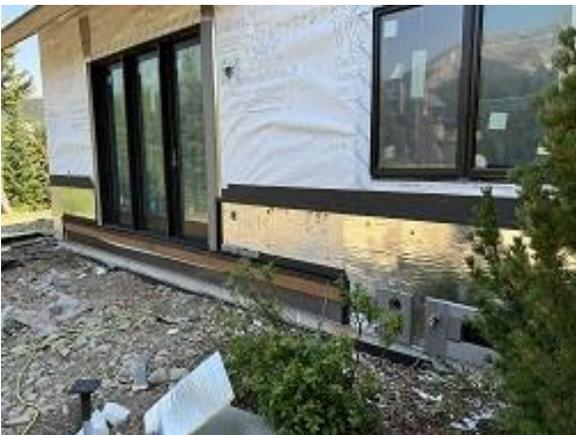
Building C7 Unit 59 Deck Ledger Installed

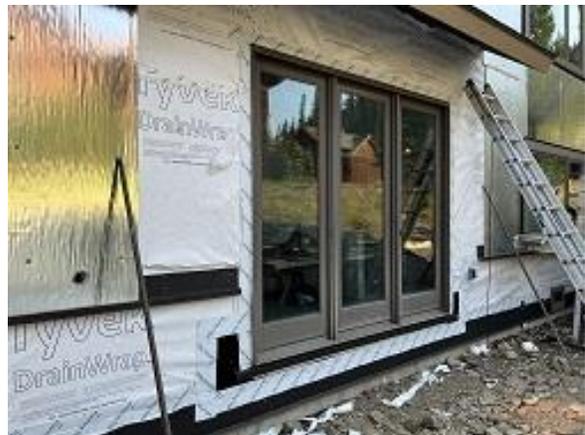
Building C9 Unit 67 Deck Door Reinstalled

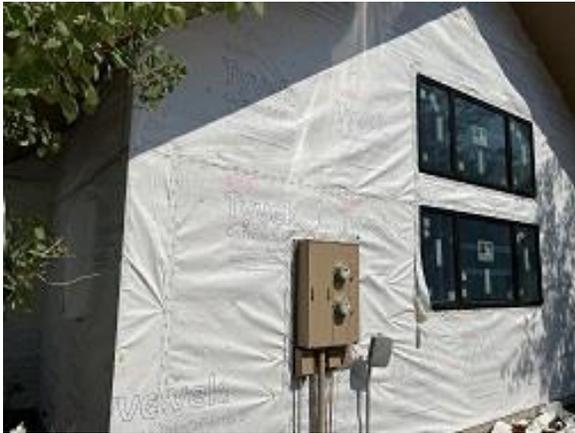
Building C10 Unit 70 Side Windows Installed

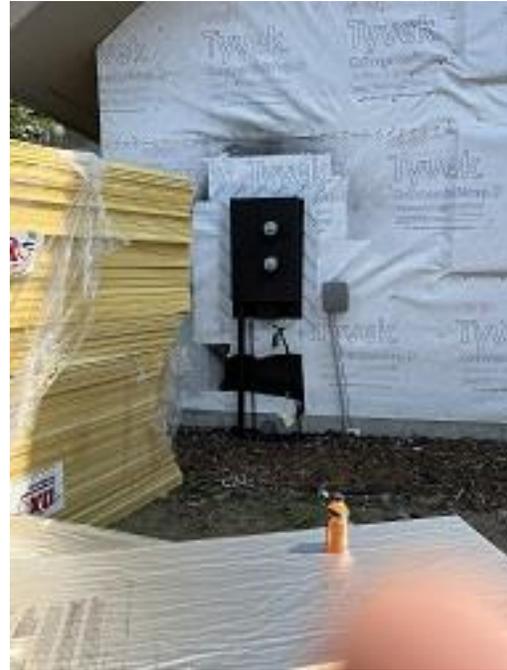
Building C4 Electric Panel Painted

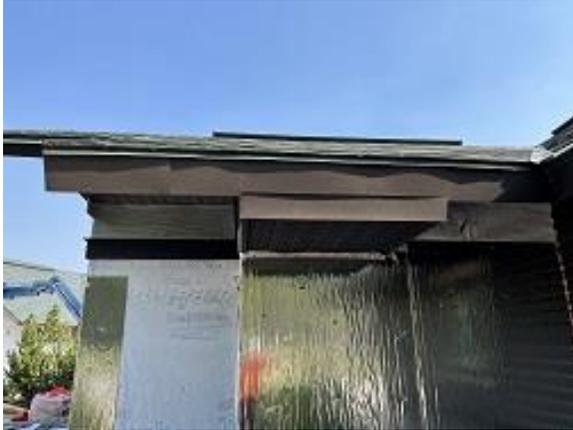
Observations – 1) A: Units 1 & 2 Front fascia, soffit & snap batten siding installed. Observed two piece soffit used instead of one piece as planned. Electrical panel painted. **2)** B: Units 3 - 7 stoops refinished, rafter repair cross ties & soffit installed. **3)** C3: Units 32 & 33 garage doors & electrical panel painted. **4)** C7: Units 59 & 60 soffit installed. **5)** C9: Units 67 & 68 front & side corrugated siding installed. Deck ledger, flashing and insulation board installed. **6)** D: Electrical panels painted.

Building A Unit 1 Fascia & Soffit Installed

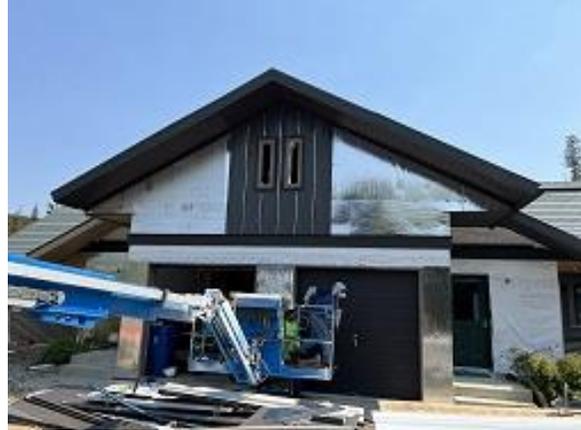
Building A Units 1 & 2 Front Snap Batten Siding Installed

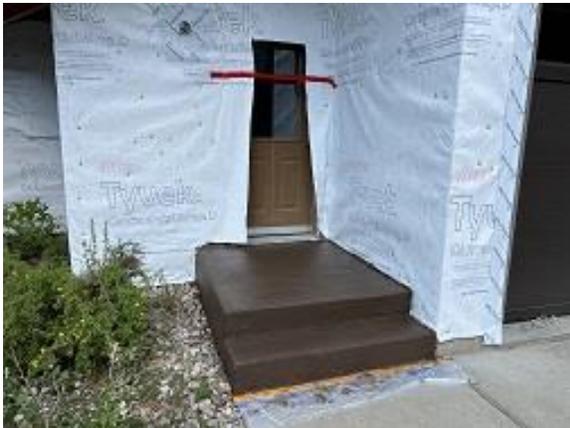
Building B Unit 4 Stoop Refinished

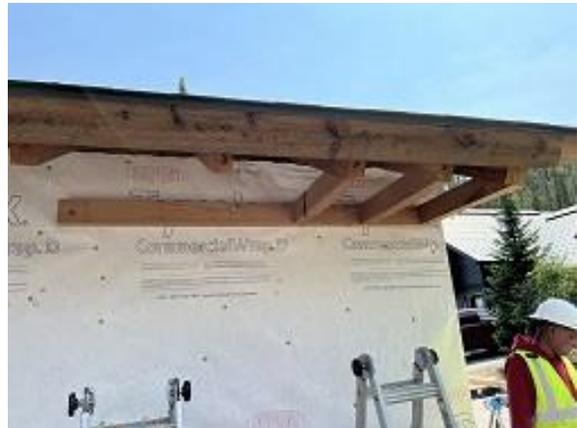
Building B Unit 5 Rafter Repair Soffit Cross Ties Installed

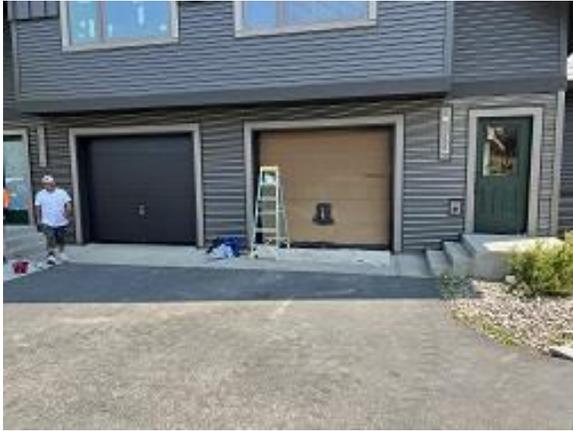
Building C3 Units 32 & 33 Garage Doors Painted

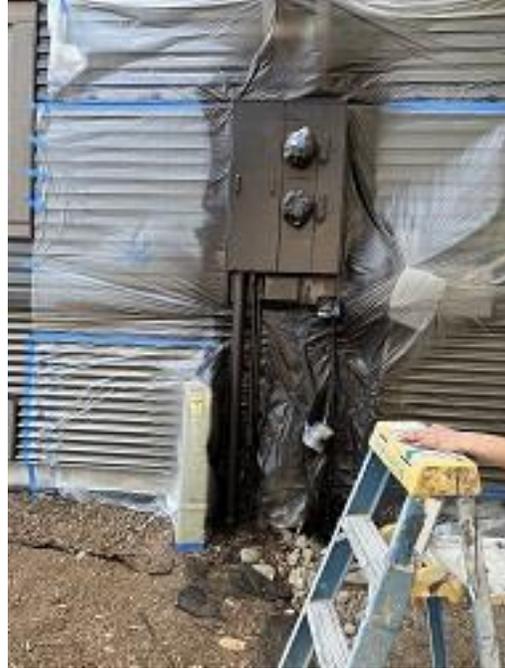
Building C3 Electric Panel Painted

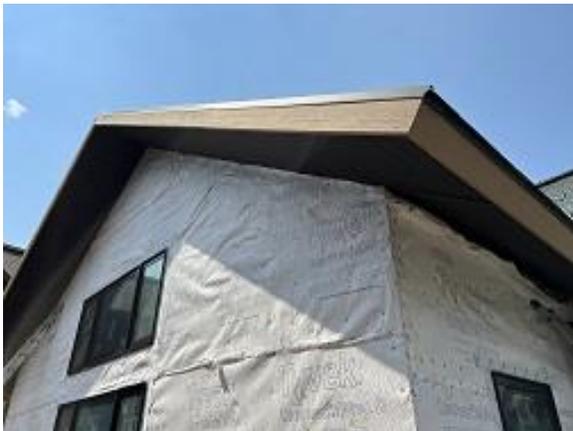
Building C7 Unit 60 Front & Side Soffit Installed

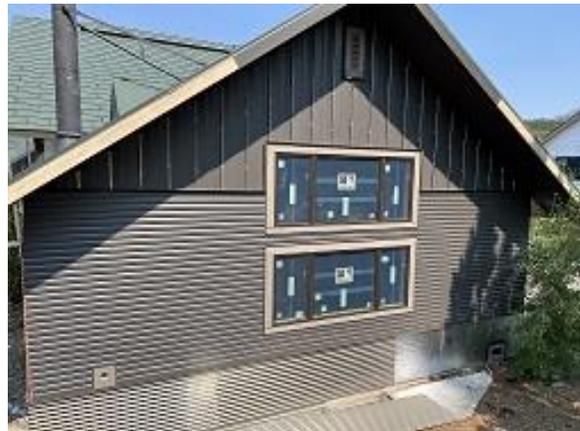
Building C9 Unit 68 Side Lap Siding Installed

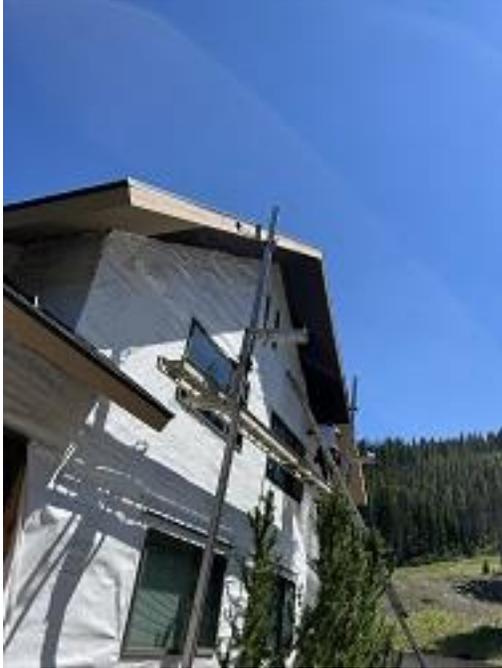
Building E9 Units 67 & 68 Soffit Installed

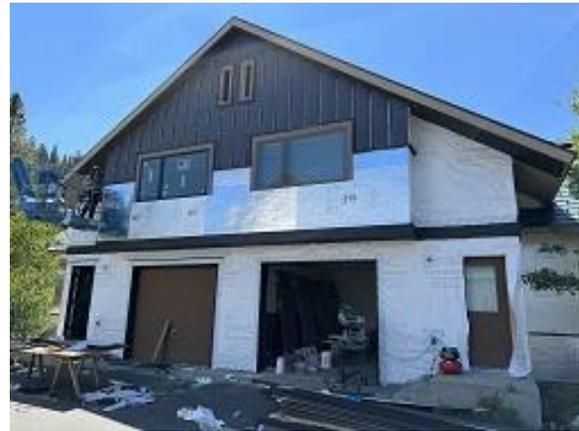
Building E9 Units 67 & 68 Front Foam Board Insulation and Snap Batten Siding Installed

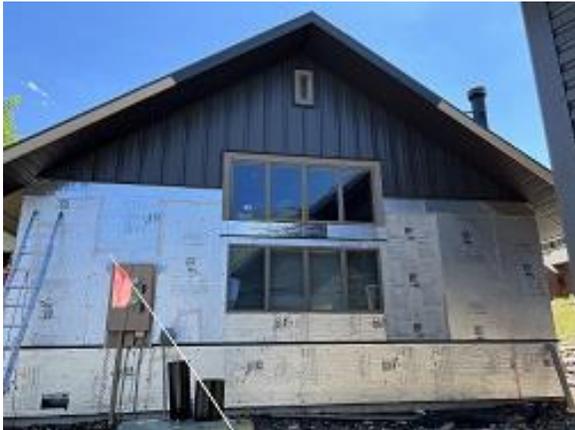
Building E9 Units 67 Side Foam Board Insulation and Snap Batten Siding Installed

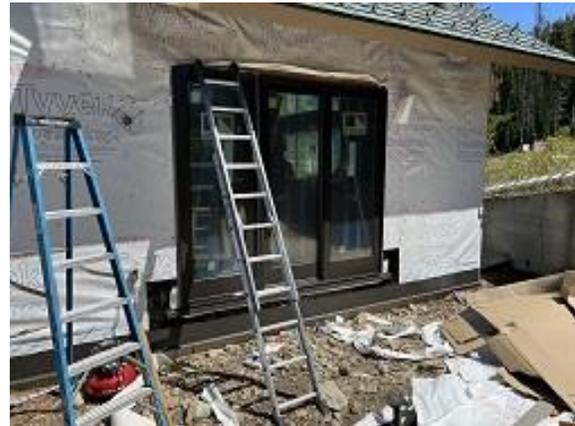
Building E9 Unit 68 Deck Door Installed
