## Daily Observation Report

Date of Report: Aug 22, 2022  
 Prepared By: Jim Goveia

**PROJECT:** BIG HORN CONDO SIDING REPLACEMENT & EXTERIOR UPGRADES PHASE 2

**REPORT #:** P2-244

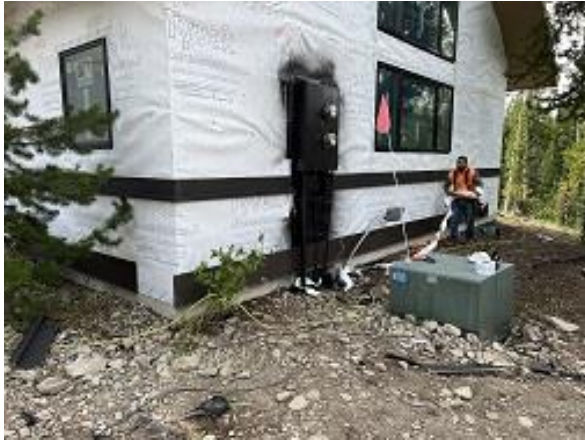
**Building C6 Unit 53 Front & Side Base & Wainscot Flashing Installed**

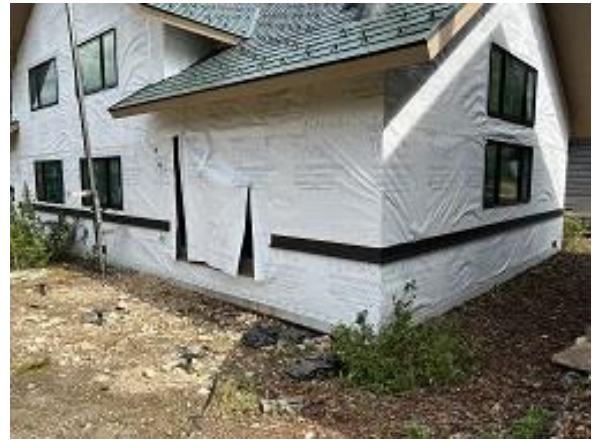
**Building C6 Unit 54 Back & Side Base & Wainscot Flashing Installed**

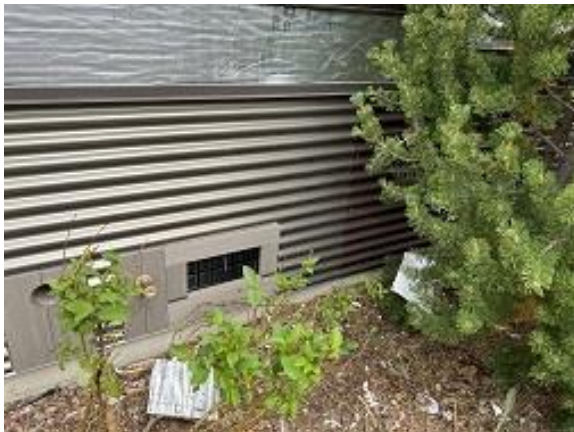
**Observations – 1)** C6: Units 53 & 54 Base, wainscot & insulation board installed. **2)** C7: Units 59 & 60 corrugated siding installed. Observed two colors of corrugated siding was installed. Determination will be made to correct with original color or match with new color siding. **3)** C9: Units 67 & 68 corrugated & lap siding installation continued.

**Building C7 Unit 59 Back Corrugated Siding Mismatched Color Installed**

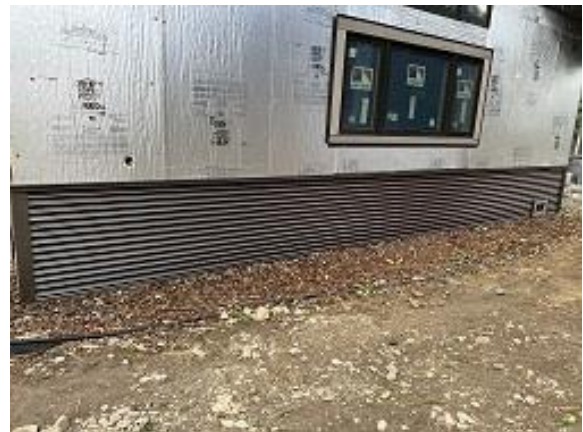
**Building C7 Unit 60 Side Corrugated Siding Installed**

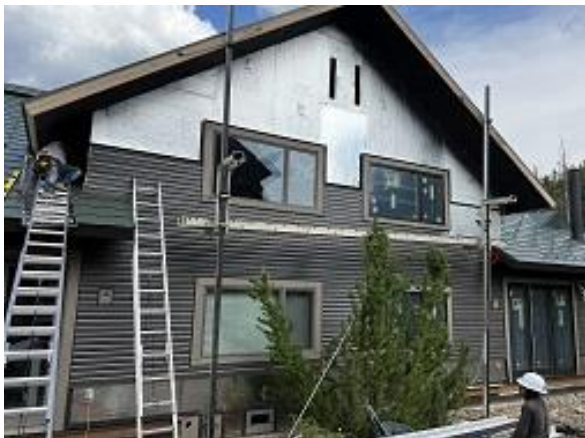
**Building C9 Units 67 & 68 Back Lap Siding Installed**

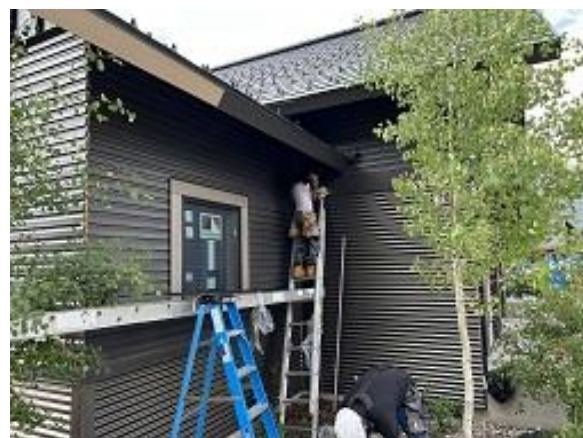
**Building C9 Unit 68 Front Lap Siding Installed**

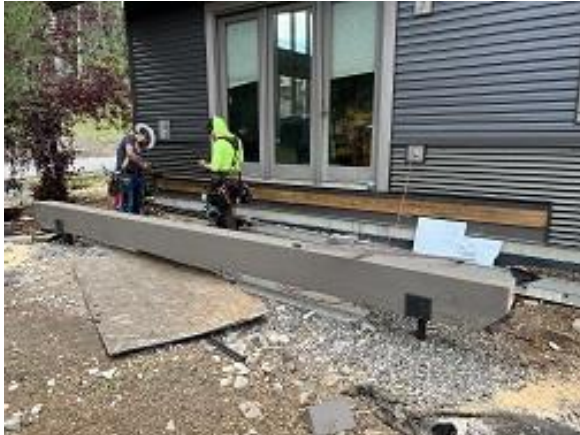
**Building C3 Unit 32 Deck Beam Installed**

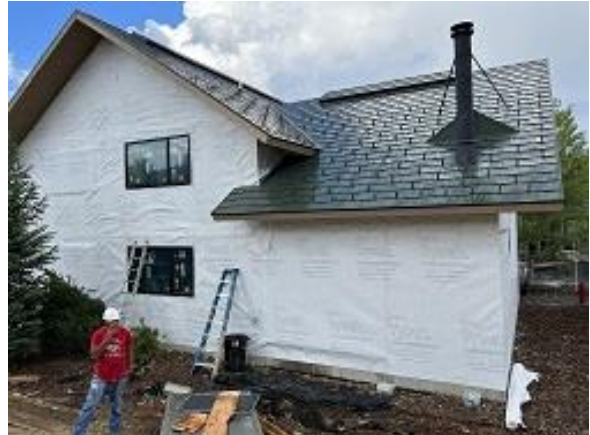
**Observations – 1)** C3: Unit 32 Deck framing began. **2)** C4: Unit 34 Window installation began. Observed damage back lower window at header. Replaced sheathing and top 2x6 of window opening. **3)** C6: Units 53 & 54 insulation board installation continued. Front door trim installed. **4)** C7: Units 59 & 60 front & side snap batten siding installed. **5)** C9: Units 67 & 68 back lap siding installed.

**Building C4 Unit 34 Back Windows Installed**

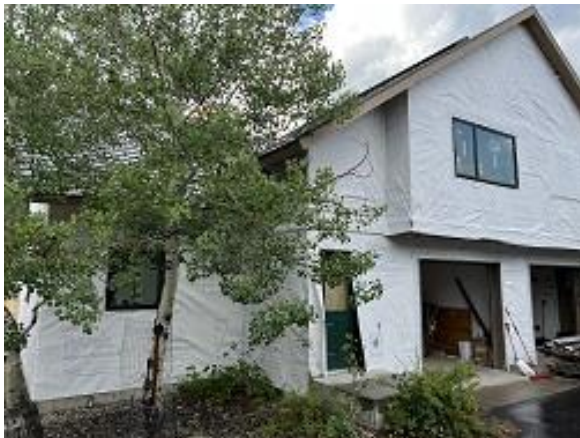
**Building C4 Unit 34 Front Windows Installed**

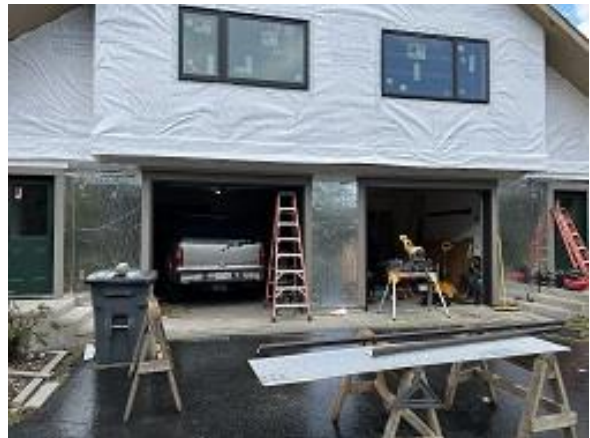
**Building C6 Units 53 & 54 Front Insulation Board & Door Trim Installed**

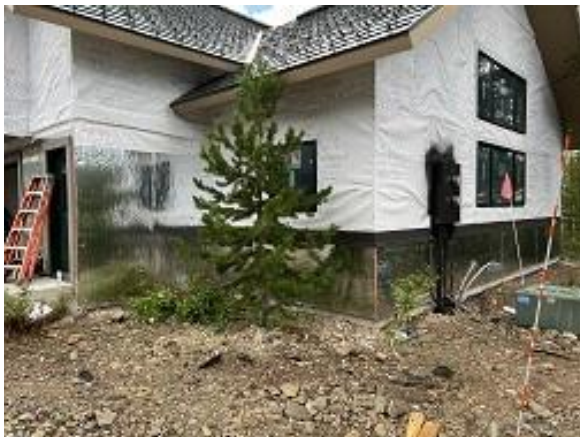
**Building C6 Unit 53 Front & Side Insulation Board Installed**

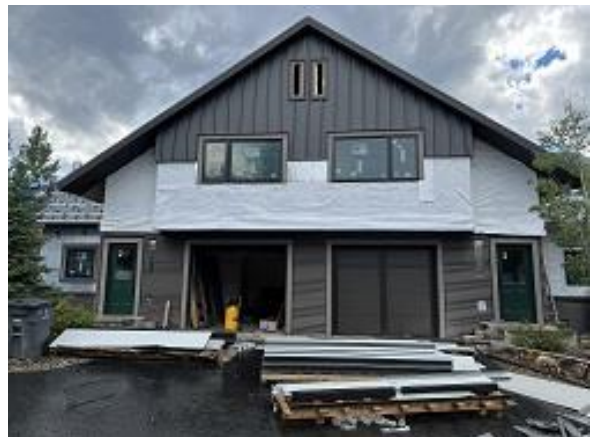
**Building C7 Unit 59 & 60 Front Snap Batten Siding Installed**

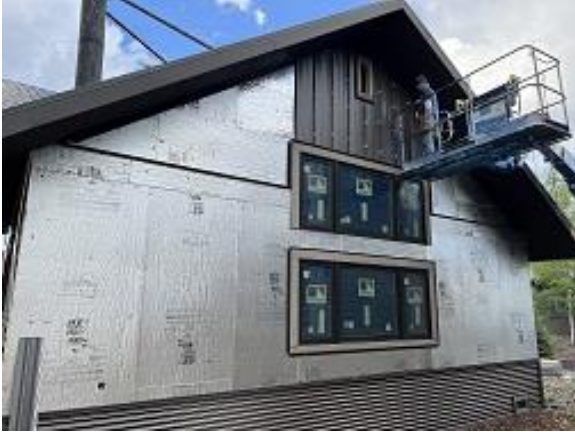
**Building C7 Unit 60 Side Snap Batten Siding Installed**

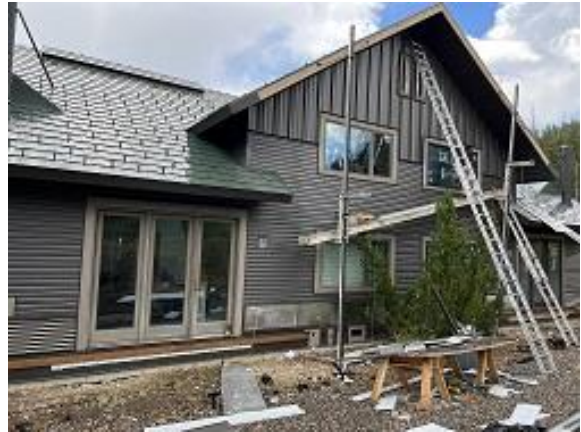
**Building C9 Units 67 & 68 Back Lap Siding Installed**

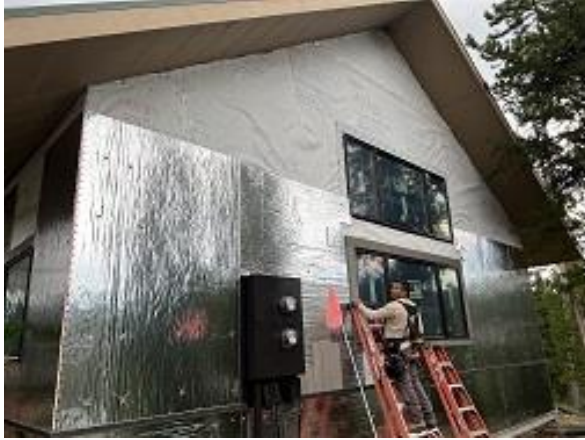
**Building C6 Unit 53 Side Insulation Board & Window Trim Installed**

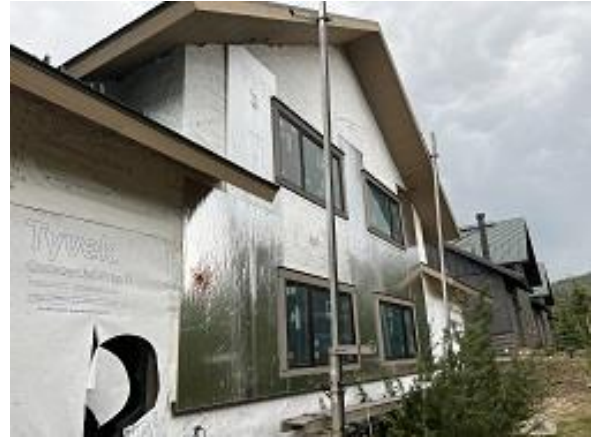
**Building C6 Units 53 & 54 Back Insulation Board & Window Trim Installed**

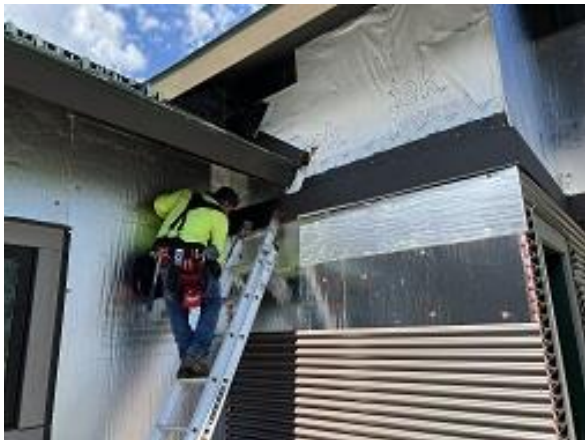
**Building C7 Unit 60 Front Diverter Installed**

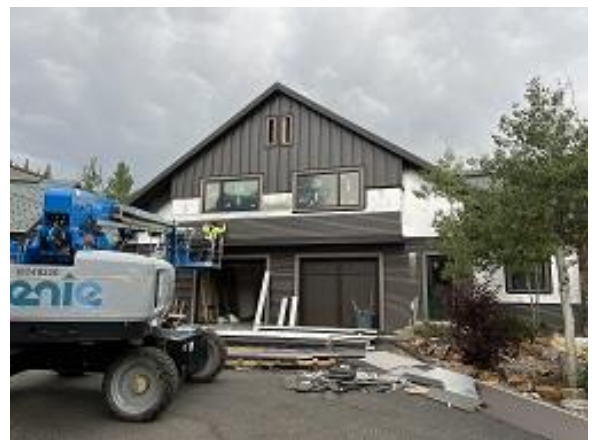
**Building C7 Units 59 & 60 Front Lap Siding Installed**

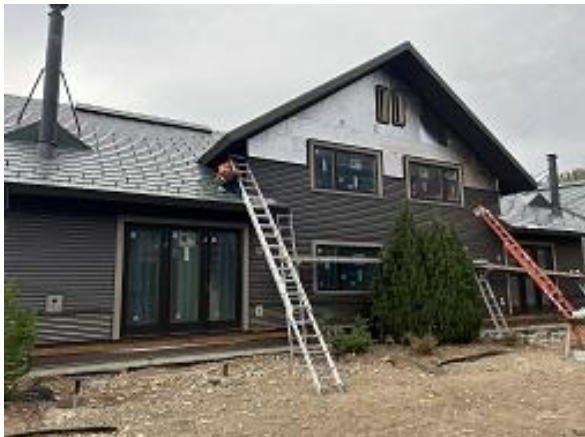
**Building C7 Units 59 & 60 Back Lap Siding Installed**

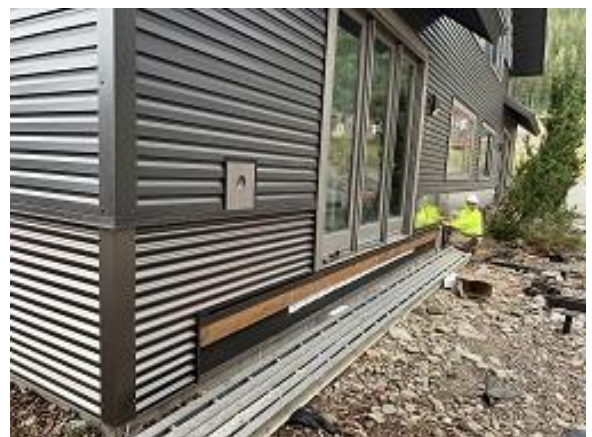
**Building C9 Units 67 & 68 Back Corrugated Siding Installed**

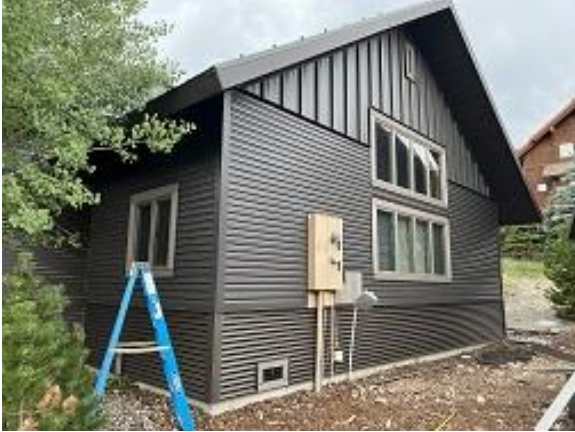
**Building C9 Unit 67 Side Corrugated Siding Installed**

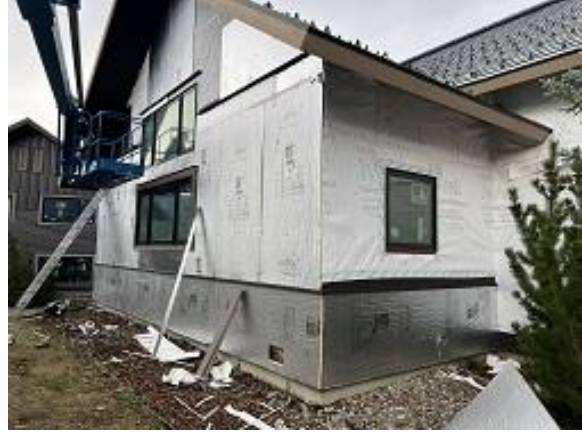
**Building C10 Unit 69 Side Base & Wainscot Flashing and Insulation Board Installed**

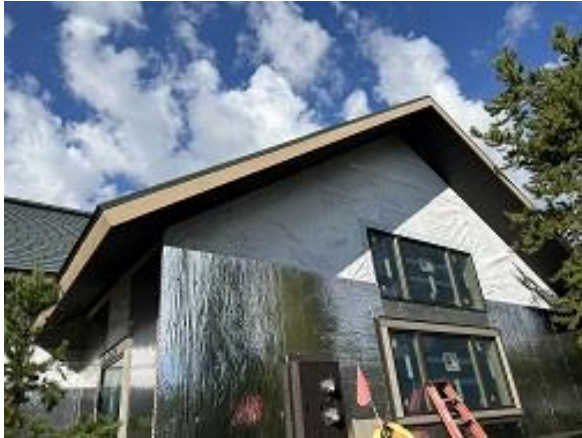
**Building C6 Unit 53 Front & Back Soffit Installed**

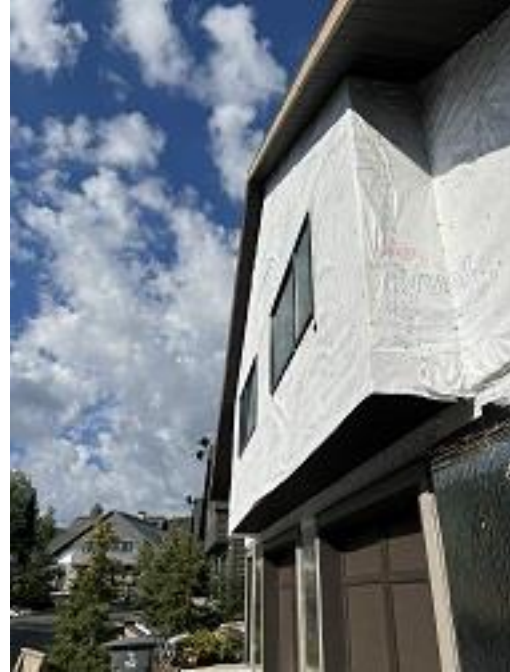
**Building C6 Units 53 & 54 Front Soffit Installed**

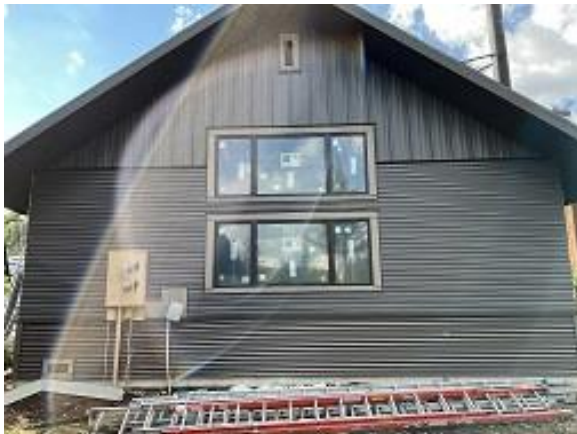
**Building C7 Unit 59 Side Lap Siding Installed**

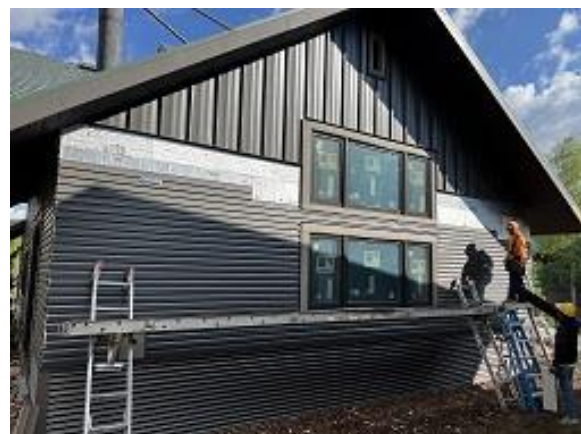
**Building C7 Unit 60 Side Lap Siding Installed**

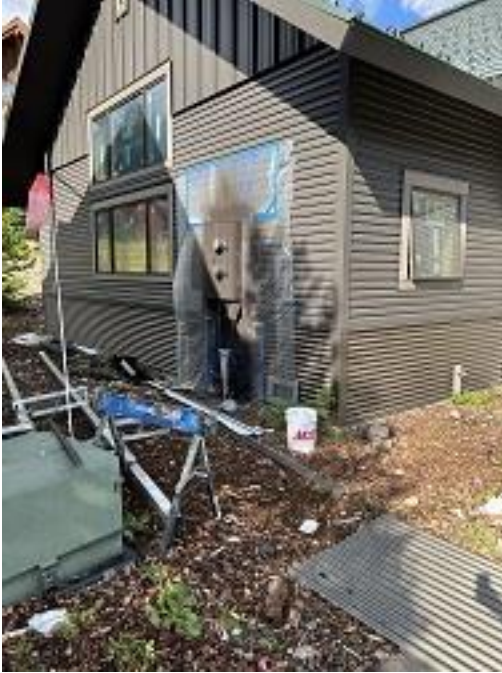
**Building C8 Unit 66 Electric Panel Painted**

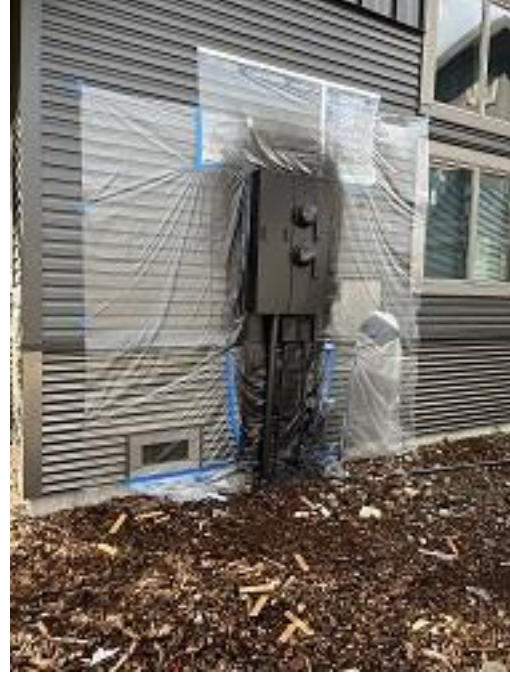
**Building C9 Unit 67 Electric Panel Painted**

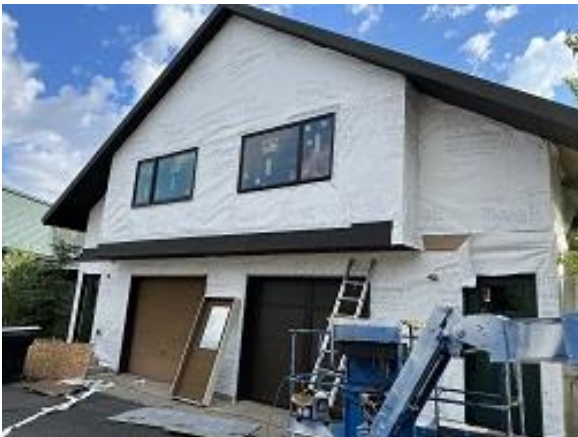
**Building C10 Units 69 & 70 Belly Band  
Flashing Installed**

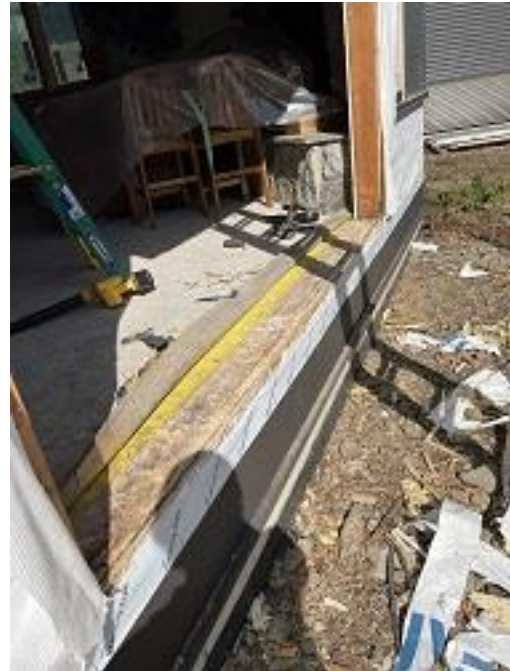
**Building C10 Unit 69 Deck Door Removed**

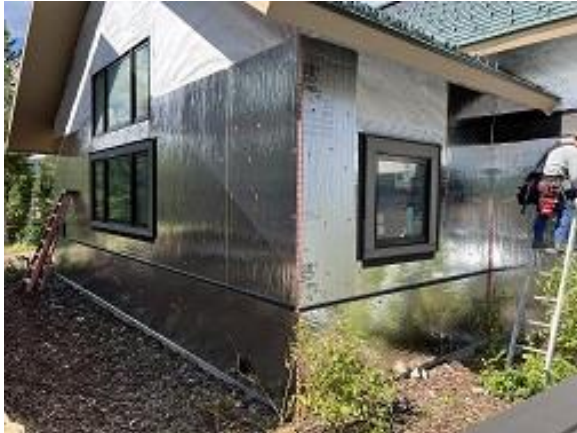
**Building C6 Unit 54 Window Trim & J Channel Installed**

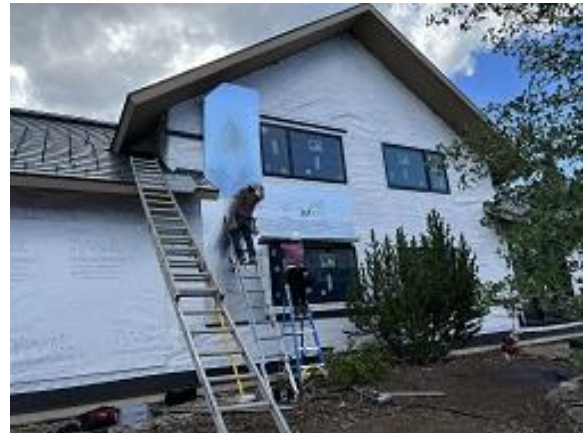
**Building C10 Units 69 & 70 Insulation Board Installed**

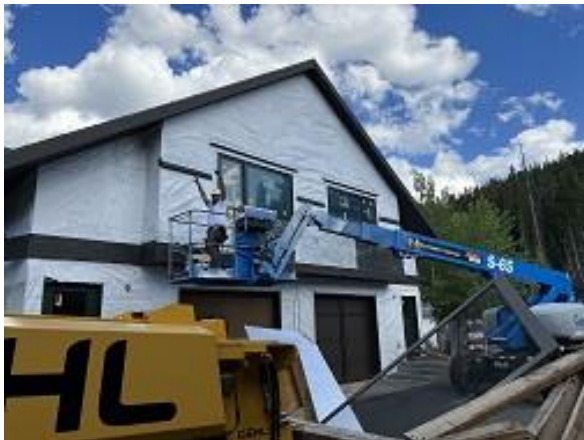
**Building C10 Units 69 & 70 Snap Batten Flashing Installed**

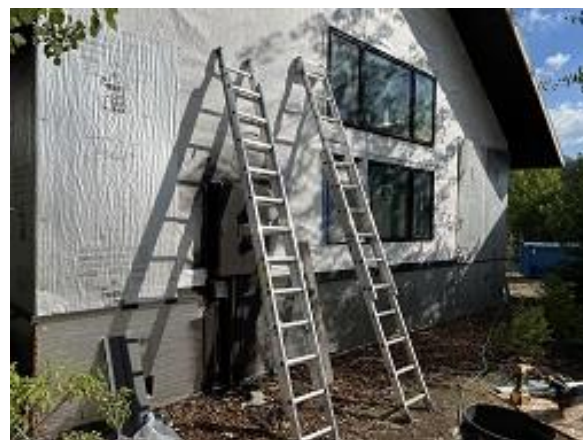
**Building C10 Unit 70 Insulation Board Installed**

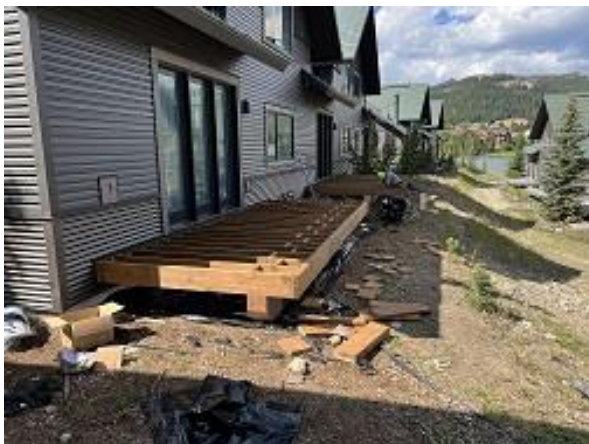
**Building D Units 36 - 38 Deck Framing Began**
