Daily Observation Report

Date of Report: Sept 12, 2022
 Prepared By: Jim Goveia

PROJECT: BIG HORN CONDO SIDING REPLACEMENT & EXTERIOR UPGRADES PHASE 2

REPORT #: P2-258

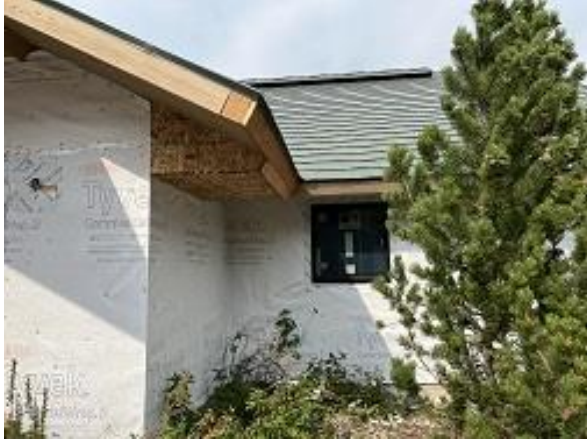
Building B Unit 3 Kitchen Window Installed & Rafter Repair Completed

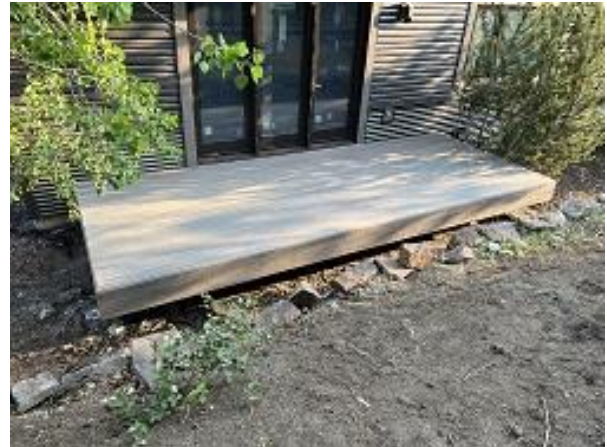
Observations – 1) B: Units 3 - 7 kitchen windows installed. Observed unit 6 installed an awning temporarily instead of casement which was not delivered on site and has been ordered. Units 3, 4 & 5 rafter repairs completed. **2) C2:** Unit 15 decking & fascia installed. Observed no expansion joint between decking and back of fascia. Fascia screws not aligned nor set with fascia drill bit as required. Fascia was applied prior to GLULAM ends were painted. **3) E5:** Units 41 - 44 Stoops coatings continued. **4) E6:** Units 45 - 48 Stoops coatings continued. Deck framing began. **5) E8:** Units 55 - 58 Deck framing completed. Observed Tyvek below deck ledger board.

Building C2 Unit 15 Decking Installed

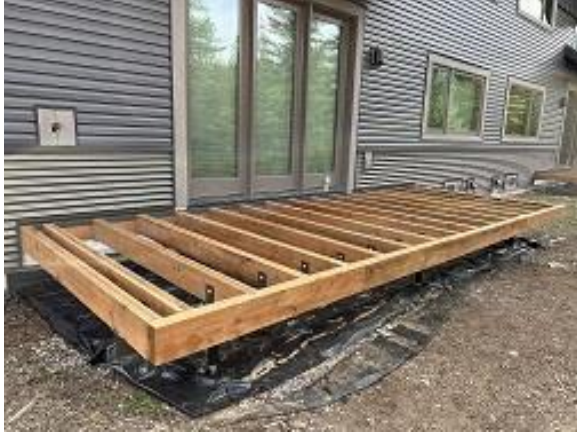
Building E8 Unit 55 Deck Framing

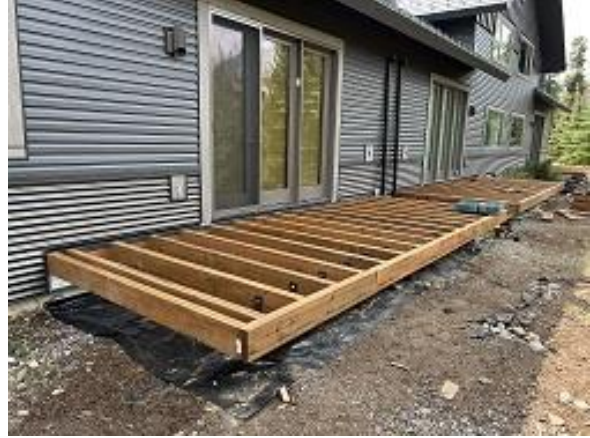
Building E8 Units 56 & 57 Deck Framing

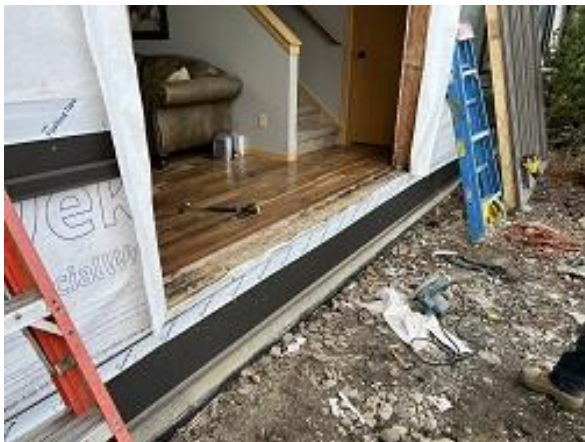
Observations – 1) B: Units 3 - 7 soffit, fascia, base & wainscot flashing installation continued. **2)** C8: Units 65 & 66 Crawl Space Radon System installed. **3)** C10 Units 69 & 70 corrugated and lap siding installation continued. Unit 70 deck door removed. Observed mold at threshold and remediation. **4)** E6: Units 45 & 48 radon system exhausts installed. **5)** E7: units 51 & 52 stoop refinishing continued.

**Building C10 Units 70 Deck Door
Removed Mold on Threshold**

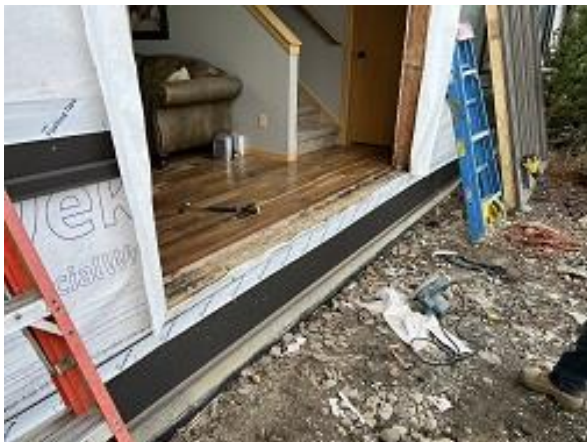
Observations – 1) B: Units 3 - 7 soffit, fascia, base & wainscot flashing installation continued. **2)** C8: Units 65 & 66 Crawl Space Radon System installed. **3)** C10 Units 69 & 70 corrugated and lap siding installation continued. Unit 70 deck door removed. Observed mold at threshold and remediation. **4)** E6: Units 45 & 48 radon system exhausts installed. **5)** E7: units 51 & 52 stoop refinishing continued. **6)** E5: Units 41, 42 and 44 radon system vents installed. E9: Units 61 - 64 radon system vents installed.

**Building C10 Units 70 Deck Door
Removed Mold on Threshold**
