## Daily Observation Report

Date of Report: Sept 19, 2022  
 Prepared By: Jim Goveia

**PROJECT:** BIG HORN CONDO SIDING REPLACEMENT & EXTERIOR UPGRADES PHASE 2

**REPORT #:** P2-263

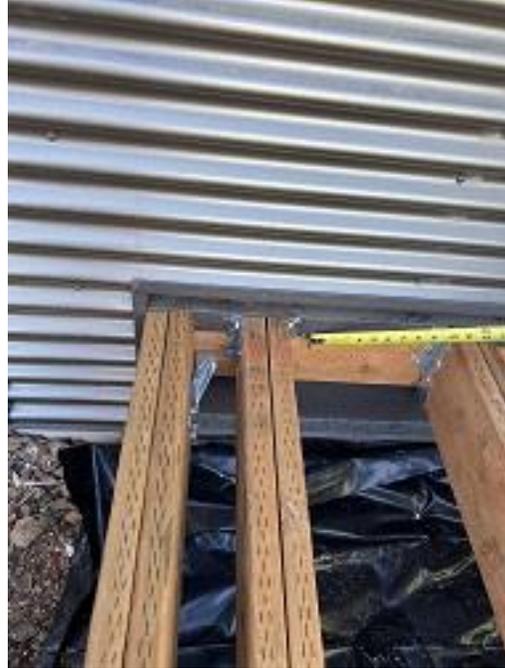
**Observations – 1) B:** Units 3 - 7 Back & Side foam insulation board, window & door trim and j channel installed. **2) C10** Units 69 & 70 back lap siding installation continued. **3) D:** Unit 37 deck fascia installed. **4) E9:** Units 61 - 64 decks framing completed. Observed incorrect rim joist hangers installed.

**Building E9 Unit 61 Observed Incorrect Joist Hanger Installed**

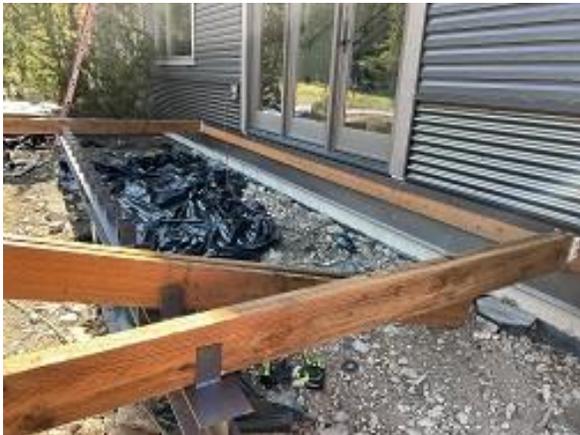
**Observations – 1)** B: Units 3 - 7 Back & Side foam insulation board, window & door trim and j channel installation continued. **2)** C3: Unit 33 deck framing began. Observed bolts missing at beam to helical piers and washers used on bolts for joist bracket causing less than optimal threads attached. **3)** C6: Unit 54 window removal & replacement to correct errors began. Units 53 & 54 satellite dishes installed. Stoop refinishing continued. **4)** C7: Unit 60 window removal & replacement to correct errors began. Observed during back lower window removal severe cuts in Tyvek that will need repaired prior to window reinstallation. **5)** C10: Units 69 & 70 back lap & snap batten siding installation continued. **6)** D: Unit 37 deck fascia installed. **7)** E8: Units 55 - 58 stoop refinishing began. **8)** E9: Units 61 - 64 decks framing completed. Observed incorrect rim joist hangers installed.

**Building C3 Unit 33 Deck Framing Installed**

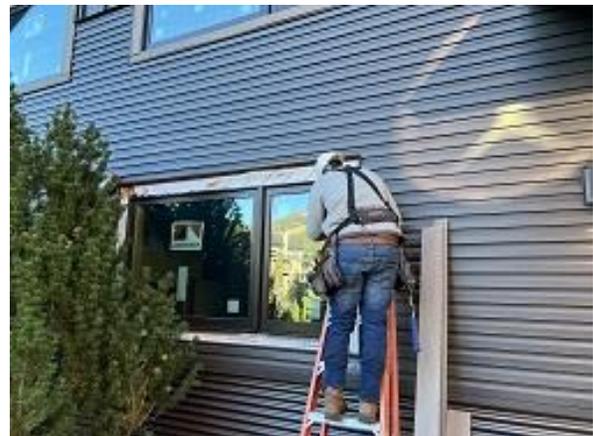
**Building C7 Unit 60 Back Lower Window Observed Tyvek Cut At J Channel**

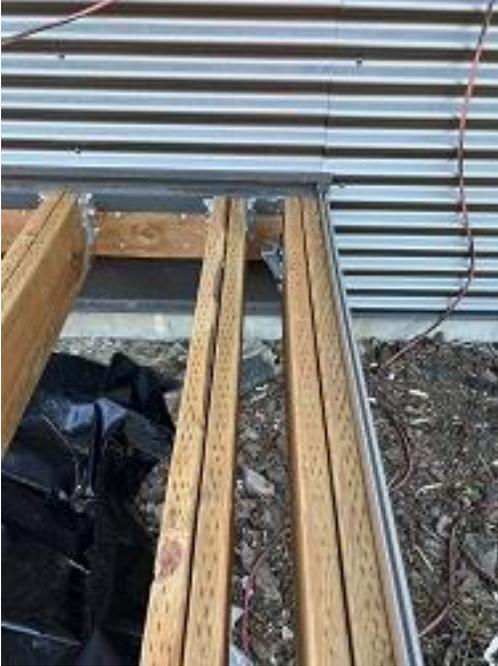
**Building E9 Unit 62 Observed Incorrect  
Deck Joist Hanger Installed**

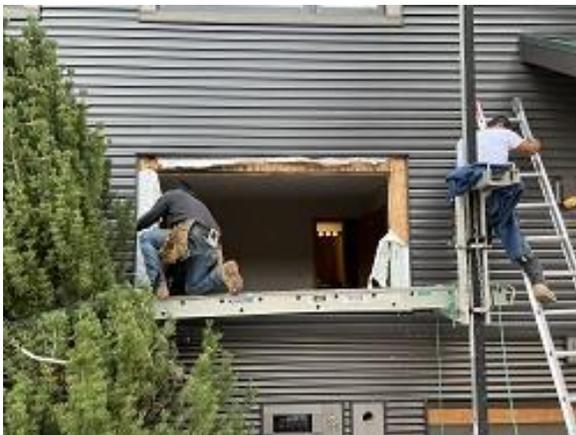
**Unit 60 Back Lower Window Install Removing Insulation Board behind Siding & Cut Tyvek**

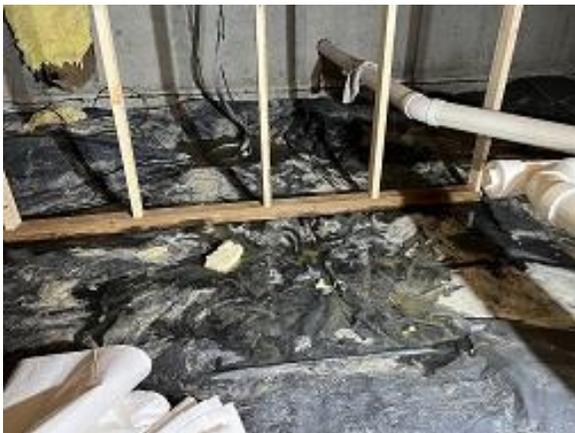
**Observations – 1)** C2: Unit 14 deck door removed and replaced with correct door completed. **2)** C4: Unit 34 deck door install completed. Unit 35 deck door removed pan & flashing installed and door reinstalled until new door arrives completed. **3)** D: Units 36 - 38 crawl space vapor barriers and radon reduction systems installed. Unit 37 deck railing installed. Observed one missing railing post bolt and three loose bolts. **4)** E5: Unit 43 Partial installation of crawl space vapor barrier and radon reduction system due to water accumulation on one side because of sump pump failure not due to radon system installers work. Sump pump must be remedied prior to completion of radon system installation.

**Building E5 Unit 43 Crawl Space  
Standing Water At Sump Pump**
