Daily Observation Report

Date of Report: Sept 6, 2022
 Prepared By: Jim Goveia

PROJECT: BIG HORN CONDO SIDING REPLACEMENT & EXTERIOR UPGRADES PHASE 2

REPORT #: P2-254

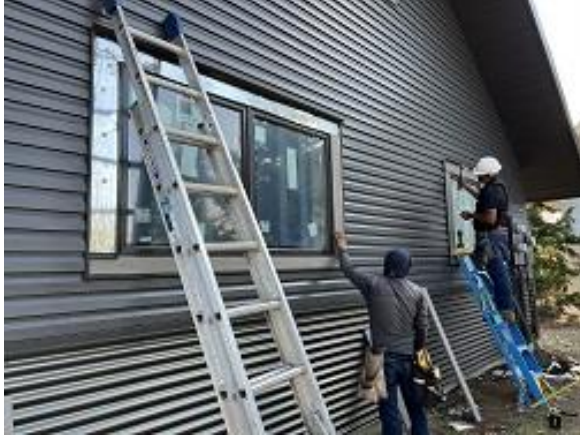
**Building A Unit 2 Side Windows
Trim Reinstalled**

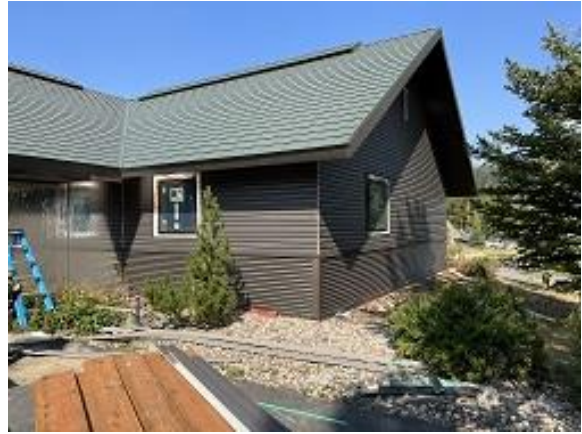
**Building A Unit 1 Kitchen & Side Windows
Reinstalled**

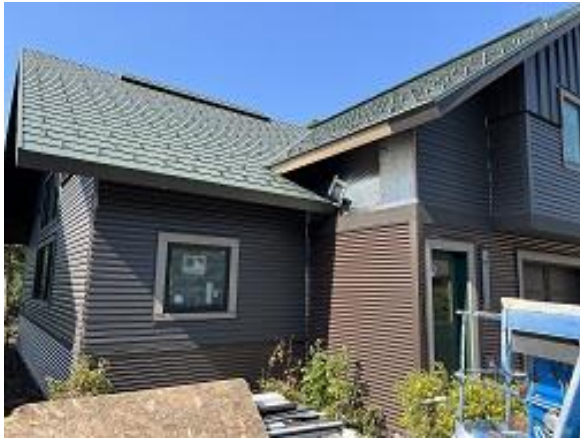
Observations – 1) A: Units 1 & 2 removed & installed correct type of windows. **2) B:** Units 3 - 7 front door installation began. **3) C6:** Units 53 & 54 Back & sides snap batten & lap siding installation continued. Front diverters installed with too obtuse angle. Observed large quantities of touch up paint on belly band and soffit. **4) D:** Unit 38 adjusted side lower window to properly align with upper window.

**Building C6 Unit 54 Diverter Installed
Appears Too Obtuse an Angle**

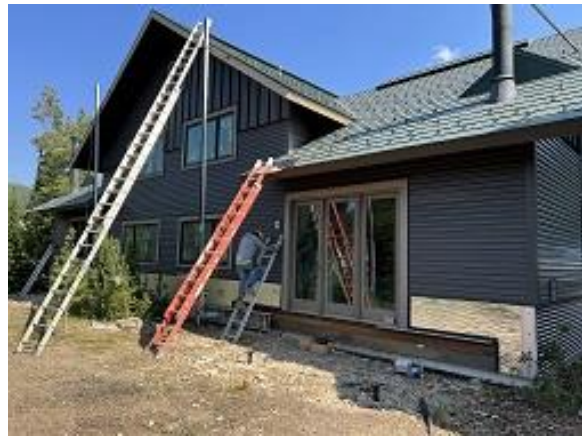
**Building C6 Units 53 & 54 Back Snap
Batten & Lap Siding Installed**

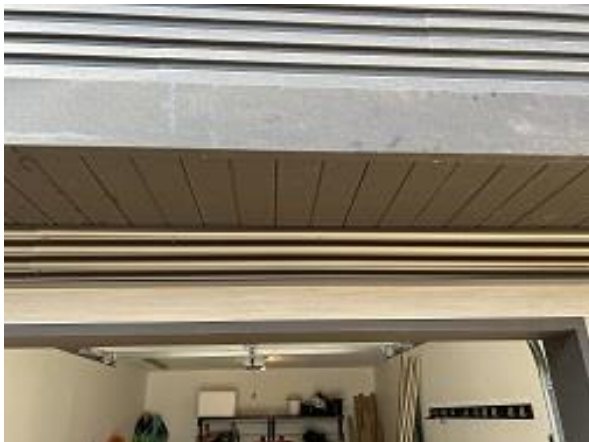
**Building C6 Unit 53 Front Belly Band
Touch Up Paint**

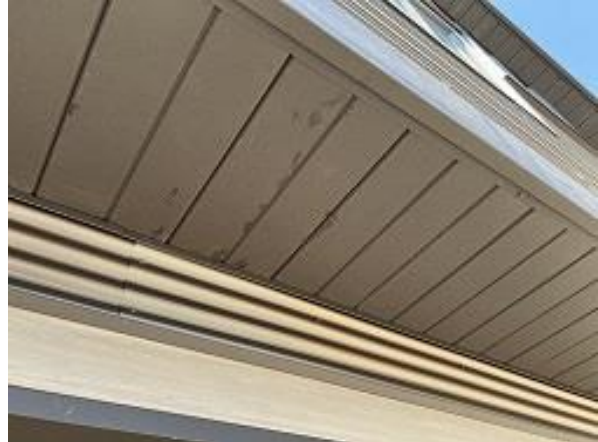
**Building C6 Unit 53 Front Soffit Touch Up
Paint**

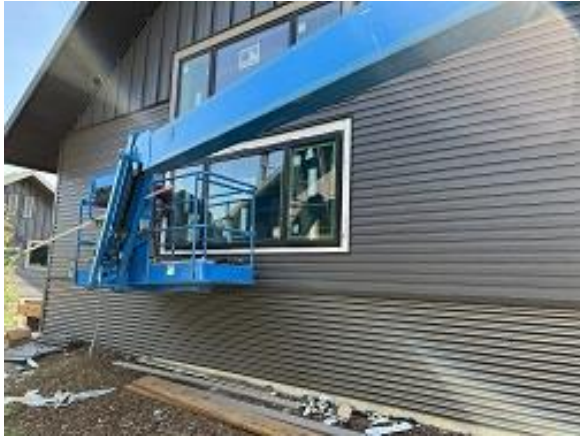
Building D Unit 38 Side Lower Window Adjusted

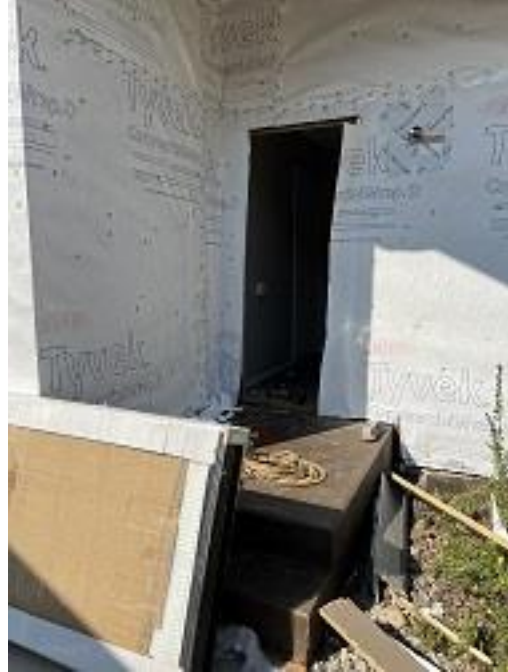
Building B Unit 3 Front Door Removed

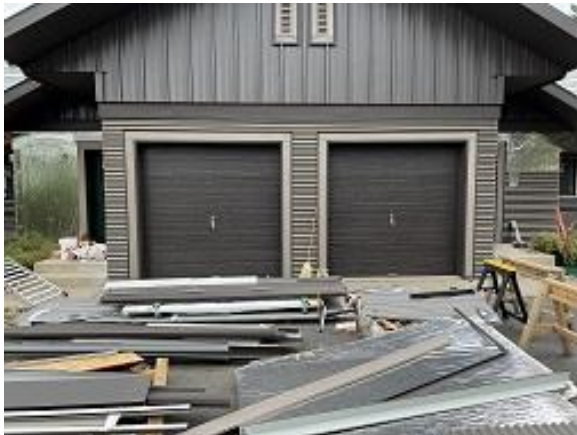
Observations – 1) A: Units 1 & 2 front corrugated siding installation continued. Observed unit 1: Chipped tile at slider and missing plugs. Unit 2: Front door hardware not plumb, missing lower jamb tabs, strike plate missing, touch up paint. Kitchen bottom shims not at corners. Slider missing plugs. **2) B:** Units 3 - 7 front door installation completed. Observed Unit 3: Front door missing lower jamb tabs, keypad not set, strike plate missing touch up paint. Slider missing plugs. Unit 4: Front door hardware not plumb, missing lower jamb tabs & strike plate. Slider missing plugs. Unit 5: Front door hardware not plumb, missing lower jamb tabs & strike plate, keypad not set. Slider latch sticks, hardware needs adjustment, plugs missing. Unit 6: Front door hardware not complete, missing lower jamb tabs & strike plate. Slider plugs missing. Unit 7: Front door hardware not plumb, missing lower jamb tabs & strike plate. Slider missing plugs. **3) C3:** Unit 33 bathrooms exhaust vents blockout installed. Units 33 & 32 stoops coatings began and crawl space radon systems installed. **4) C4:** Units 34 & 35 stoops coatings began. **5) C5:** Units 39 & 40 crawl space radon systems installed. **6) D:** Unit 36 - 38 Stoops coatings began. **7) E5:** Units 41 & 42 deck framing began. Observed unit 41 - 43 deck ledger boards had cracks longer than 3" that needed replacement. Unit 42 & 43 deck ledger boards were replaced. **8) E8:** Units 55 - 58 radon system exhaust downspouts installed.

Building A Units 1 & 2 Front Corrugated Siding Installed

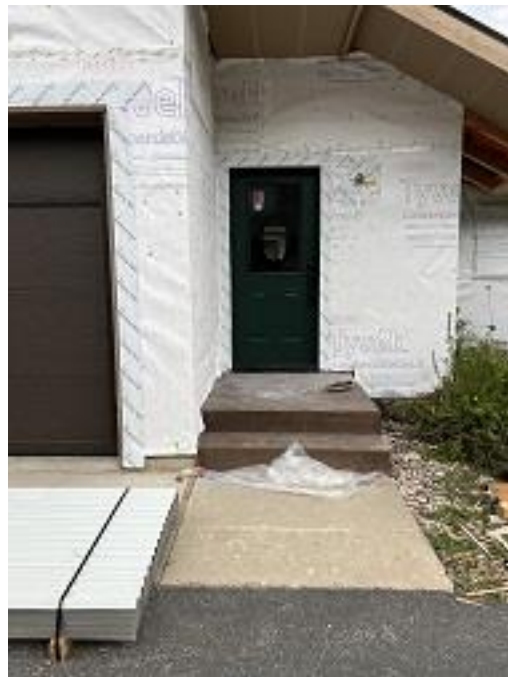
Building B Unit 3 Front Door Installed
