## Daily Observation Report

Date of Report: Aug 29, 2022  
 Prepared By: Jim Goveia

**PROJECT:** BIG HORN CONDO SIDING REPLACEMENT & EXTERIOR UPGRADES PHASE 2

**REPORT #:** P2-249

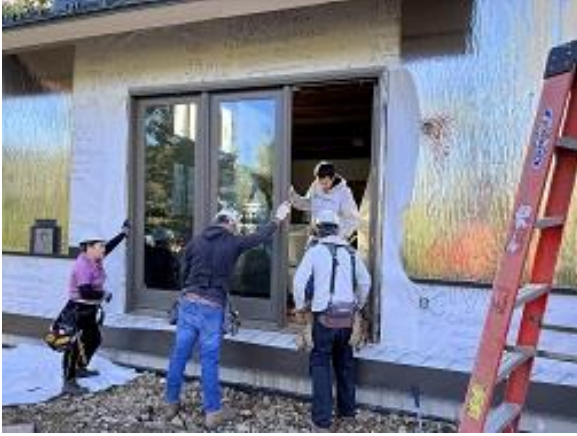
**Building C6 Unit 53 Deck Door Removed**

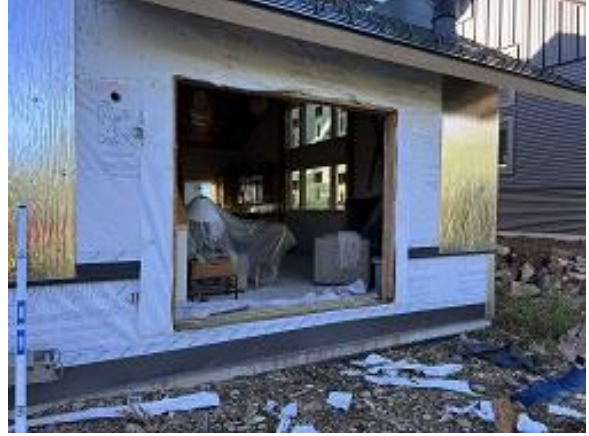
**Building C6 Unit 54 Deck Door Removed**

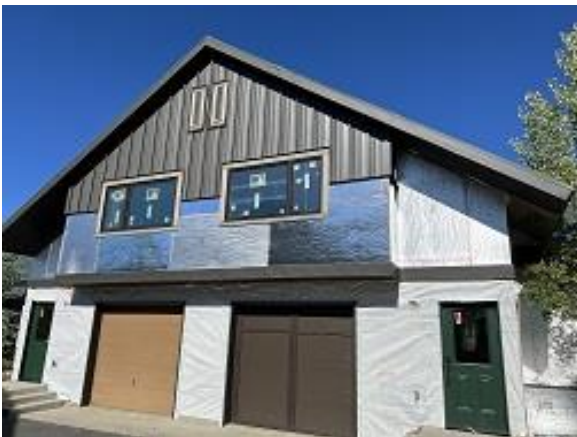
**Building C10 Units 69 & 70 Front Snap  
Batten Siding Installed**

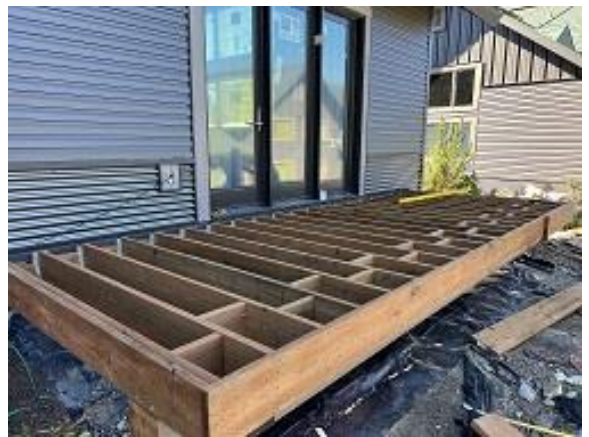
**Building D Unit 38 Deck Framing**

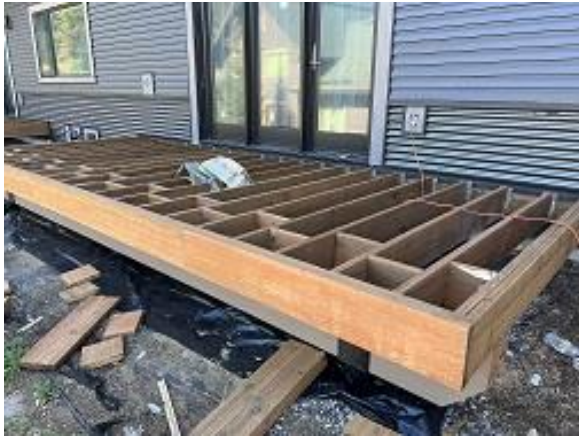
**Building D Unit 37 Deck Framing**

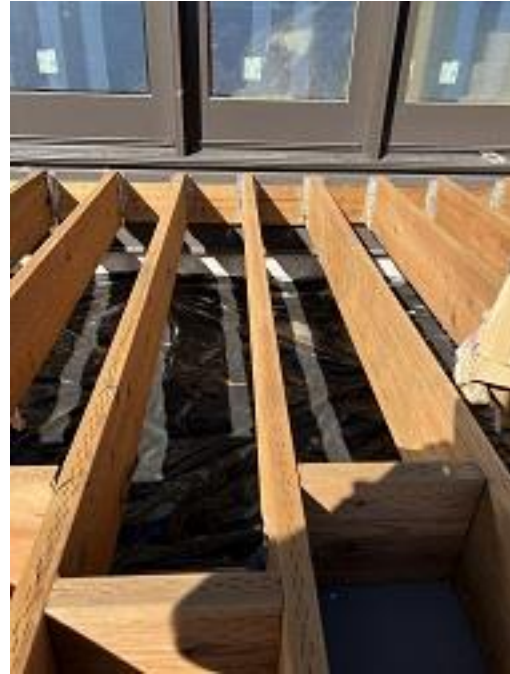
**Observations – 1)** C6: Units 53 & 54 deck doors removed and replaced. **2)** C10: Units 69 & 70 front snap batten siding installed. **3)** D: Units 36 - 38 deck framing continued. Unit 37 Observed deck ledger checking greater than 3". **4)** E5: Units 41 - 43 grading under deck for correct clearance from grade to GLULAM. **5)** E6, E8, E9 touch up painting began. Observed liberal paint application. Recommended lighter touch up paint and wiping off excess.

**Building D Unit 37 Deck Framing Ledger Board Check Longer Than 3 in**

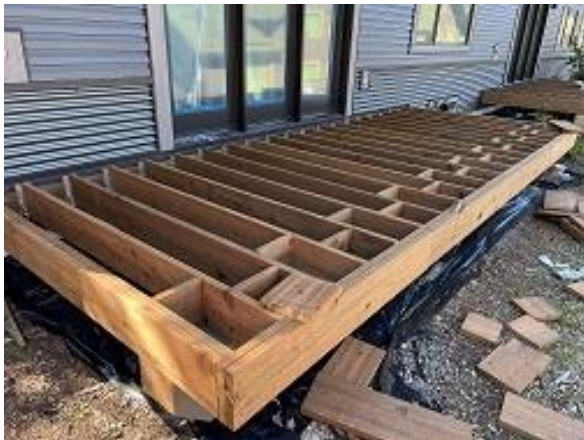
**Building D Unit 36 Deck Framing**

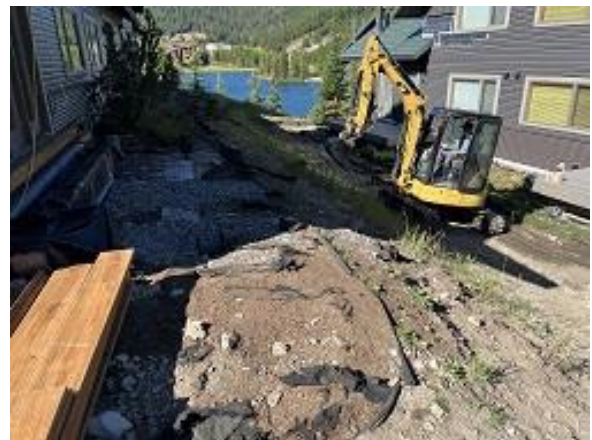
**Building E5 Units 41 - 43 Required Clearance Grading Under Decks**

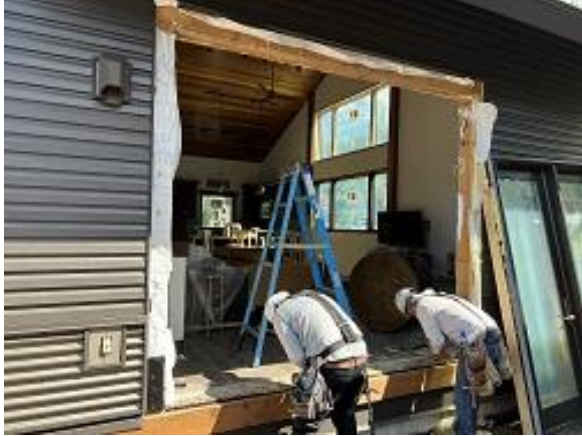
**Building C5 Unit 39 Deck Door Removed to Correct Install**

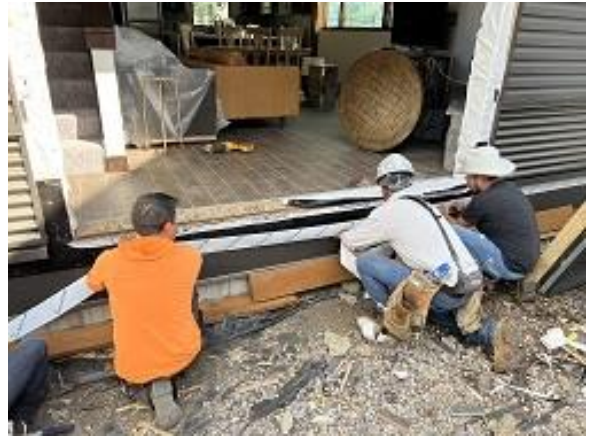
**Building C5 Unit 39 Deck Door Flashing Tape Installed**

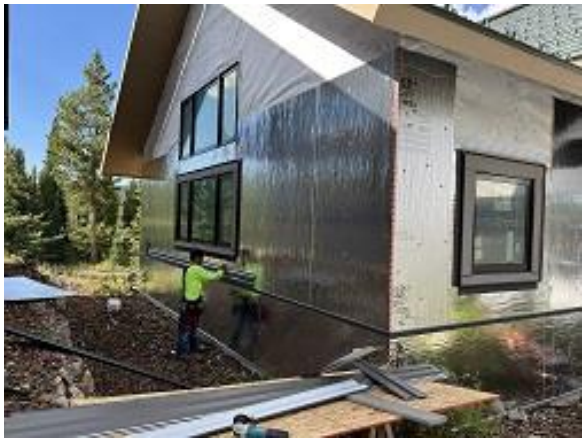
**Building C6 Unit 54 Side Lap Siding Installed**

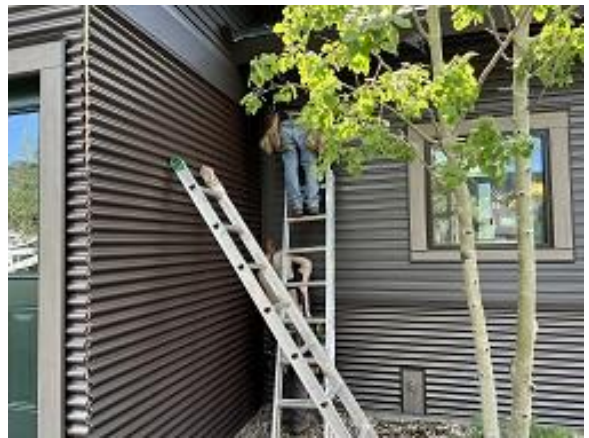
**Building C7 Unit 59 Front Corners Installed**

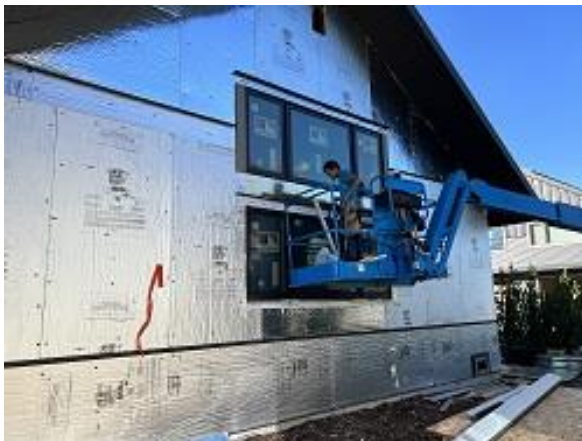
**Building C10 Unit 69 Side Window Trim Installed**

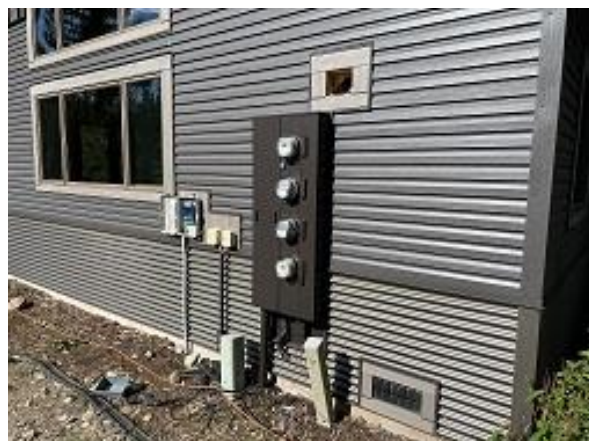
**Building E8 Unit 58 Side Electric Panel Painted**

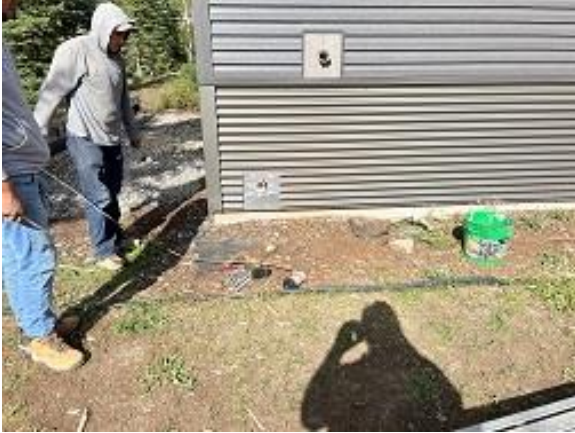
**Building E8 Unit 58 Side Radon System  
Vent Blocking Location Cut**

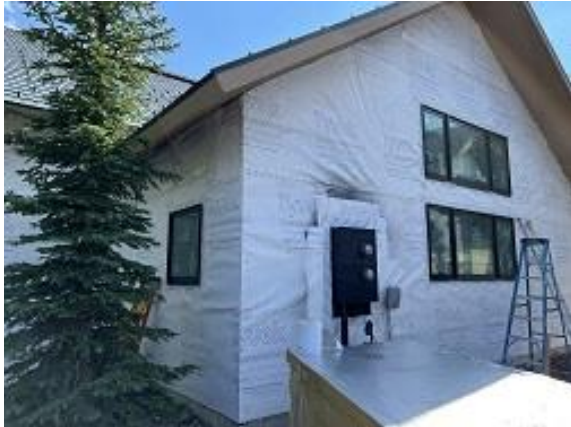
**Observations – 1)** C4: Unit 35 windows installed. Observed kitchen casement installed was triple pane Heatlock and should have been without Heatlock. **2)** C6: Unit 54 side lap siding installed. Unit 53 side j channel installed. **3)** C7: Units 60 front corners installation completed. **4)** E9: Units 61 - 64 crawl space radon system installed. Unit 61 Observed lots of insulation on ground and stored items that needed moved for installation. Unit 62 observed sump pump discharge hose is currently on top of radon system vapor barrier not outside.

**Building C4 Unit 35 Kitchen & Side Windows Installed**

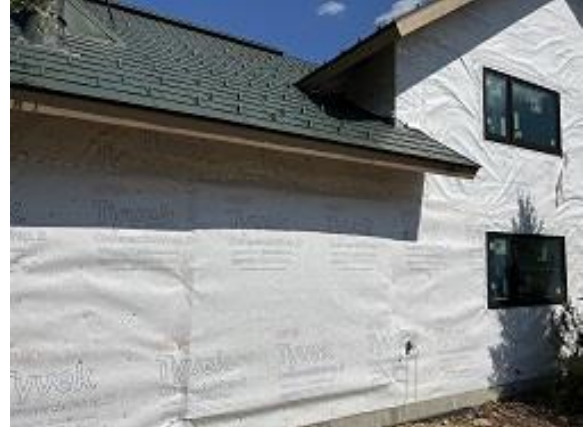
**Building C4 Unit 35 Back Windows Installed**

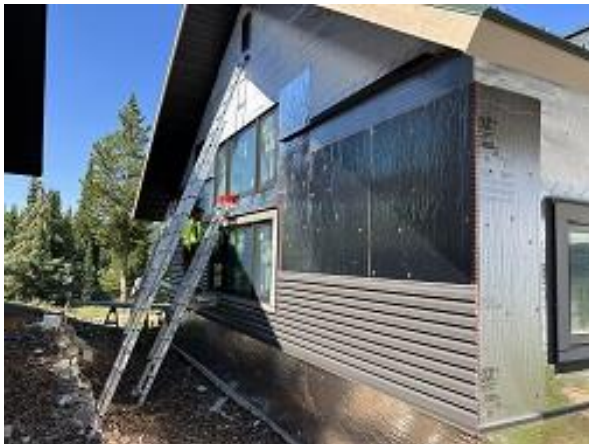
**Building C6 Unit 54 Side Lap Siding Installed**

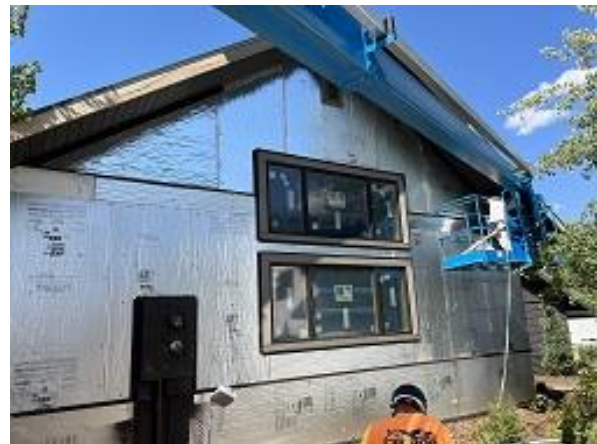
**Building C6 Unit 53 Side Snap Batten J Channel Installed**

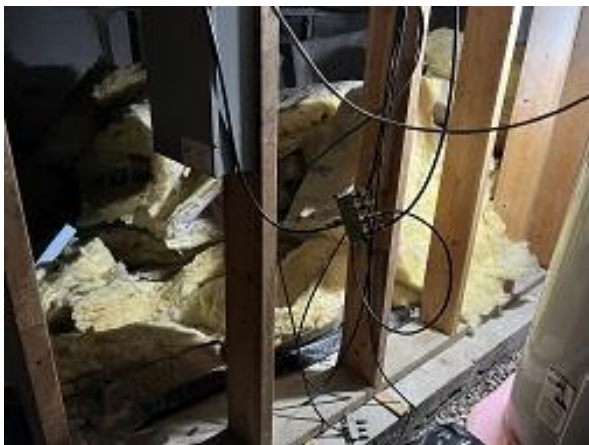
**Building E9 Unit 61 Crawl Space Insulation Was Down Needed Moved for Radon System Install**

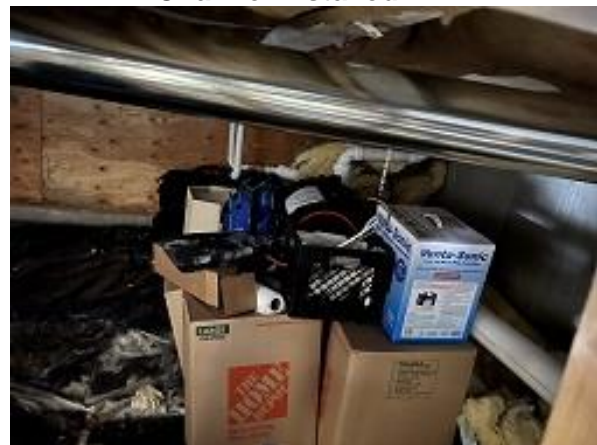
**Building E9 Unit 61 Crawl Space Stored Items Needed Moved for Radon System Install**

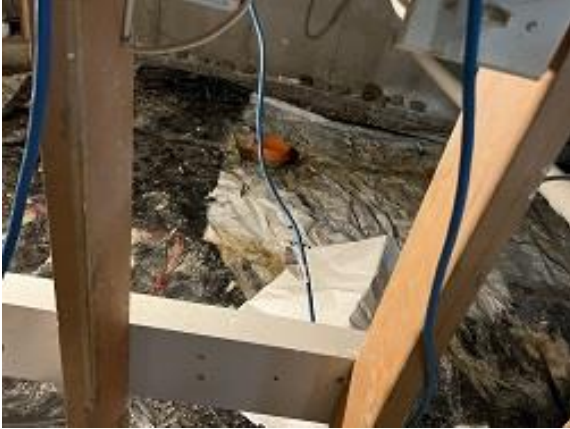
**Building E9 Unit 62 Crawl Space Sump  
Pump Found During Radon System Install**

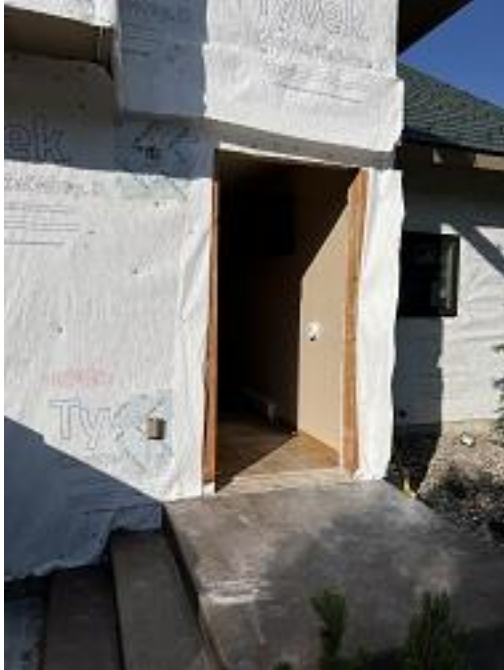
**Building C4 Unit 35 Front Door Removed**

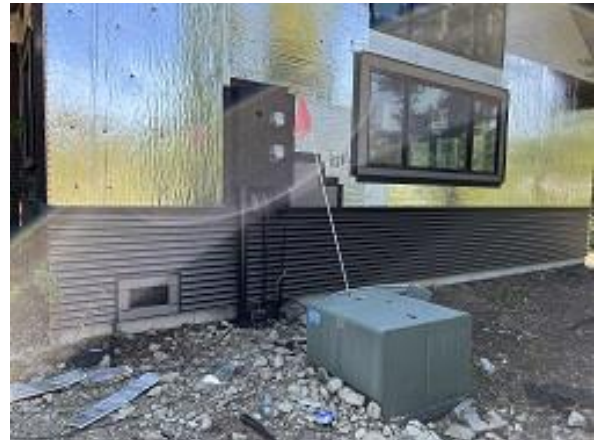
**Building C6 Unit 53 Side Corrugated Siding Installed**

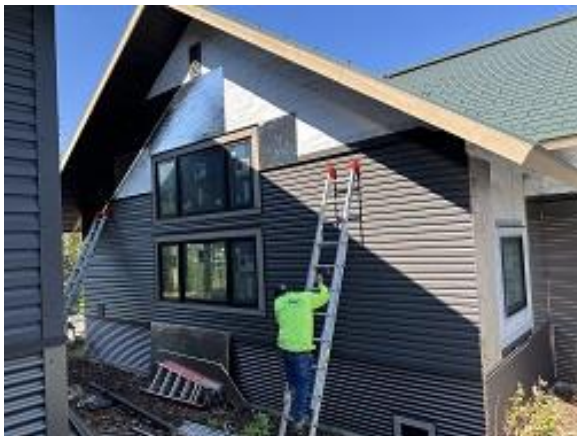
**Building C6 Unit 54 Side Foam Board Insulation Installed**

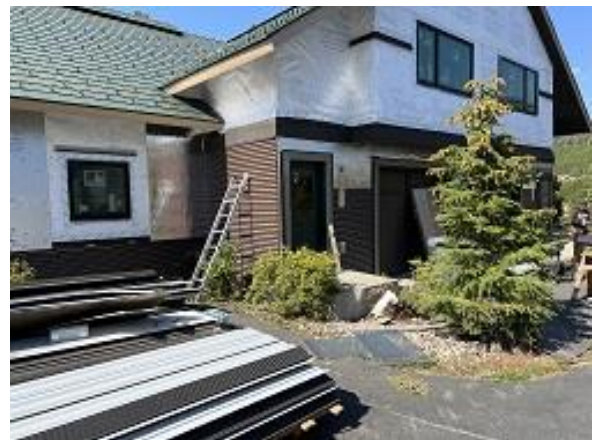
**Building C6 Unit 54 Front Corrugated Siding Installed**

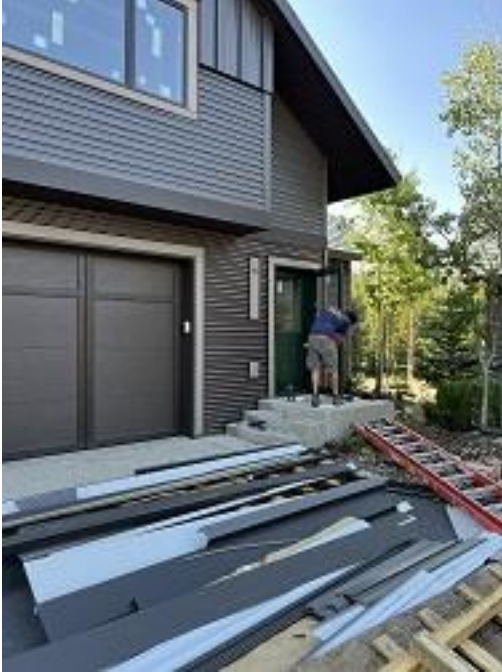
**Building C7 Unit 59 Storm Door Installed**

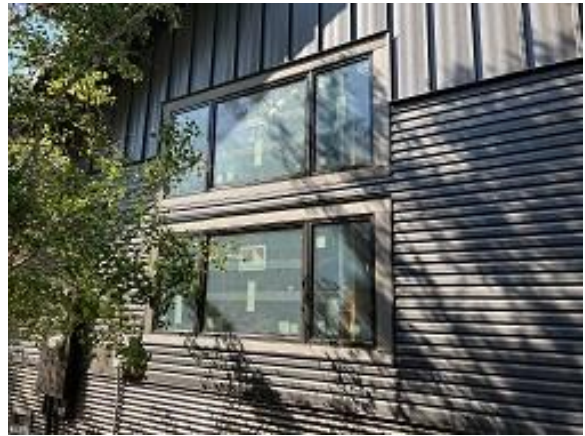
**Building D Unit 36 Side Windows Installed**

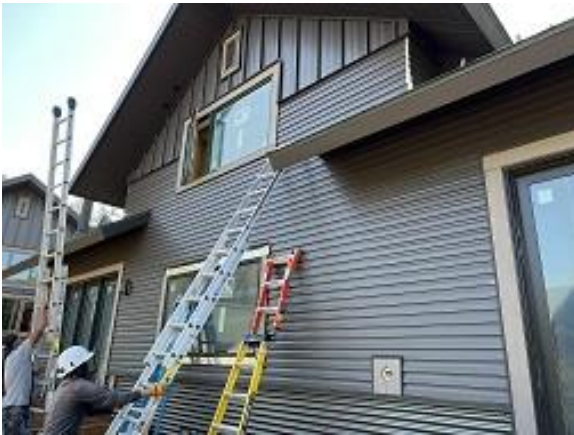
**Building D Unit 36 Back Windows Installed**

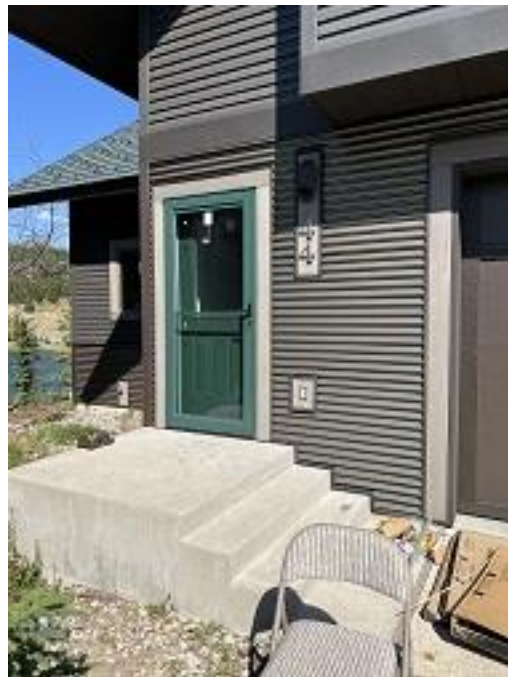
**Building E5 Unit 44 Storm Door Installed**

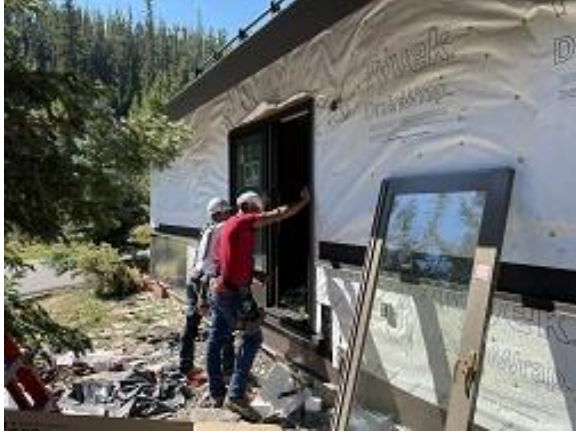
**Building A Unit 1 Deck Door Installed**

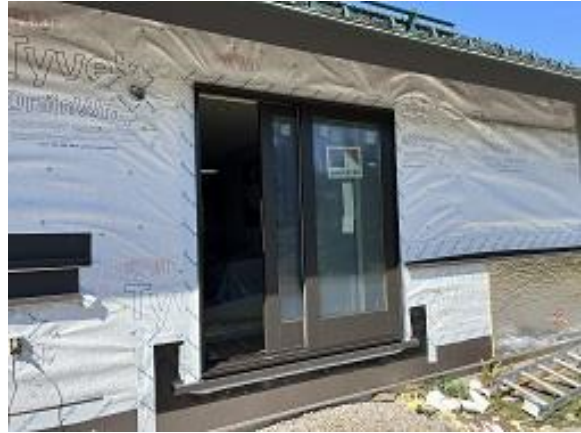
**Building A Unit 2 Deck Door Installed**

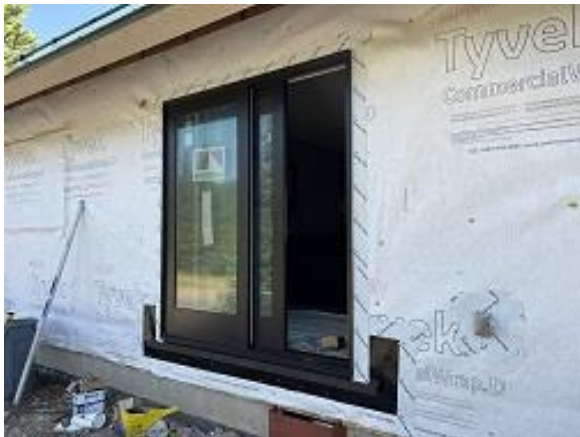
**Building B Unit 3 Deck Door Installed**

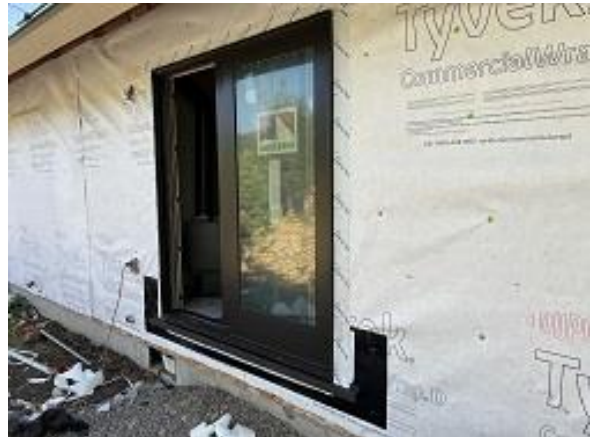
**Building B Unit 4 Deck Door Installed**

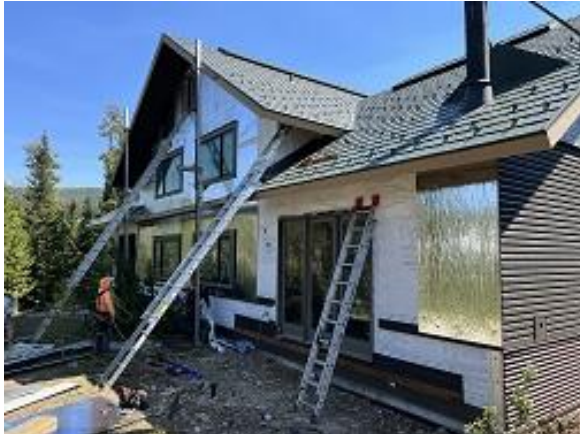
**Building C6 Units 53 & 54 Back Foam Board Insulation, Window Trim & J Channel Installed**

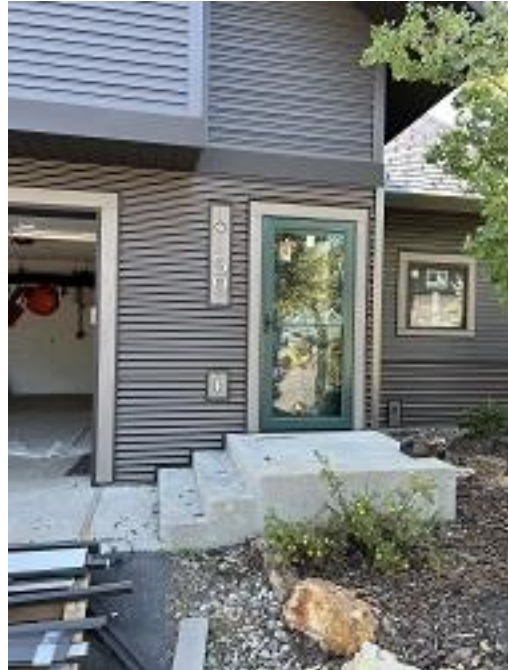
**Building C7 Unit 59 Storm Door Installed**

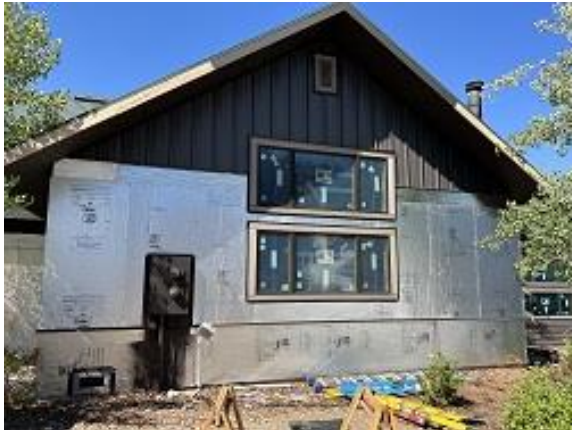
**Building C10 Unit 70 Side Snap Batten Siding Installed**

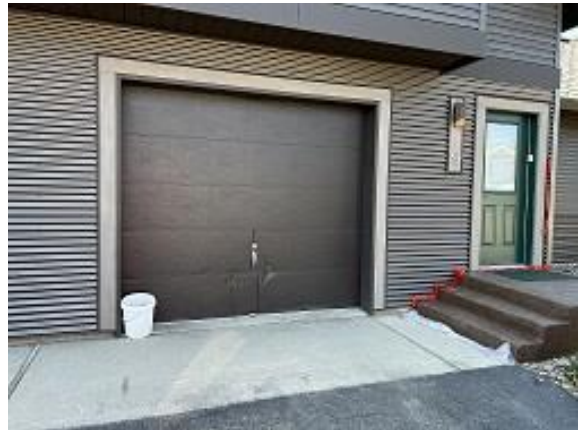
**Building E1 Unit 9 Garage Door Damaged**
