Daily Observation Report

Date of Report: Sept 26, 2022
 Prepared By: Jim Goveia

PROJECT: BIG HORN CONDO SIDING REPLACEMENT & EXTERIOR UPGRADES PHASE 2

REPORT #: P2-268

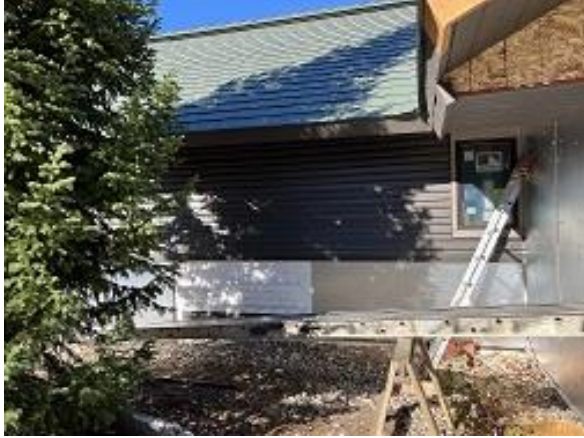
Building B Unit 4 Front Lap Siding Installed

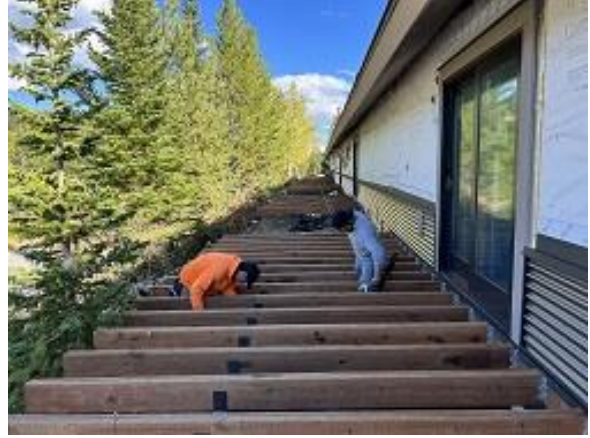
Building B Units 3 - 7 Deck Joists Install Continued

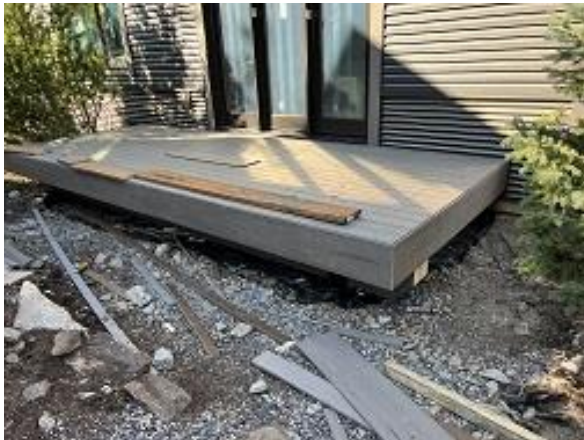
Observations – 1) B: Units 3 - 7 lap siding installation continued. Deck joists installation began. **2) C2:** Unit 14 decking & fascia installed. Observed wrong fasteners used on deck ledger. **3) C4:** Unit 34 & 35 head flashing, insulation board, window & door trim, j channel installed. **4) C6:** Unit 54 Decking & fascia installed. Observed wrong ledger fasteners used. **5) C9:** Unit 68 Deck & fascia installed Observed missing ledger fasteners. **6) E5:** Unit 44 Deck framing began.

Building C2 Unit 14 Decking & Fascia Installed

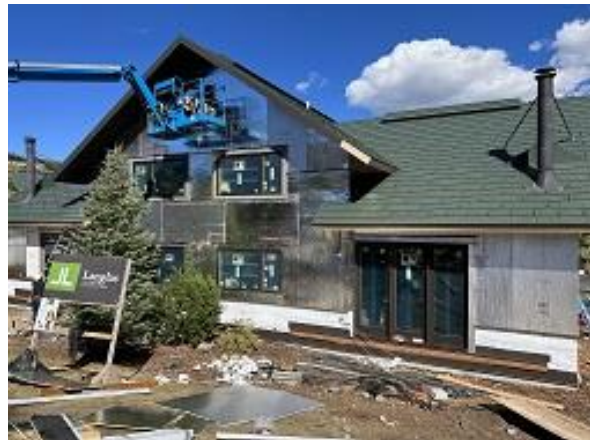
Building C4 Units 34 & 35 Back Head Flashing, Insulation Board, Window Trim & J Channel Installed

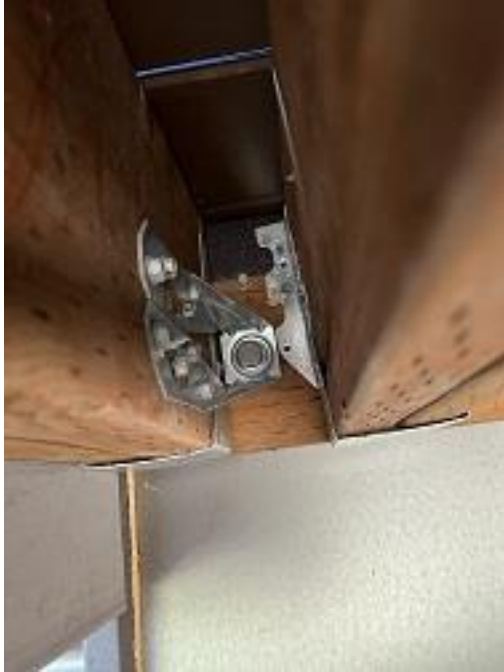
**Building C6 Unit 53 Deck Ledger
Wrong Fastener**

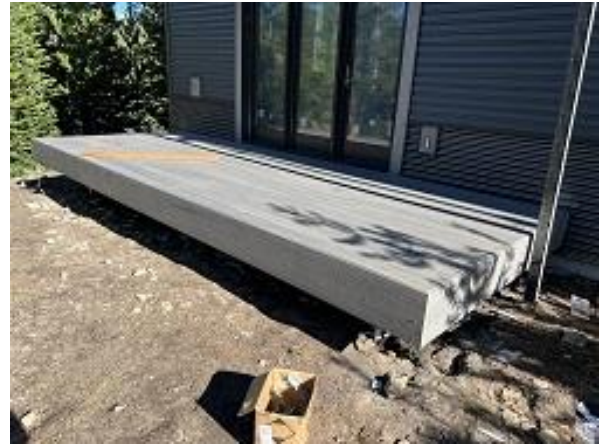
**Building C6 Unit 53 Decking & Fascia
Installed**

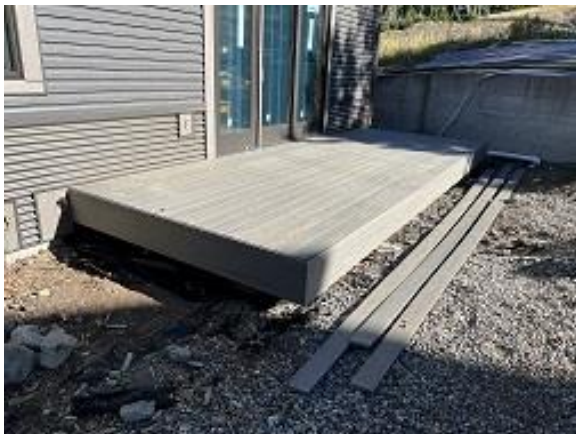
**Building C9 Unit 68 Decking &
Fascia Installed**

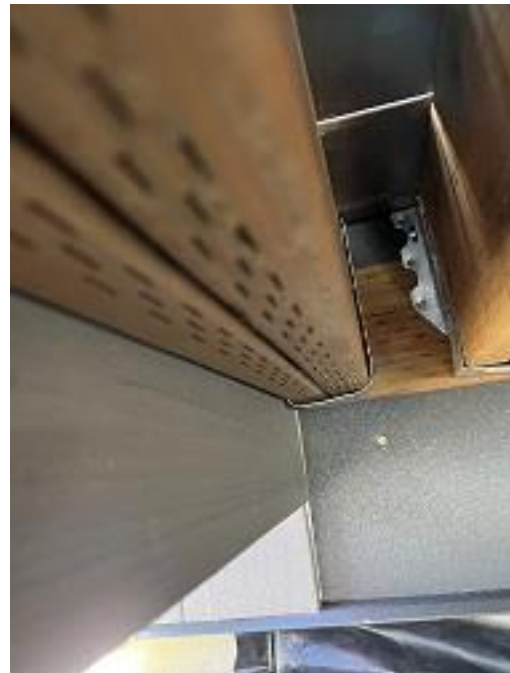
**Building C9 Unit 68 Deck Ledger Missing
Fasteners**

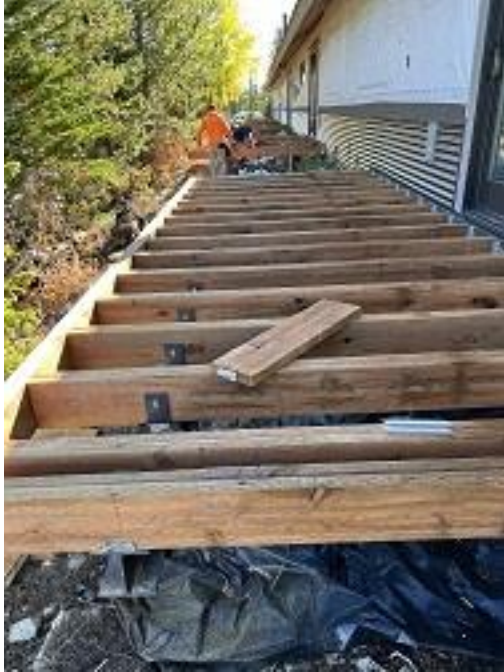
Observations – 1) B: Units 3 - 7 corrugated siding began. Deck framing installation continued. Observed joist to beam bolt length too short needs scoring or replacement. **2)** C4: Unit 34 & 35 insulation board, window & door trim, j channel installation continued. **3)** C9: Units 67 & 68 stoop refinishing continued. **4)** C10: Units 69 & 70 stoop refinishing continued. Unit 70 deck framing began. **5)** E5: Unit 41 Deck railing installed. Observed missing railing mounting brackets and missing ledger joist hanger and lag bolts. Unit 44 deck framing continued.

Building B Unit 7 Deck Framing

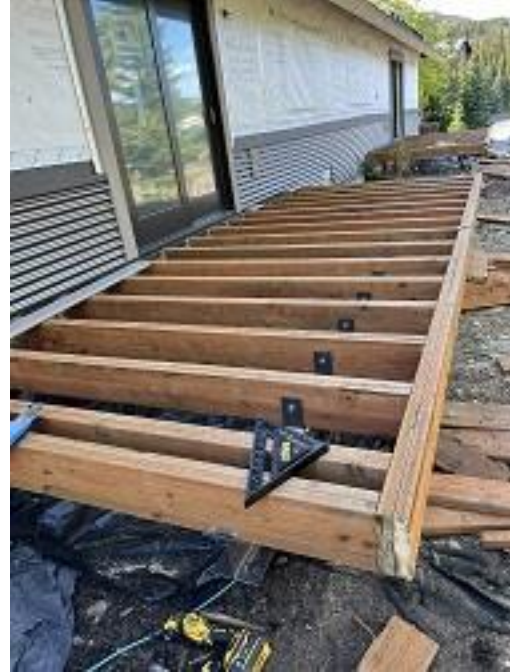
Building B Unit 6 Deck Framing

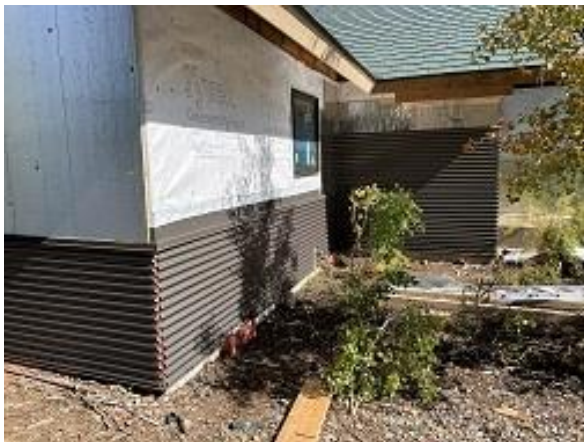
Building B Unit 7 Front Corrugated Siding Installed

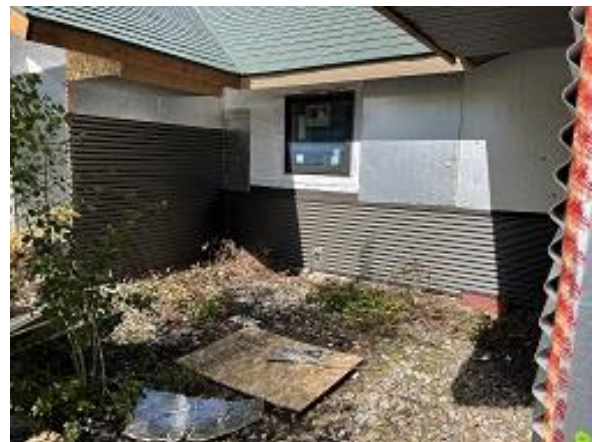
Building B Unit 6 Front Corrugated Siding Installed

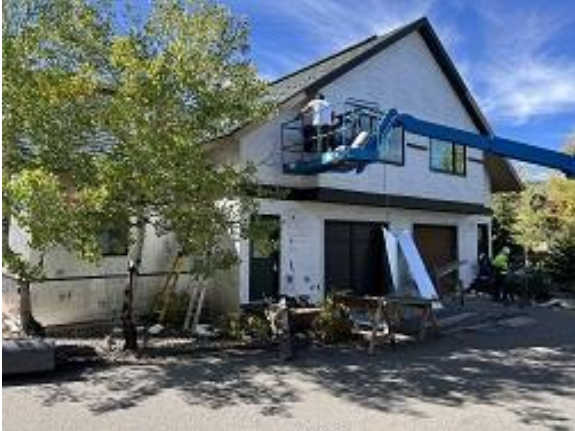
Building C4 Units 34 & 35 Front Belly Band & Snap Batten Flashing Installed

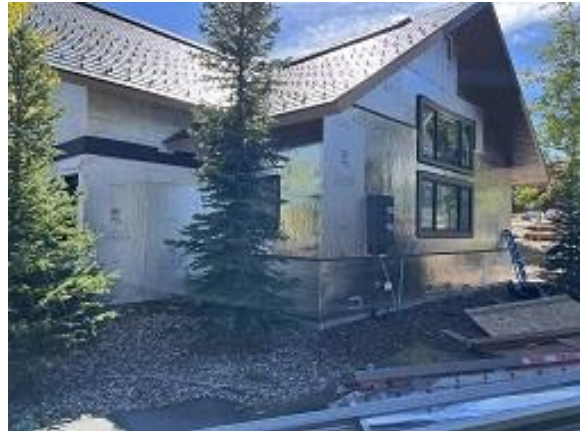
Building C4 Unit 35 Side Foam Insulation, Window Trim Installed

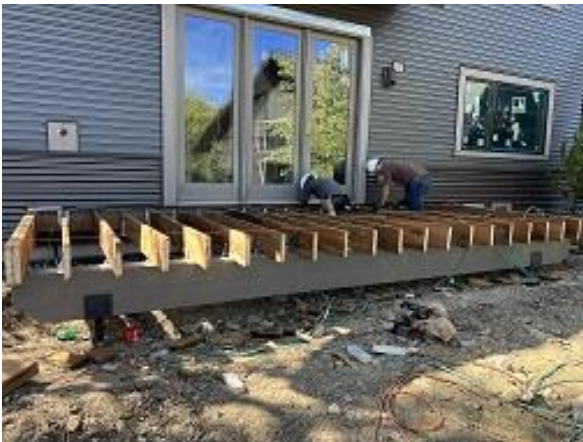
Building C10 Unit 70 Deck Framing Installed

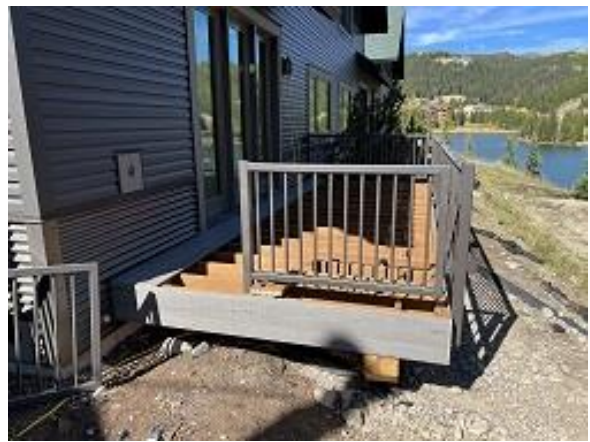
Building E5 Unit 41 Deck Railing Installed

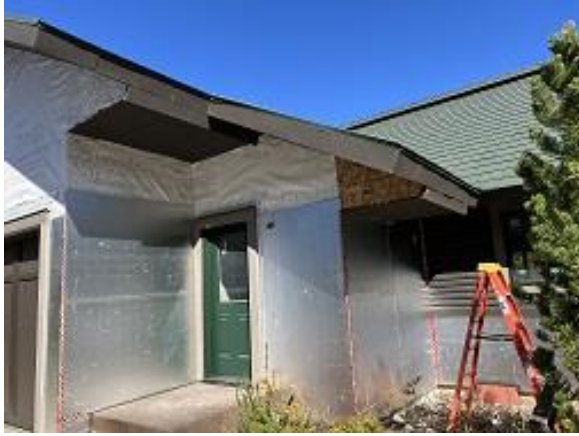
Observations – 1) B: Units 3 - 7 front and deck fascia installation began. Observed the fascia on repaired rafter locations and wider fascia locations is two piece fascia instead of the requested one piece. **2) C1:** Unit 12 side observed water meter was mounted to siding instead of blocking. **3) C3:** Unit 32 deck rail installed. Observed missing Simpson brackets and decking inconsistent cuts. **4) C4:** Unit 34 & 35 front snap batten siding installed. **5) C9:** Units 67 & 68 stoop refinishing completed. Crawl space radon reduction system installed. **6) C10:** Units 69 & 70 stoop refinishing completed. Crawl space radon reduction system installed. **7) E5:** Unit 44 deck framing continued and side windows installed.

Building B Unit 3 Front Fascia Installed

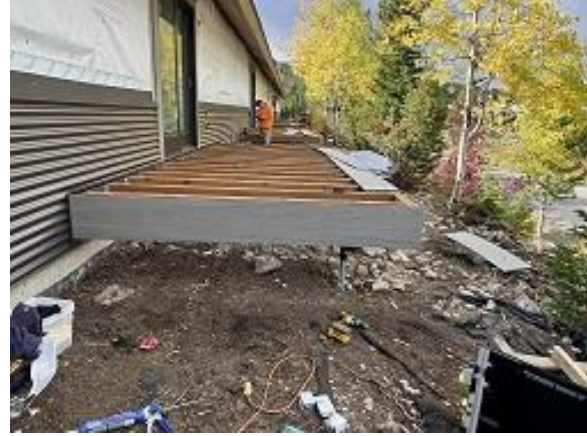
Building B Unit 3 Deck Fascia Installed

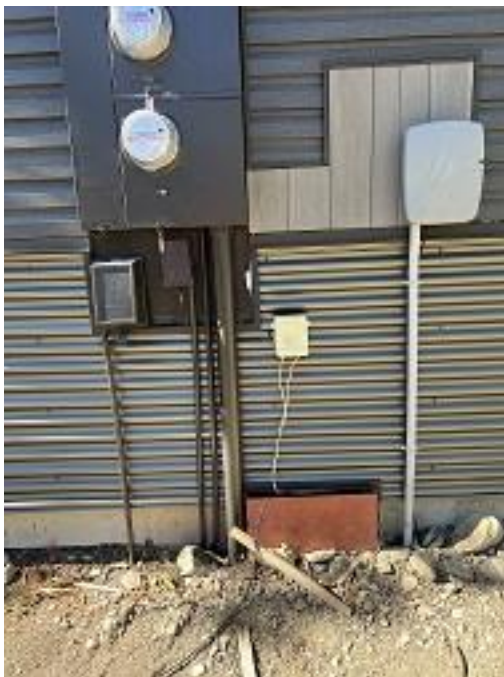
**Building C1 Unit 12 Side Water Meter
Attached to Siding**

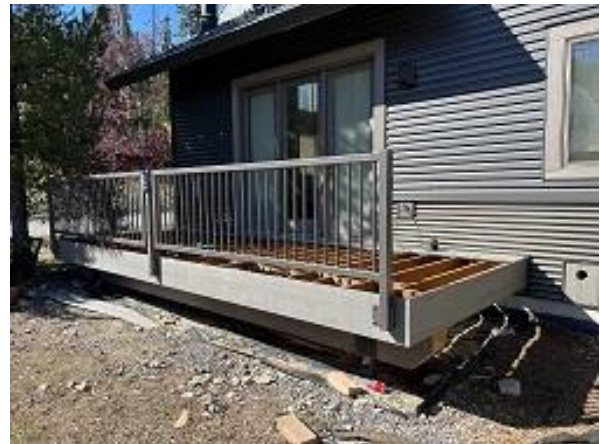
Building C3 Unit 32 Deck Railing Installed

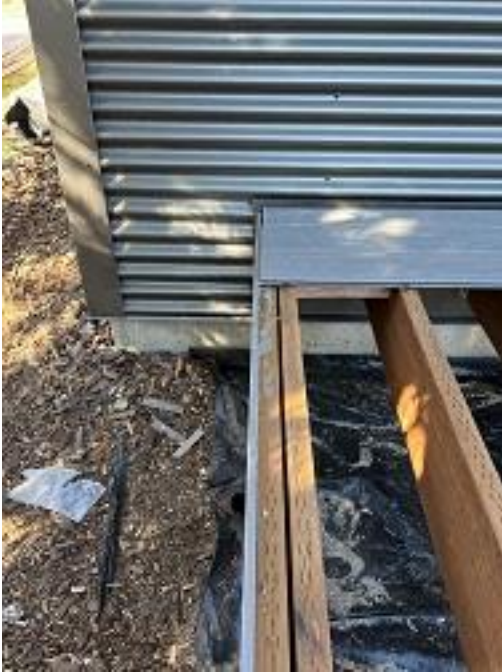
**Building C3 Unit 32 Decking
Inconsistent Cuts**

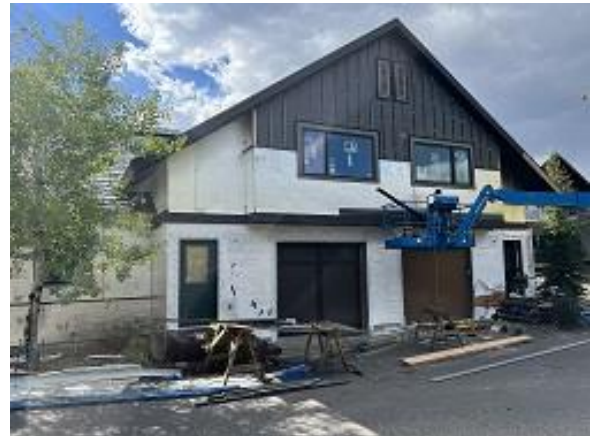
**Building C4 Units 34 & 35 Front Snap
Batten Siding Installed**

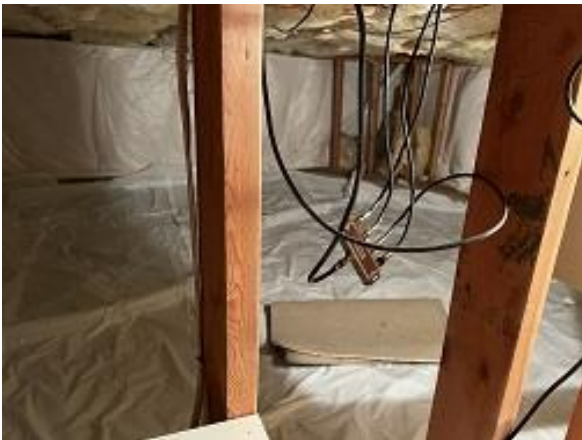
**Building C9 Unit 68 Crawl Space Radon
Existing Vapor Barrier Accepted**

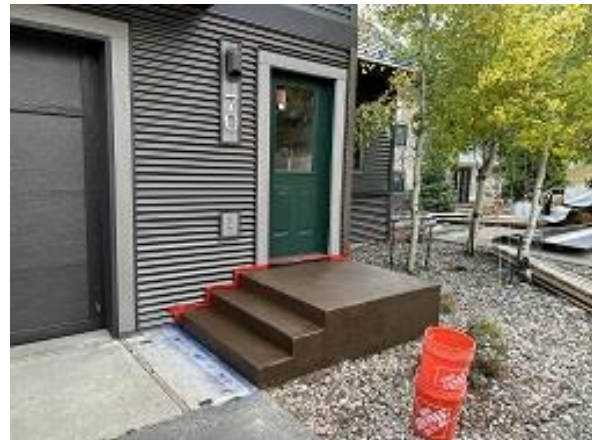
**Building C10 Units 70 Stoop Refinishing
Completed**

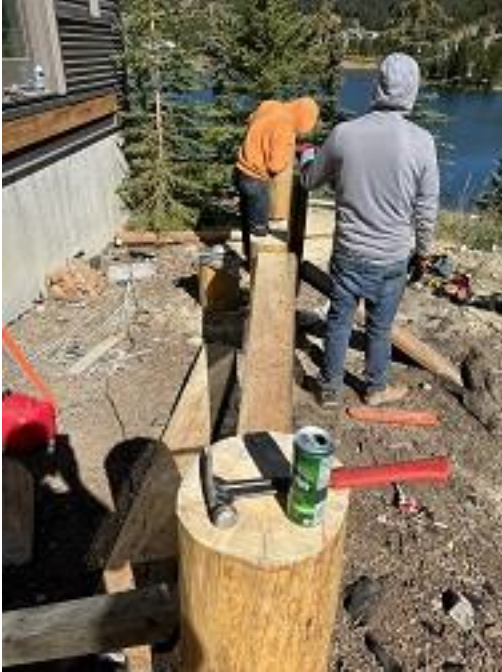
**Building E5 Unit 44 Deck Framing
Continued**

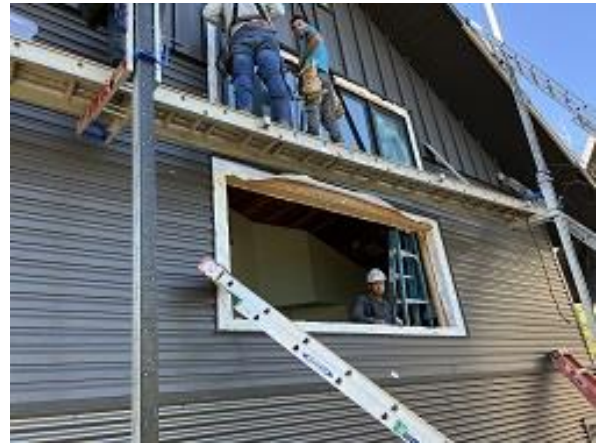
**Building E5 Unit 44 Side Windows
Installed**

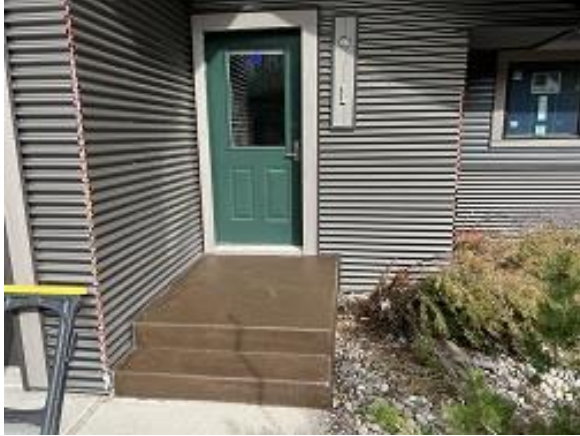
Building A Unit 1 Stoop Refinished

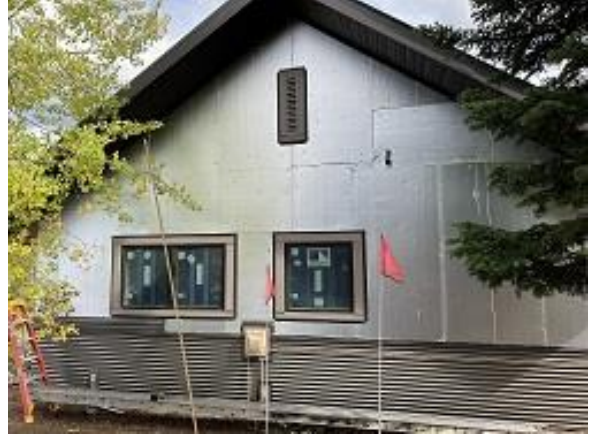
Building B Unit 7 Side Lap Siding Installed

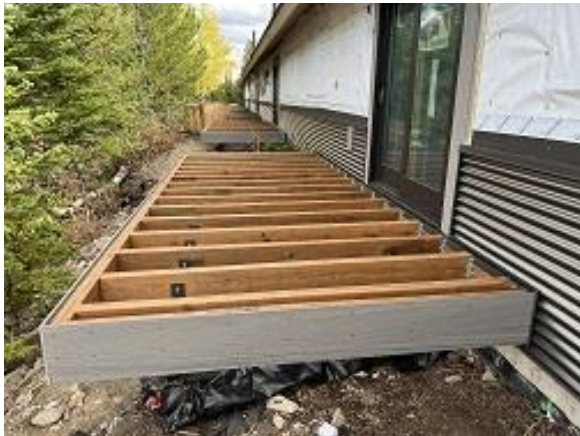
Building B Unit 7 Deck Fascia Installed

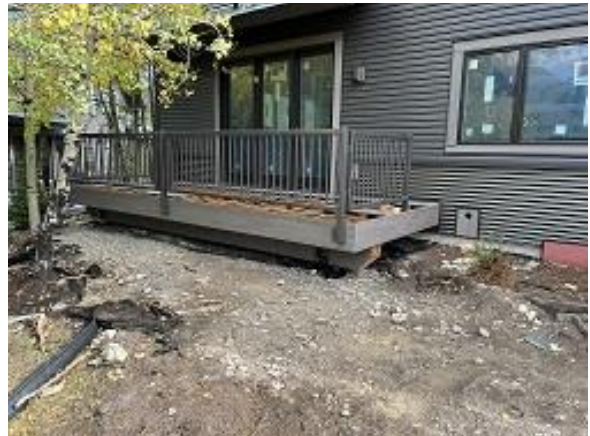
Observations – 1) A: Units 1 & 2 Stoops refinished. **2) B:** Units 3 - 7 front and deck fascia installation continued. Unit 7 side lap siding installation began. **3) C1:** Unit 12 Deck railing installed. Observed Simpson brackets not installed. **4) C4:** Unit 34 & 35 front lap siding installed. **5) E5:** Unit 43 Deck railing installed. Observed Simpson brackets not installed. Unit 44 deck framing continued and window installation completed.

Building C1 Unit 12 Deck Railing Installed

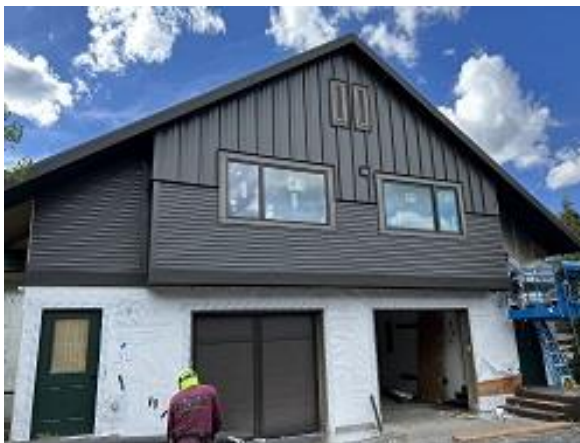
Building C4 Units 34 & 35 Front Lap Siding Installed

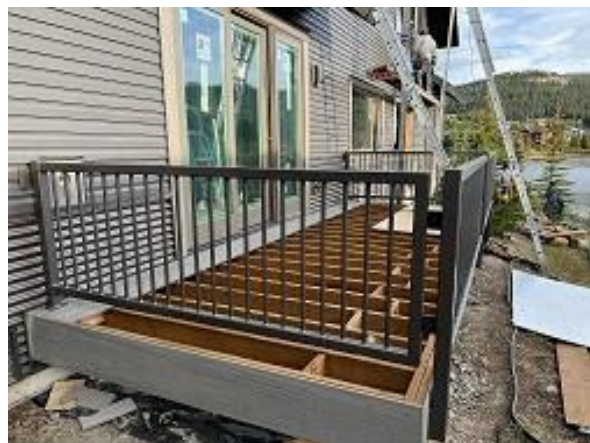
Building E5 Unit 43 Deck Railing Installed

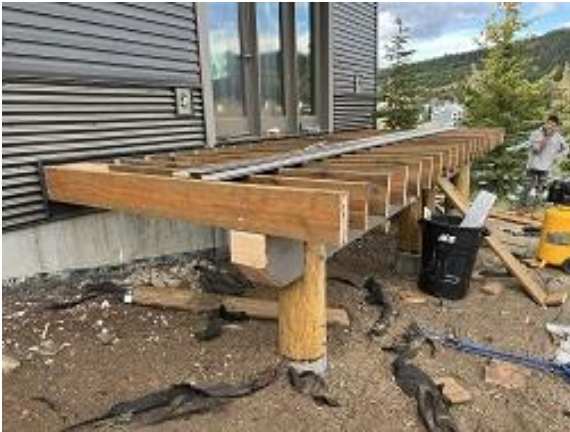
Building E5 Unit 44 Deck Joists Installed

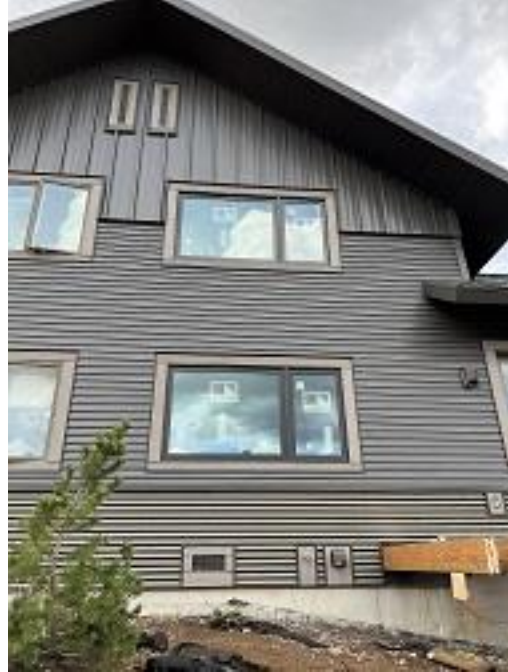
Building E5 Unit 44 Back Windows Installed

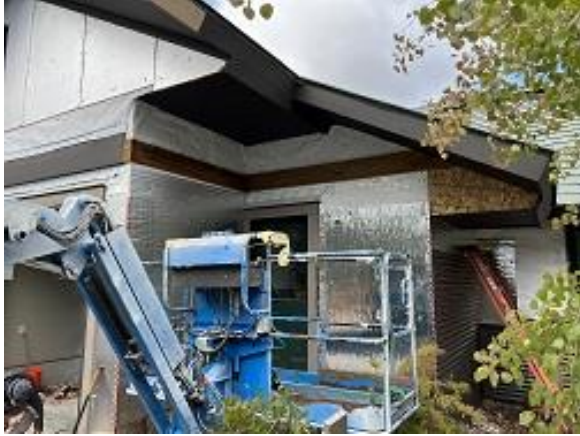
**Building B Units 6 Front Belly Band
Flashing Installed**

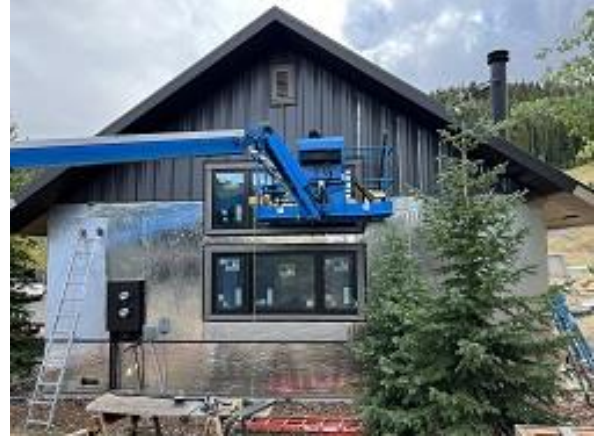
**Building C4 Unit 35 Side Snap Batten
Siding Installed**

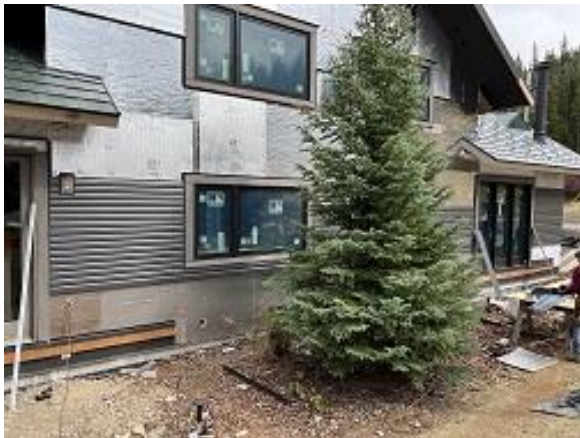
**Building C4 Units 34 & 35 Back Lap
Siding Installed**

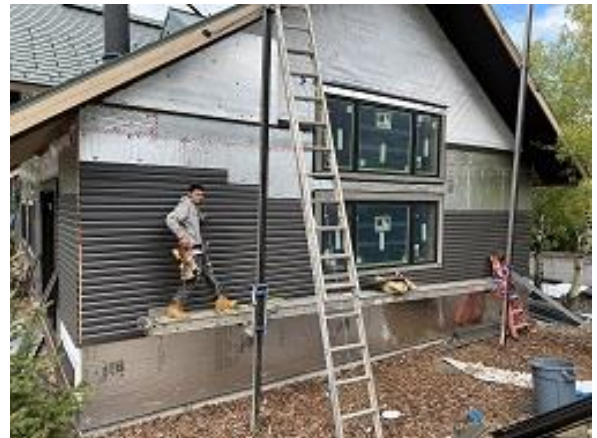
**Building C4 Unit 34 Side Lap Siding
Installed**

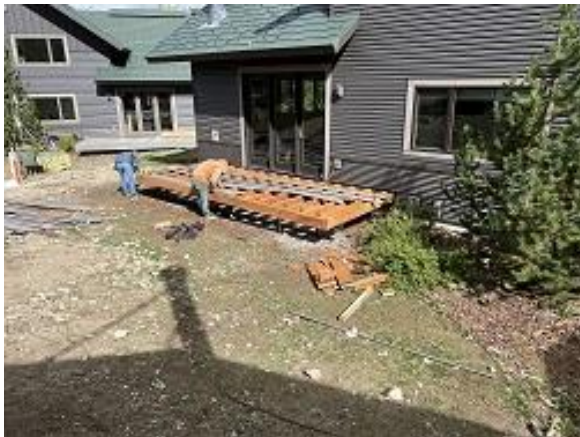
**Building C5 Unit 40 Deck Framing
Completed**

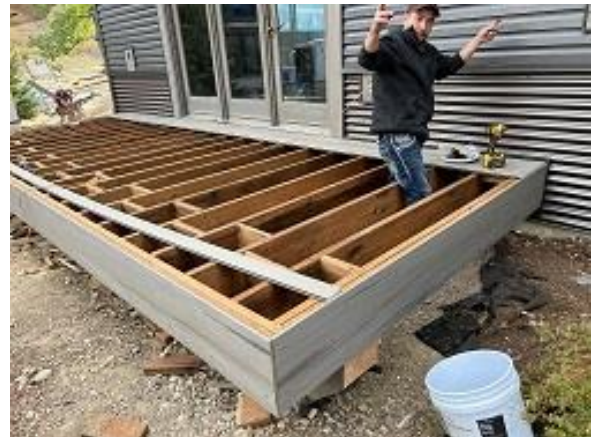
**Building C10 Unit 70 Deck Fascia
Installed**
