# Elkhorn Creek Lodges

September 1, 2023 • Big Sky, MT

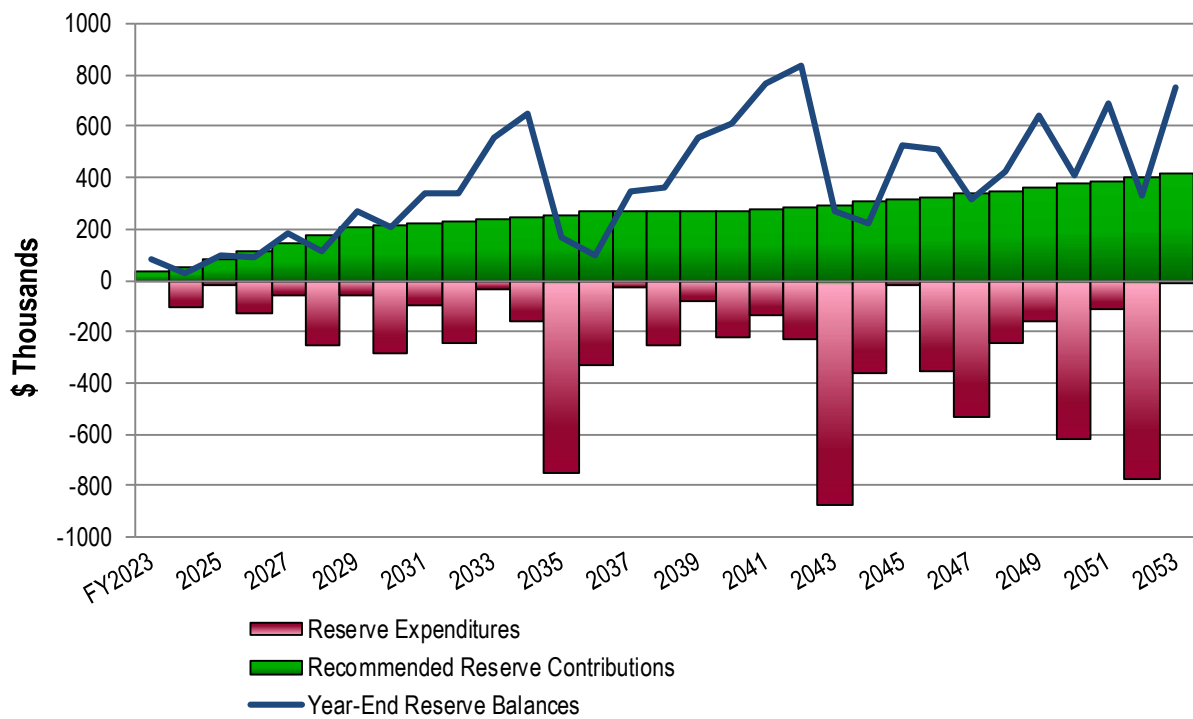
Year	Reserve Contributions (\$)	Reserve Balances (\$)	Year	Reserve Contributions (\$)	Reserve Balances (\$)	Year	Reserve Contributions (\$)	Reserve Balances (\$)
2024	54,000 (Budgeted)	28,752	2034	248,200	656,773	2044	305,100	221,905
2025	85,000	101,328	2035	256,900	167,814	2045	315,800	529,801
2026	116,000	95,097	2036	265,900	103,275	2046	326,900	511,830
2027	147,000	188,678	2037	265,900	343,981	2047	338,300	322,148
2028	178,000	117,025	2038	265,900	363,912	2048	350,100	431,571
2029	209,000	269,869	2039	265,900	553,934	2049	362,400	637,497
2030	216,300	207,493	2040	265,900	608,806	2050	375,100	405,857
2031	223,900	341,358	2041	275,200	765,077	2051	388,200	689,615
2032	231,700	336,287	2042	284,800	838,903	2052	401,800	326,421
2033	239,800	556,717	2043	294,800	270,273	2053	415,900	753,008

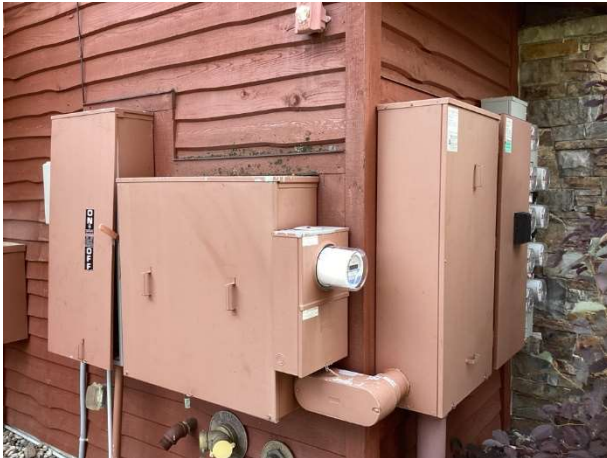
**Electrical panels**

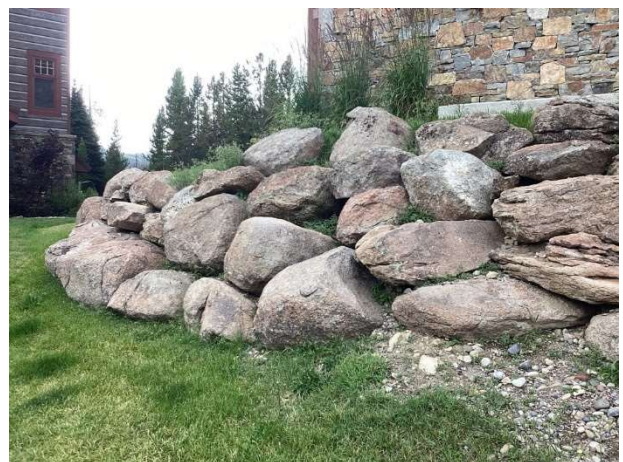
**Stone boulder retaining wall**

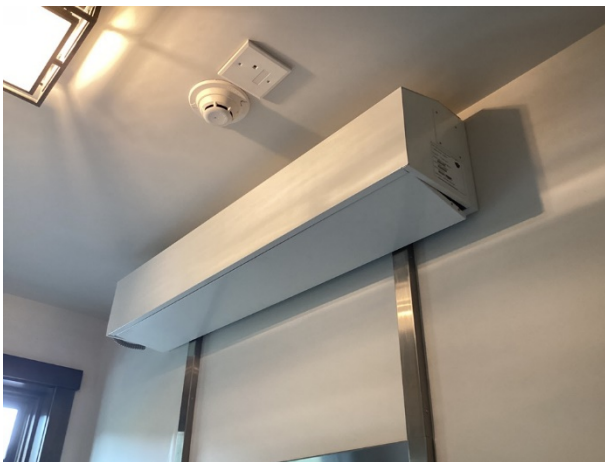
**Building Two fire door**

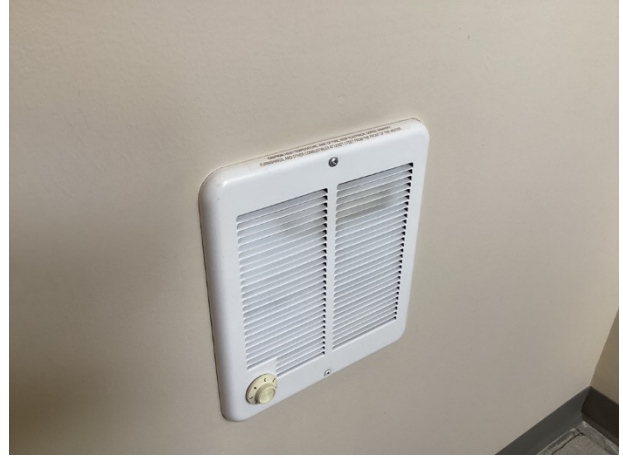
**Stairwell unit heater**

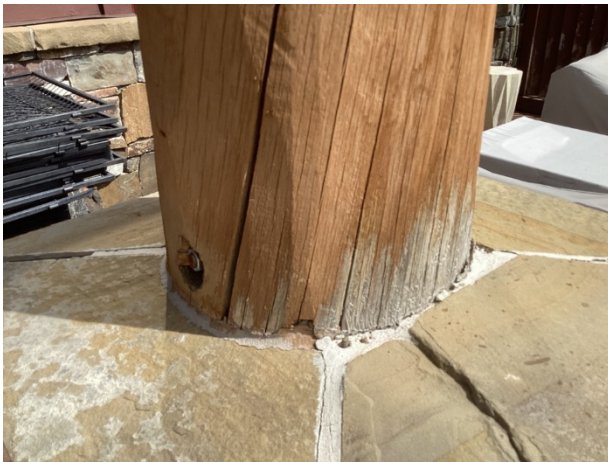
**Timber balcony post base weathering**

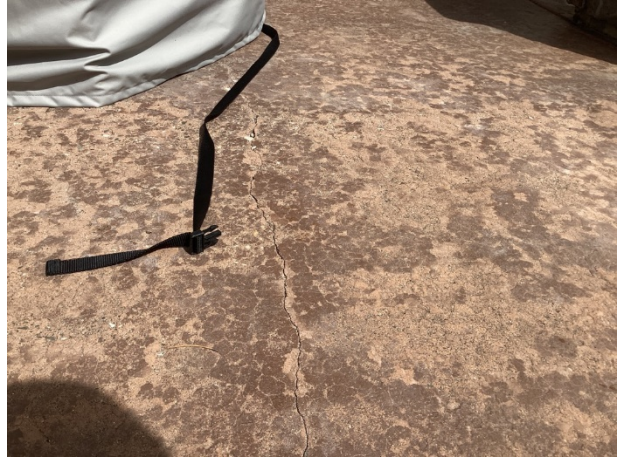
**Unit owner garage doors**

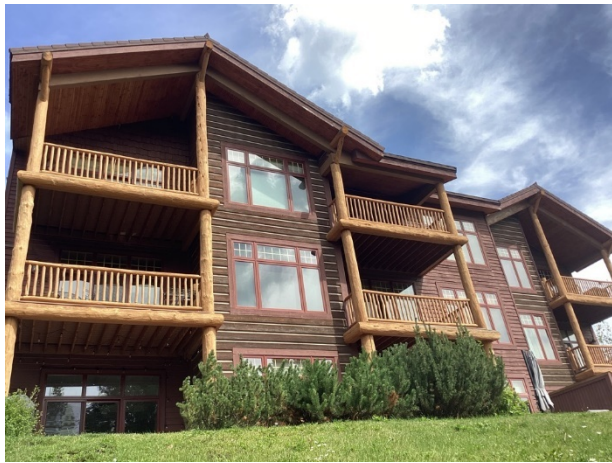
**Building One exterior rear elevation view**

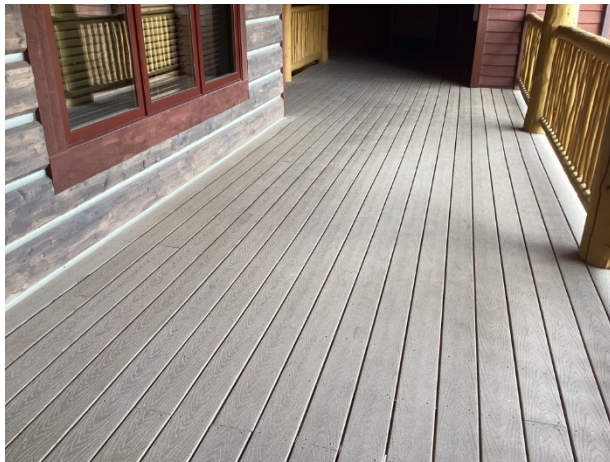
**Composite breezeway deck at Building One**

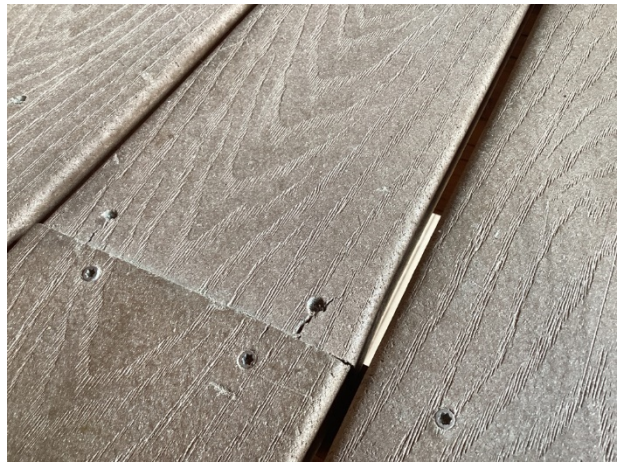
**Decking cracks at fasteners**

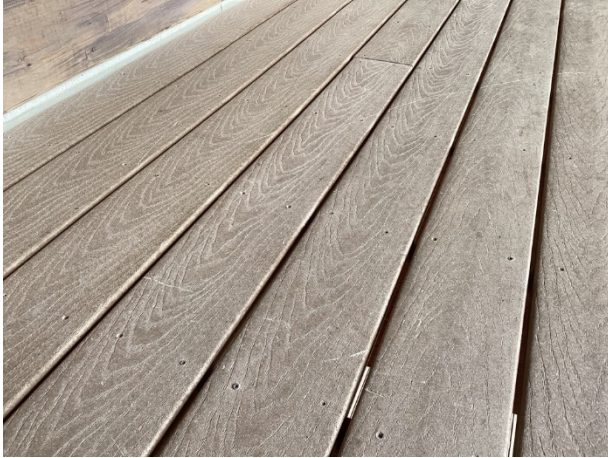
**Decking scratches**

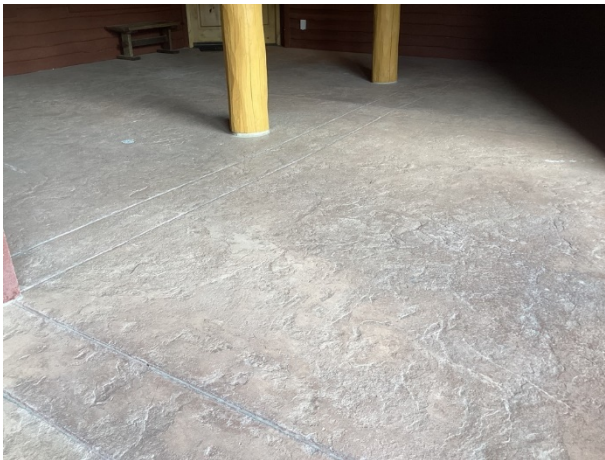
**Condition:** Good overall with no visible deterioration

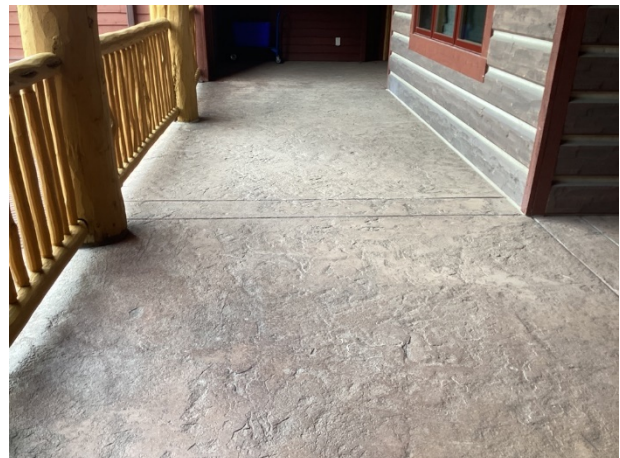
Concrete breezeway at Building One

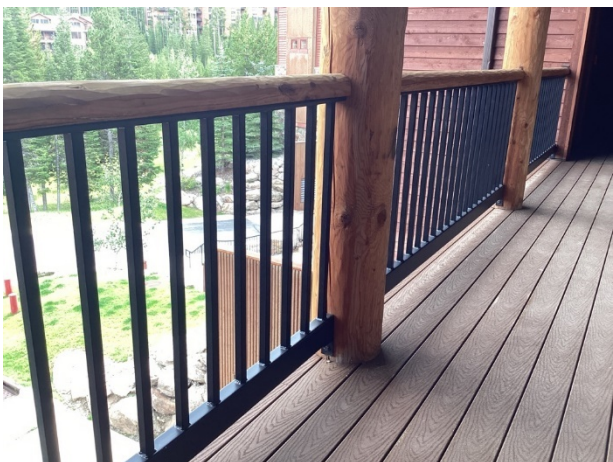
**Steel railings at Building Two (Long lived)**

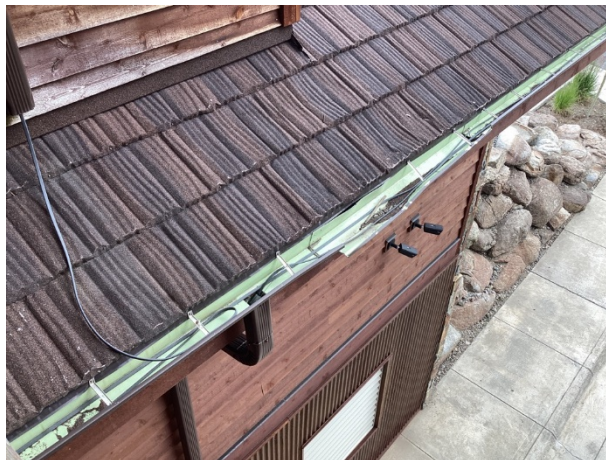
**Gutter damage and heat tape at Building Two**

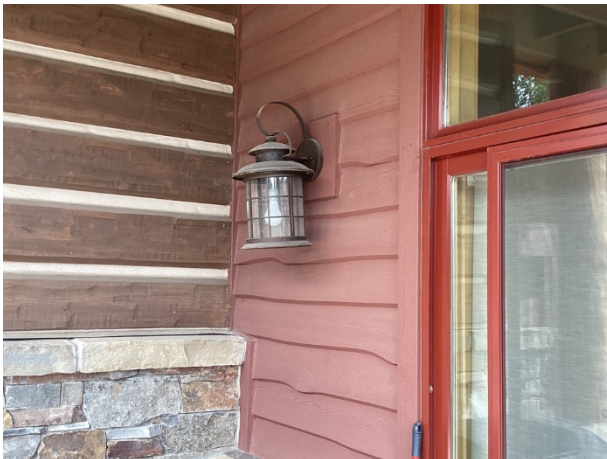
**Building One wall mounted light fixture**

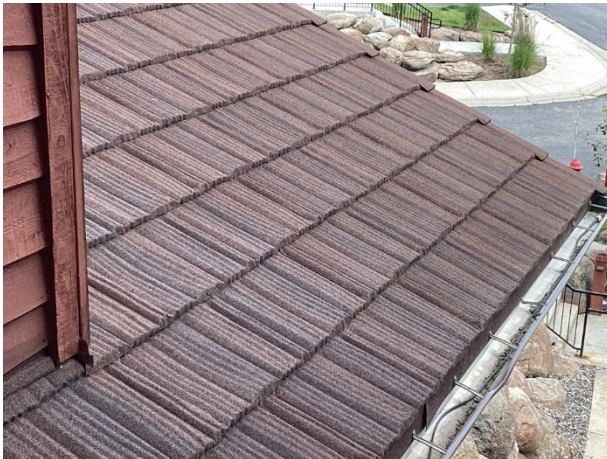
Stone coated metal roofing

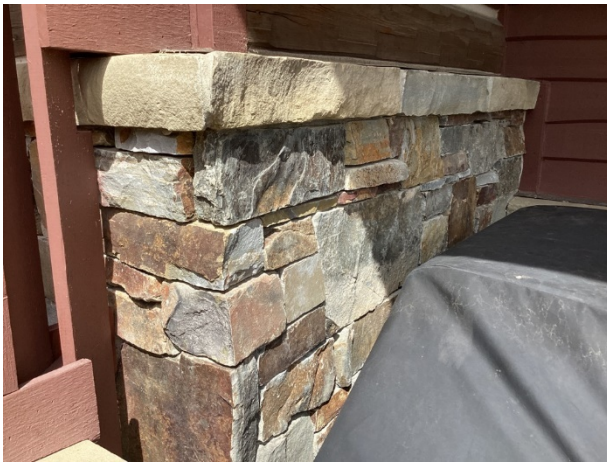
**Condition:** Good overall with no significant stone damage noted. We note isolated areas of mortar loss and efflorescence staining.

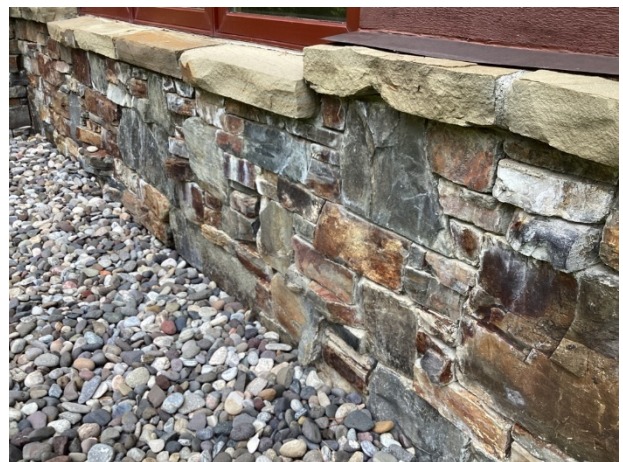
**Stone efflorescence**

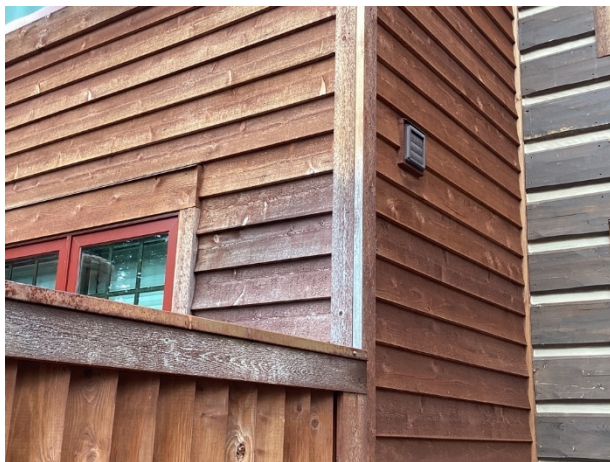
Finish wear at siding at Building Two

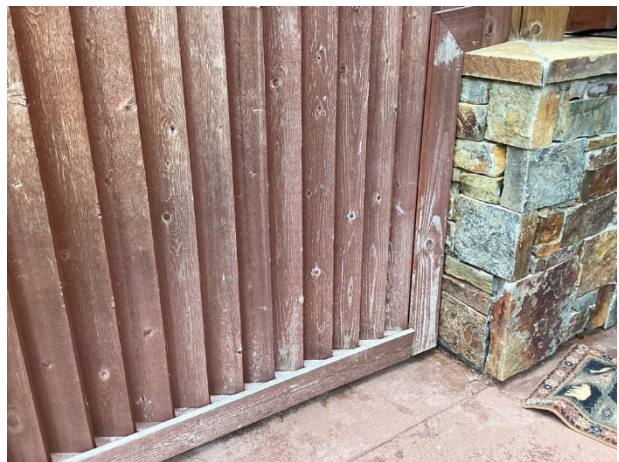
Privacy wall finish loss at Building Two

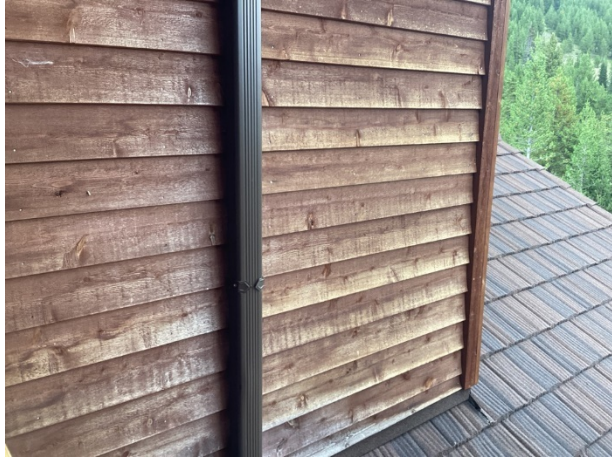
**Finish wear at siding at Building Two**

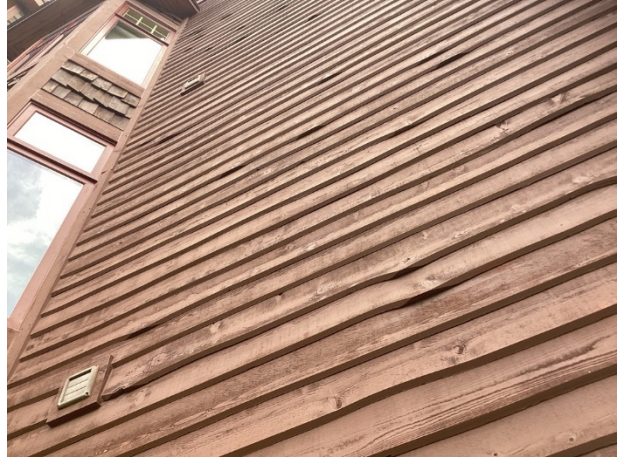
**Lap wood siding at Building One**

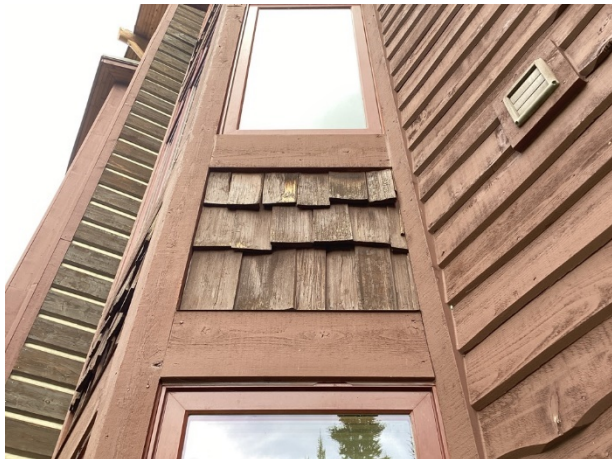
**Finish deterioration at shake siding at Building One**

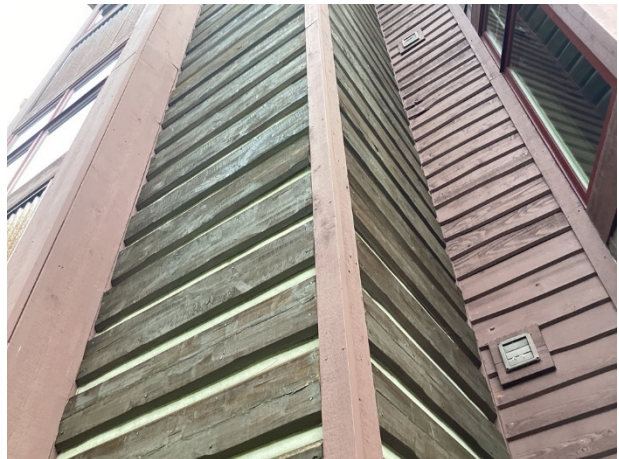
**Log style siding at Building One**

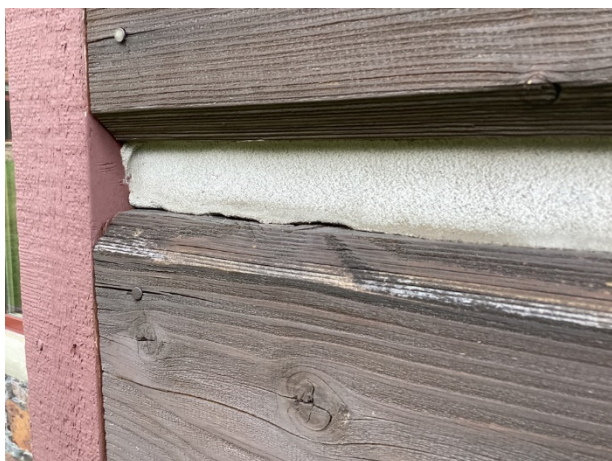
**Isolated chinking deterioration**

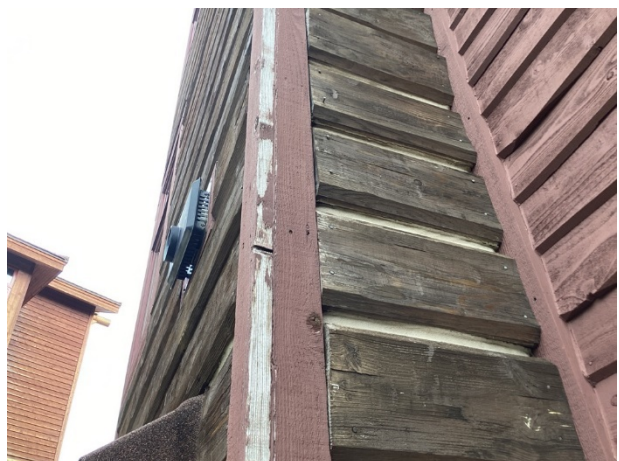
**Corner trim finish wear at Building One**

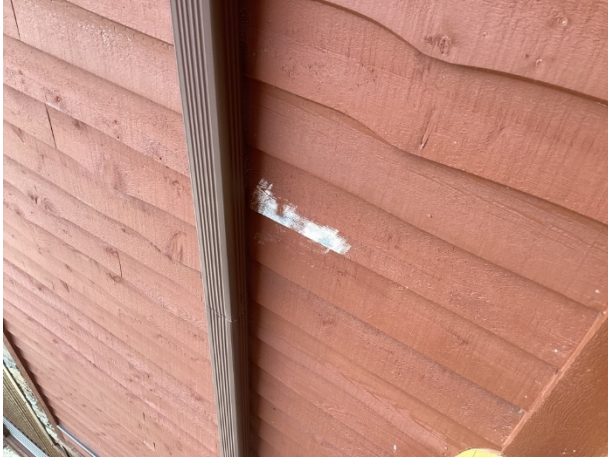
**Siding finish loss near downspout at Building One**

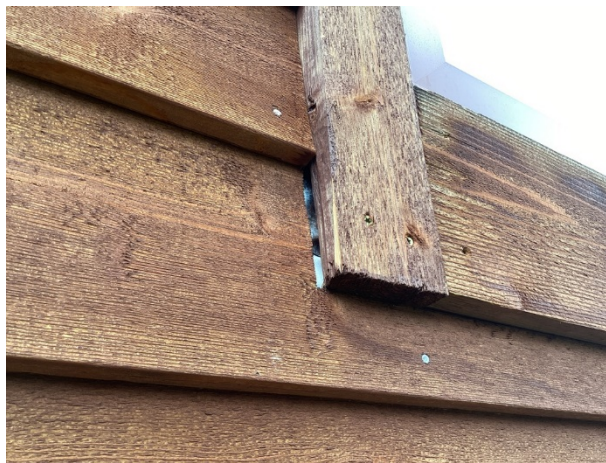
**Gap between trim and siding at Building Two**

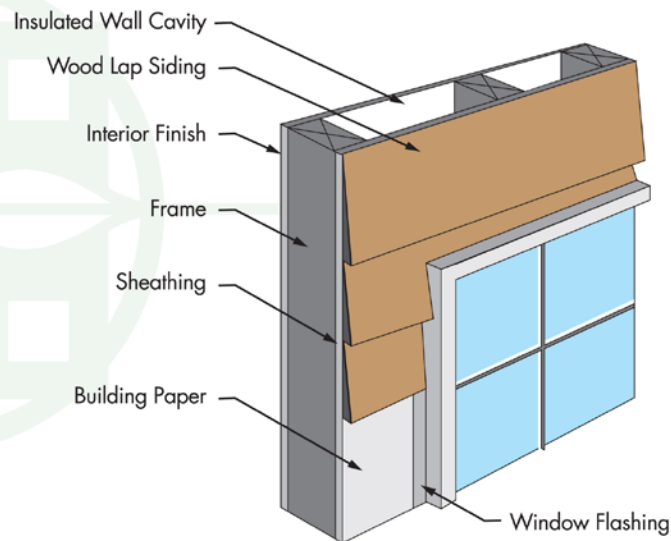
## LAP SIDING DETAIL

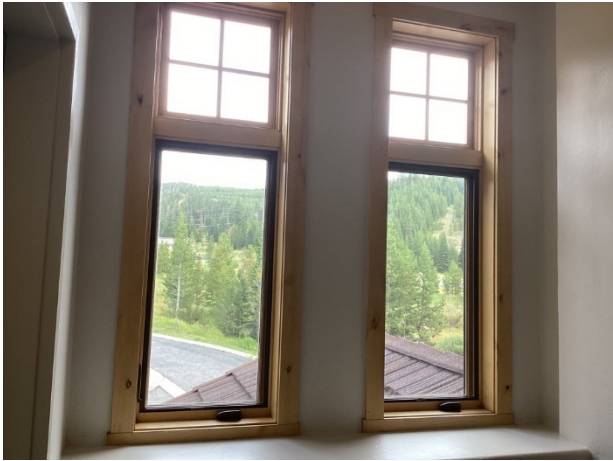
Common windows at stairwell

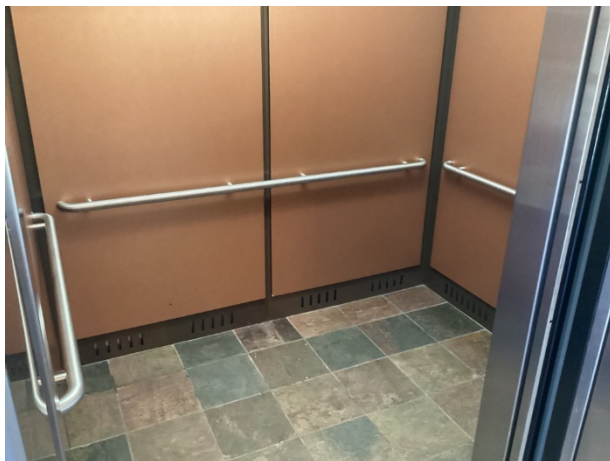
**Elevator cab finishes at Building One**

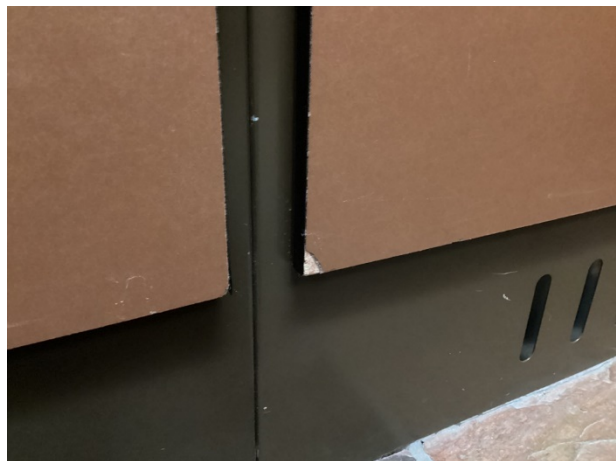
**Wall damage at Building One**

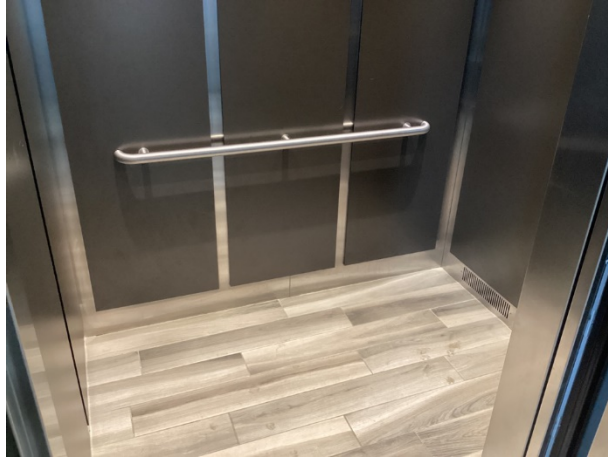
**Elevator cab finishes at Building Two**

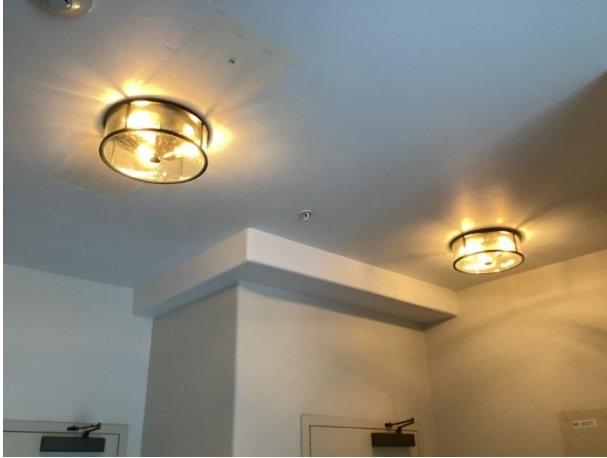
**Elevator landing lighting**

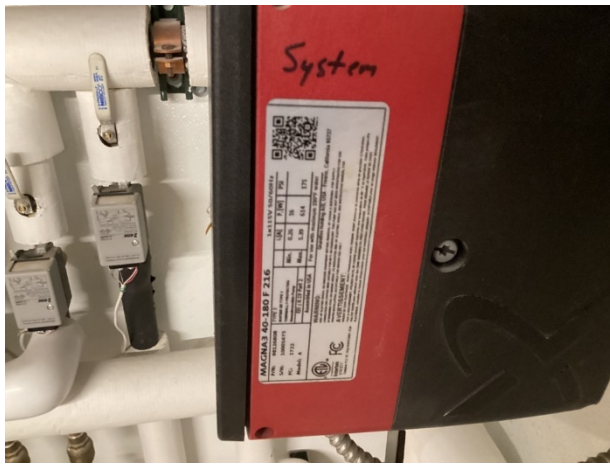
**Circulation pump serial tag**

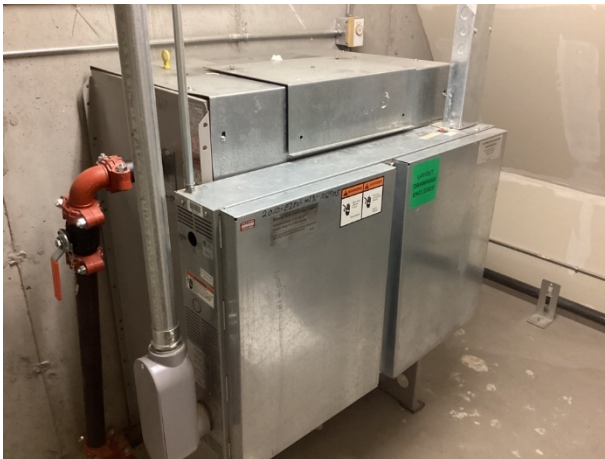
Hydraulic elevator equipment at Building One

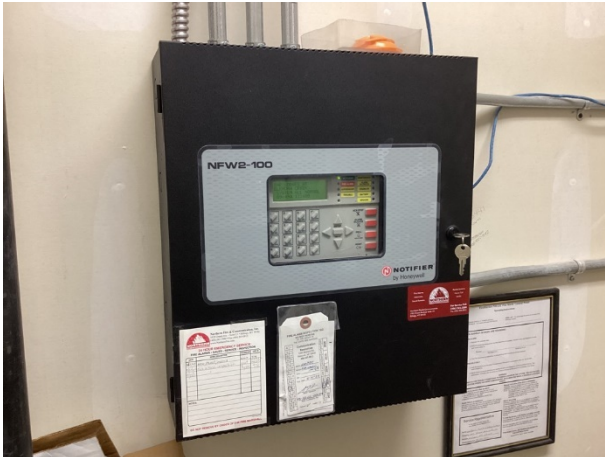
**Control panel at Building One**

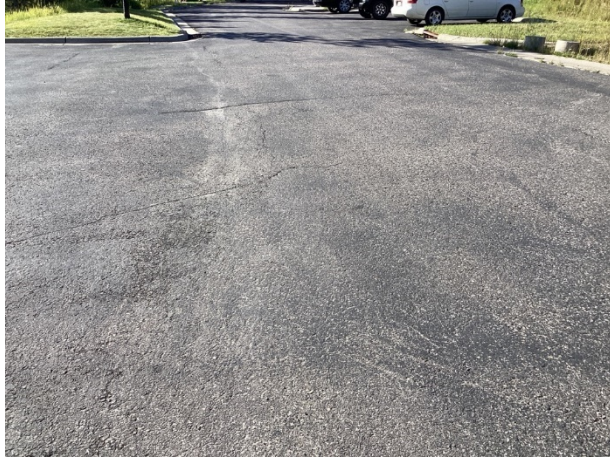
**Asphalt pavement access drive overview**

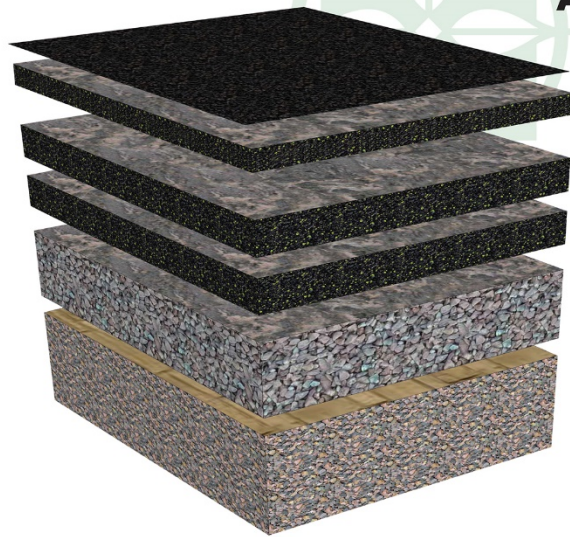
**Component Detail Notes:** The initial installation of asphalt uses at least two lifts, or two separate applications of asphalt, over the base course. The first lift is the binder course. The second lift is the wearing course. The wearing course comprises a finer aggregate for a smoother more watertight finish. The following diagram depicts the typical components although it may not reflect the actual configuration at Elkhorn Creek:

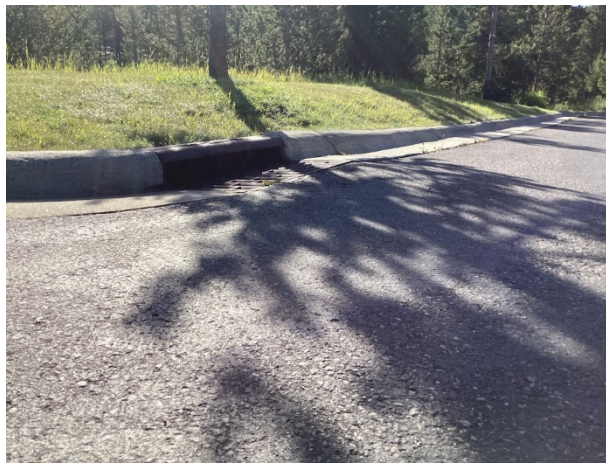
**Heaves near catch basin**

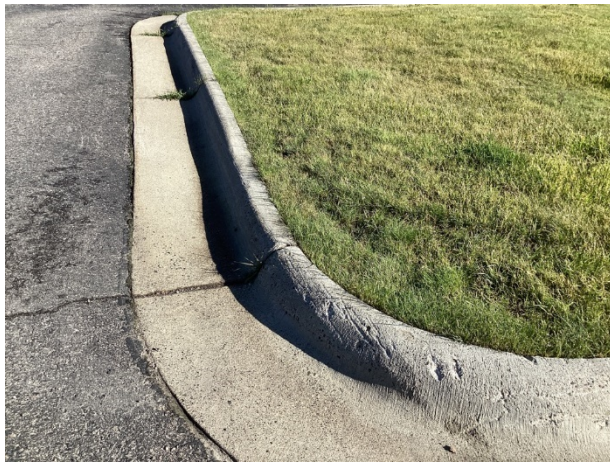
**Concrete curb and gutter**

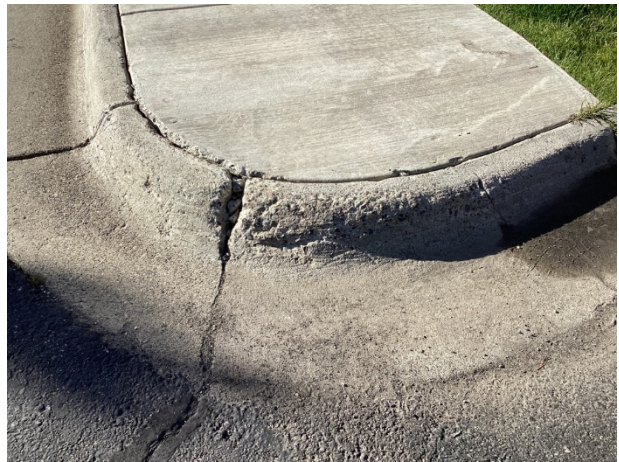
**Curb spalls and cracks**

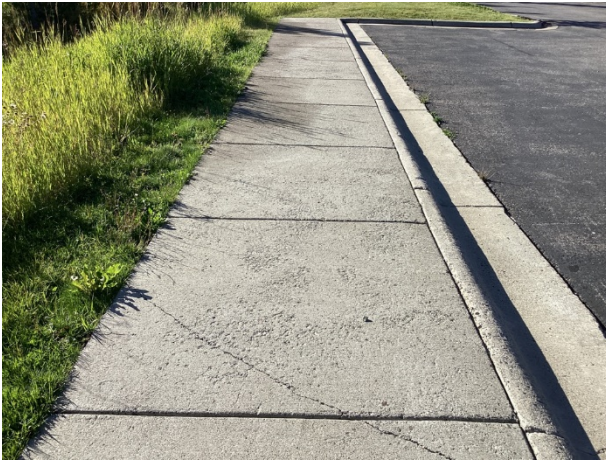
Sidewalk spalls and cracks

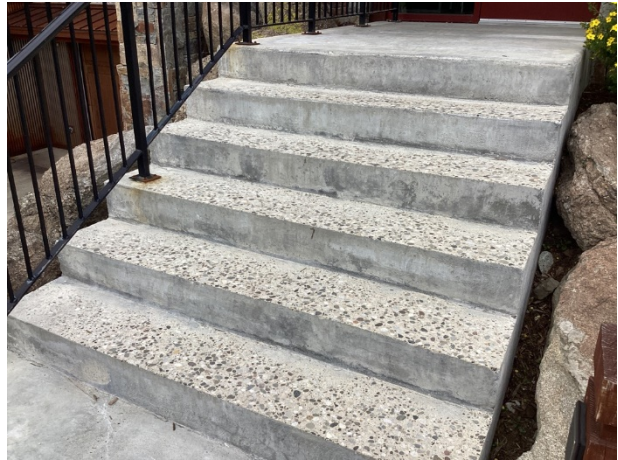
Building Two previous grinding repairs

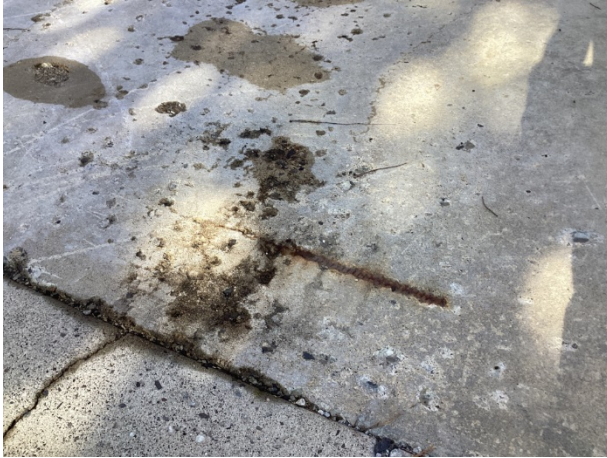
**Exposed rebar at Building One entry sidewalk**

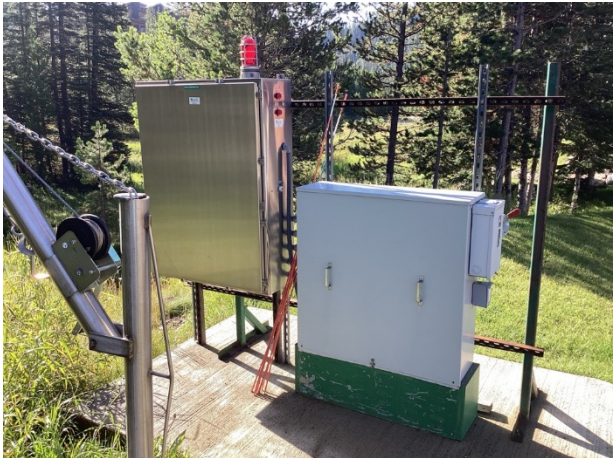
**Lift station controls**

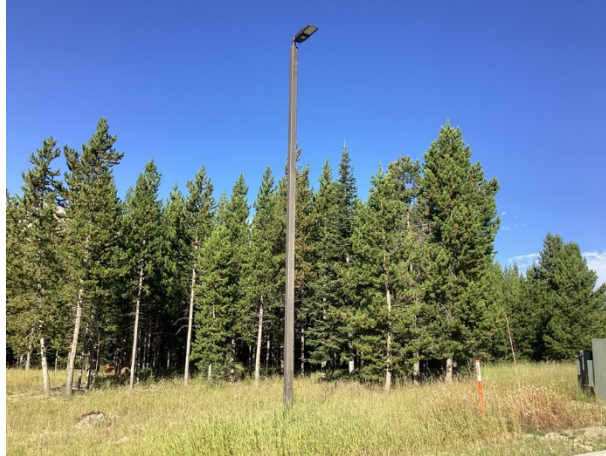
**Light pole and fixture**

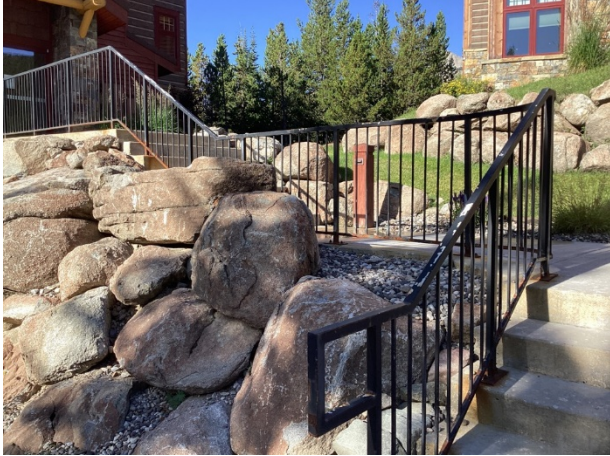
**Building One entry railing**

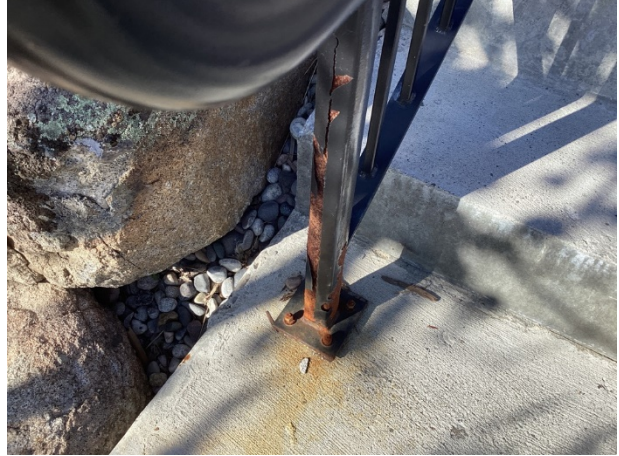
**Building Two railing base rust**

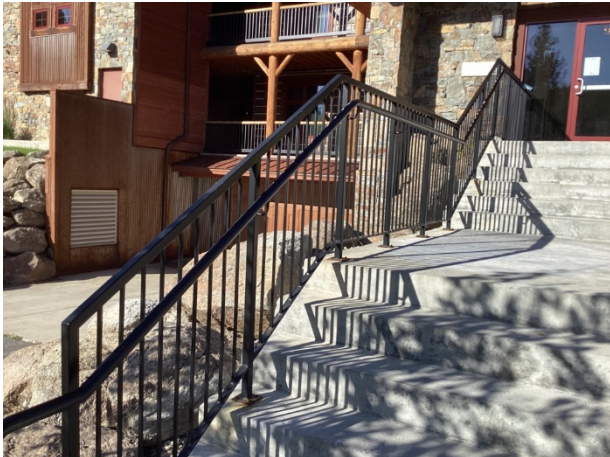
**Building Two railing**

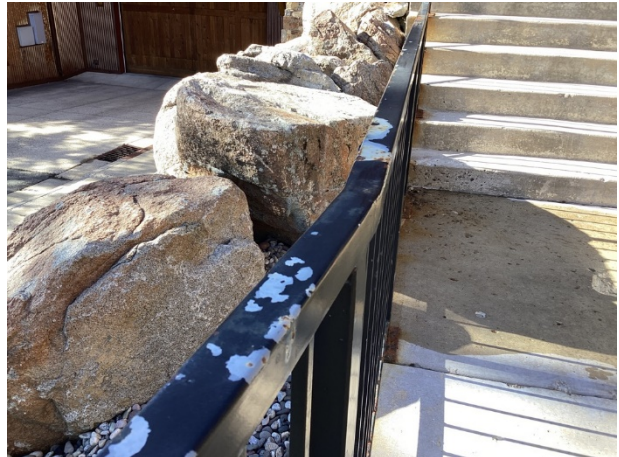
**Railing finish deterioration**

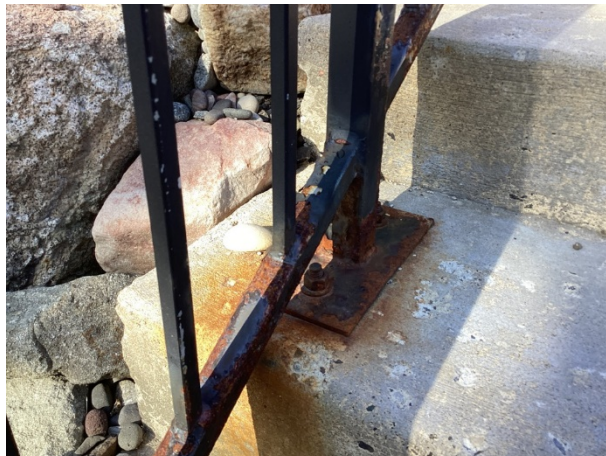
**Significant base rust**

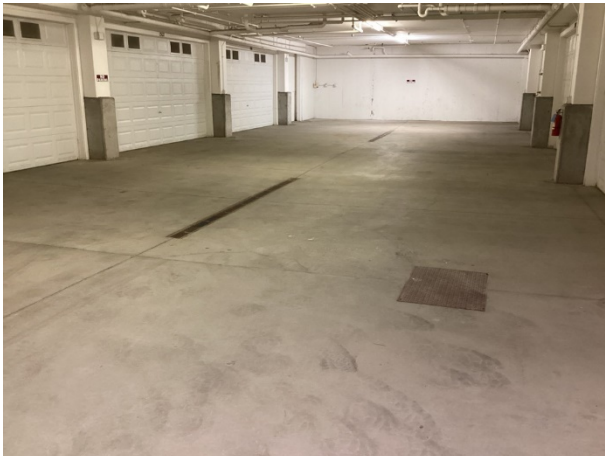
On-grade garage floor overview

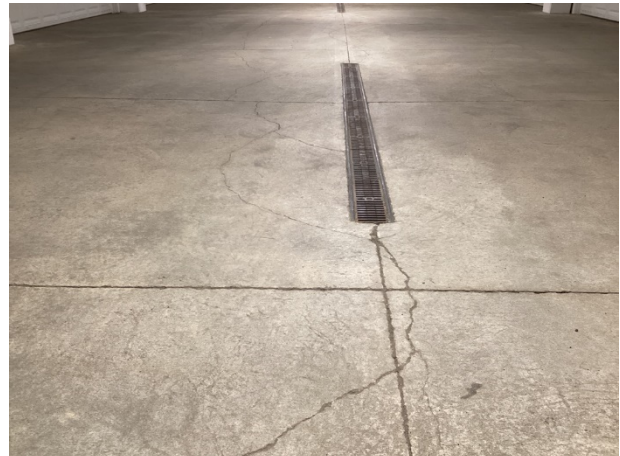
Concrete cracks at Building Two

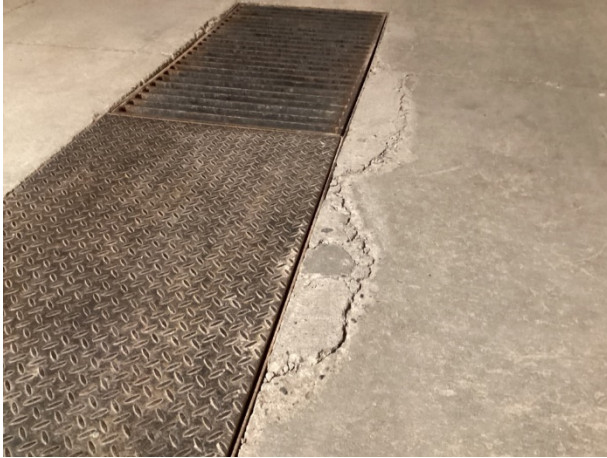
**Cracks near drainage vault**

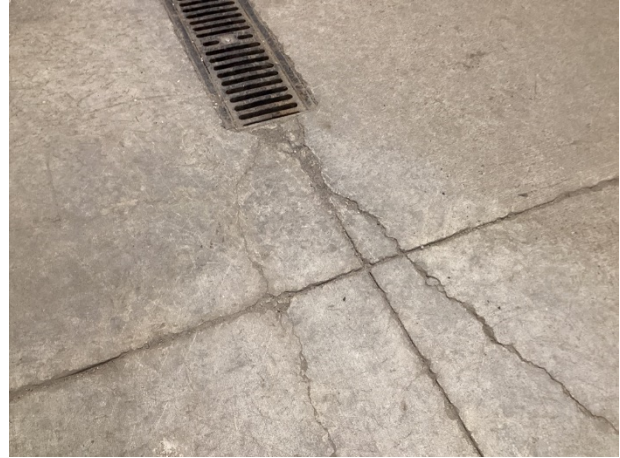
**Cracks near drain**

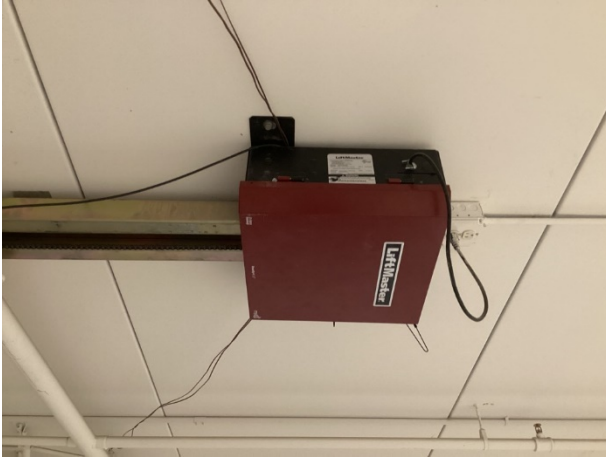
**Garage door operator at Building Two**

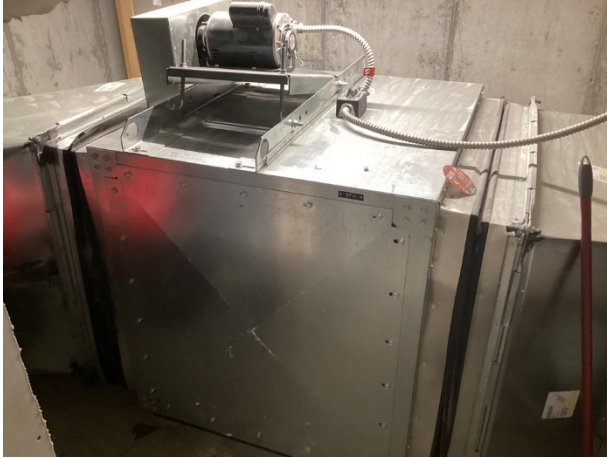
**Garage exhaust fan**

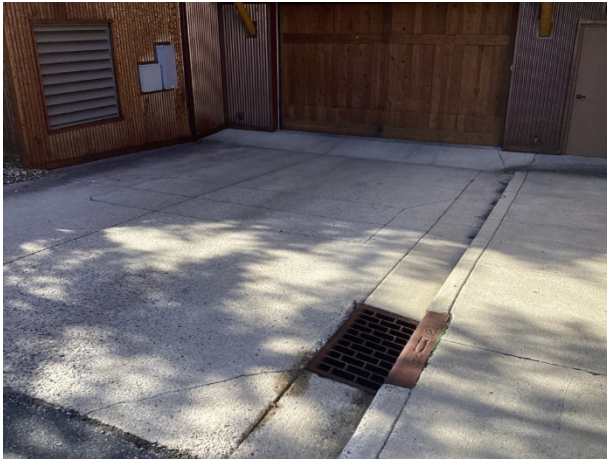
Garage ramp with snow melt system at Building One

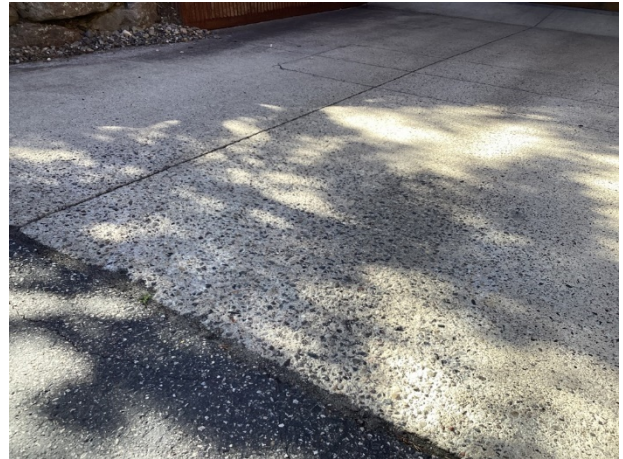
Building One ramp spalls

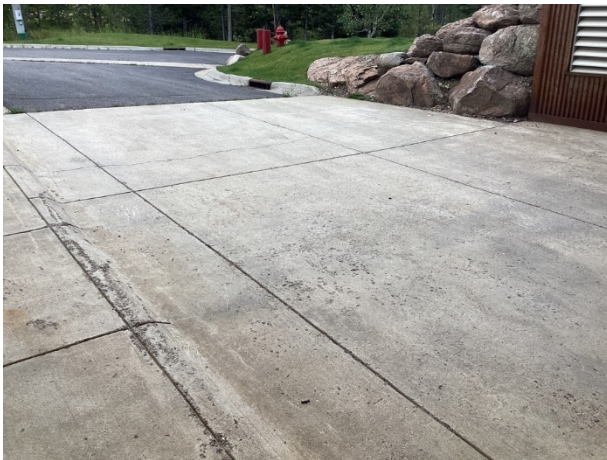
Garage ramp with snow melt system at Building Two

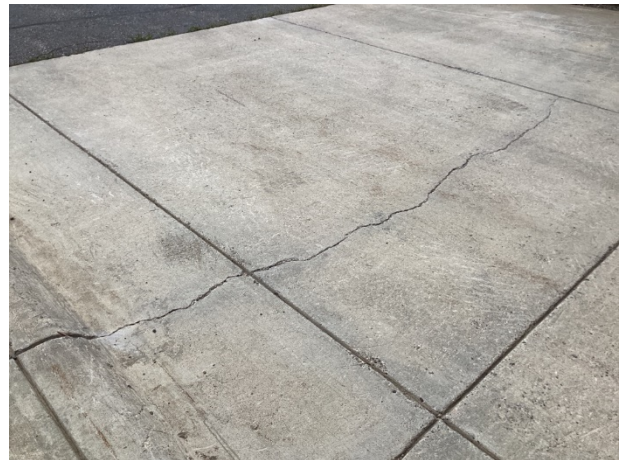
Cracks at Building Two ramp

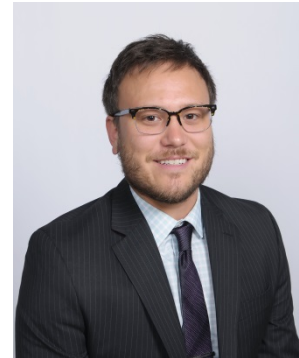
The following is a partial list of over 750 clients served by Tanner Oldenburger demonstrating his breadth of experiential knowledge of community associations in construction, remediation procedures and related buildings systems.

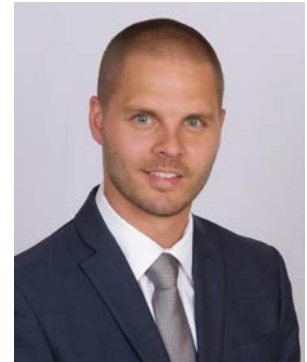
The following is a partial list of clients served by Christopher DeWall demonstrating his breadth of experiential knowledge of community associations in construction and related buildings systems.
