## Daily Observation Report

Date of Report: June 7, 2021  
 Prepared By: Jim Goveia

**PROJECT:** BIG HORN CONDO SIDING REPLACEMENT & EXTERIOR UPGRADES PHASE 1

**REPORT #:** 032

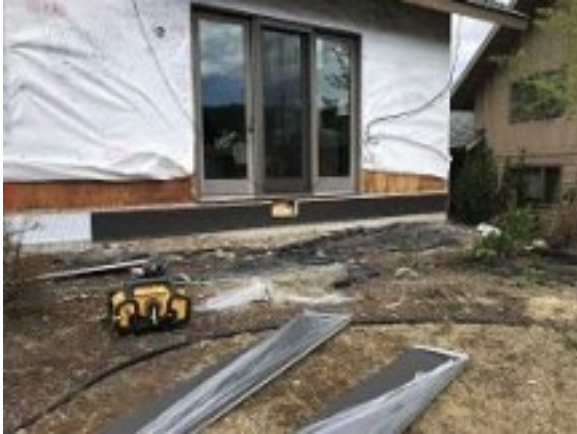
**TESTS/INSPECTIONS –** E3: MCM observed that there is metal flashing missing in two locations as detailed on architectural plans dated 02.05.21 page A1-7 detail 9 and 2. This condition can be seen on picture below Building E3 Unit 24. There should be metal flashing at 37" above the bottom flashing and above each window trim. MCM will notify the contractor to immediately correct.

**Building E3 Unit 24 Metal Flashing Installation Building E1 Unit 11 Diverter Flashing**
